Profile/Photo Observation Report

| Street: | East 38th Avenue | Flow Control: | Not Controlled |
| Use: | Sanitary Sewage Pipe | Material: | VCP |
| US MH: | M-903-006 | DS MH: | M-903-009 |

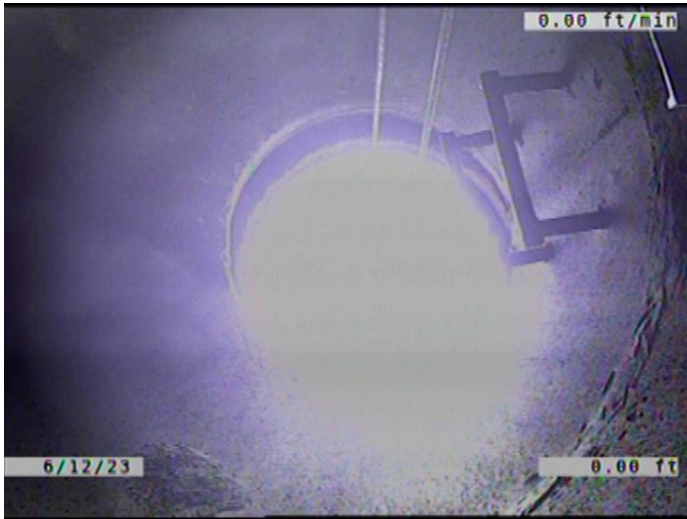
Code: **AMH**
Description: **Manhole**

Distance (ft): **.0**
Structural Grade: **0**
O&M Grade: **0**
Clock Start/From:
Clock To:
1st Value:
2nd Value:
Value Percent:
Continuous Index:
Within 8" of Joint: **NO**
Remarks: **M-903-009**

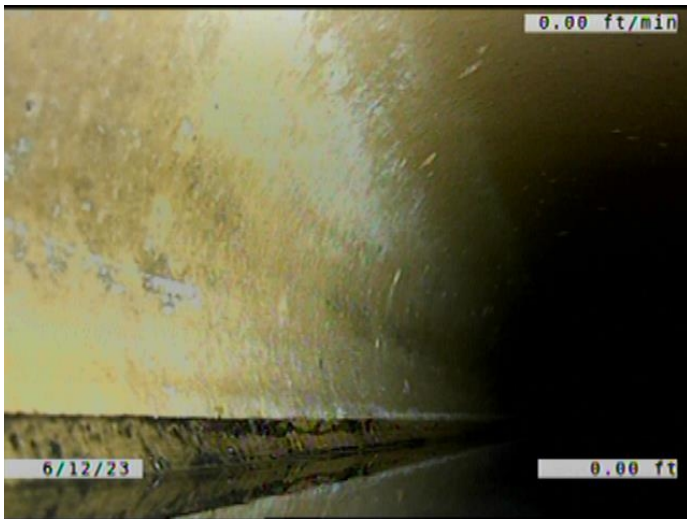
Code: **MWL**
Description: **Miscellaneous Water Level**

Distance (ft): **.0**
Structural Grade: **0**
O&M Grade: **0**
Clock Start/From:
Clock To:
1st Value:
2nd Value:
Value Percent: **25.000**
Continuous Index:
Within 8" of Joint: **NO**
Remarks:

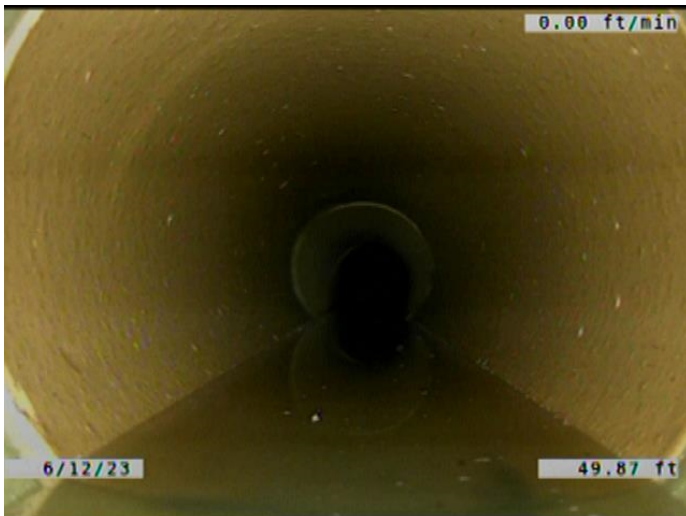
Code: **MWL**
Description: **Miscellaneous Water Level**

Distance (ft): **49.9**
Structural Grade: **0**
O&M Grade: **0**
Clock Start/From:
Clock To:
1st Value:
2nd Value:
Value Percent: **15.000**
Continuous Index:
Within 8" of Joint: **NO**
Remarks:

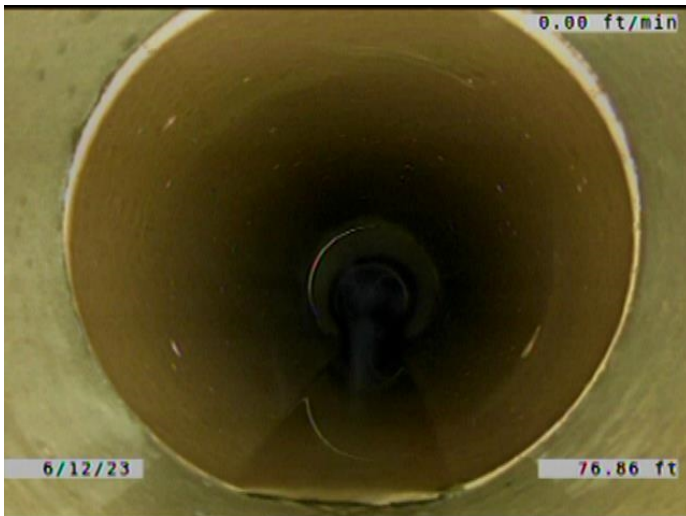
Code: **MWL**
Description: **Miscellaneous Water Level**

Distance (ft): **76.9**
Structural Grade: **0**
O&M Grade: **0**
Clock Start/From:
Clock To:
1st Value:
2nd Value:
Value Percent: **5.000**
Continuous Index:
Within 8" of Joint: **NO**
Remarks:

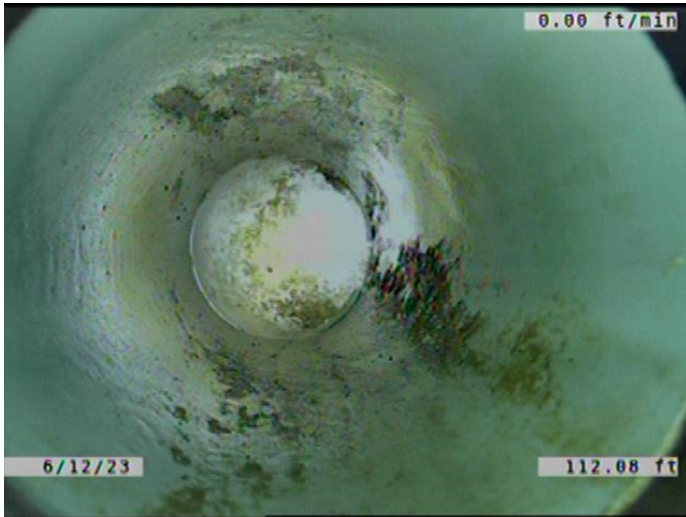
| Code: | TB |
| Description: | Tap Break-in/Hammer |
| Distance (ft): | 112.1 |
| Clock Start/From: | 12 |
| 1st Value: | 6.000 |

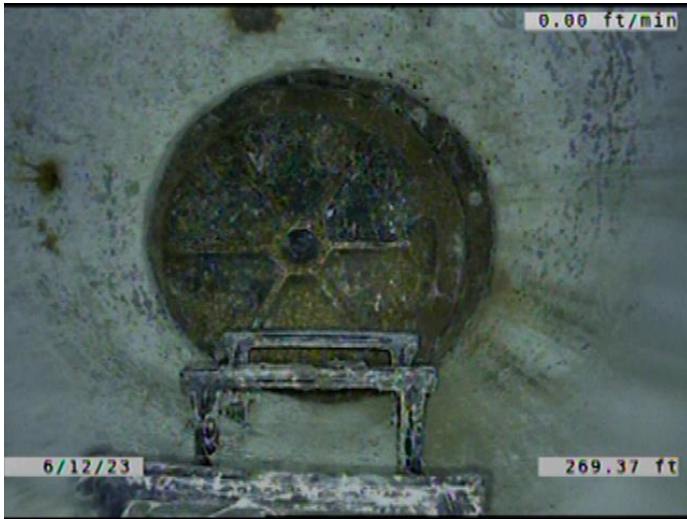
| Code: | AMH |
| Description: | Manhole |
