Profile/Photo Observation Report

| Street: | E 38TH AVE & SPENCER PL | Flow Control: | Not Controlled |
| City: | Hobart, IN | Year Renewed: | |
| US MH: | M-903-006 | DS MH: | M-903-011 |

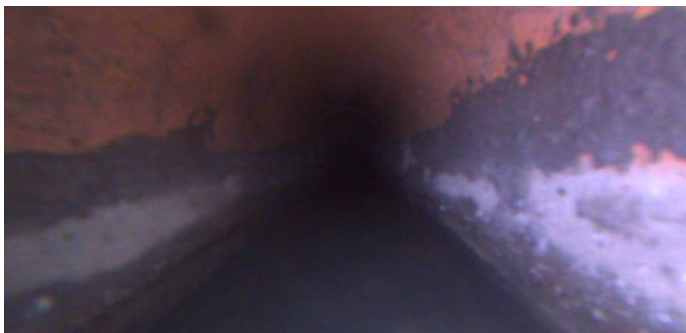
Code: **AMH**
Description: **Manhole**

Distance (ft): **.0**
Structural Grade: **0**
O&M Grade: **0**
Clock Start/From:
Clock To:
1st Value:
2nd Value:
Value Percent:
Continuous Index:
Within 8" of Joint: **NO**
Remarks: **M-903-011**

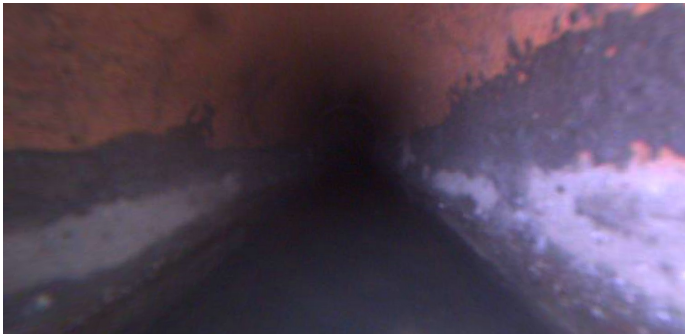
| Code: | MWL |
| Description: | Water Level |

| Value Percent: | 30.000 |

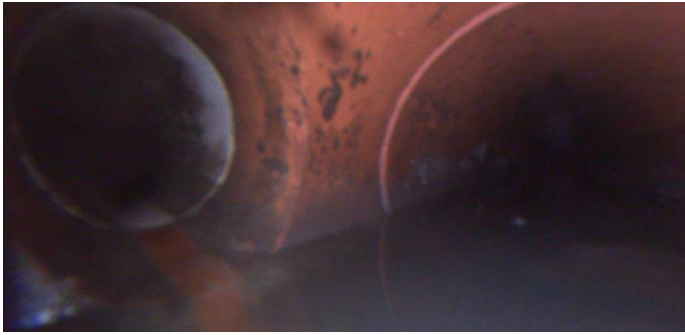
Code: **TFA**
Description: **Tap Factory Active**

Distance (ft): **36.5**
Structural Grade: **0**
O&M Grade: **0**
Clock Start/From: **9**
Clock To:
1st Value: **4.000**
2nd Value:
Value Percent:
Continuous Index:
Within 8" of Joint:
Remarks:

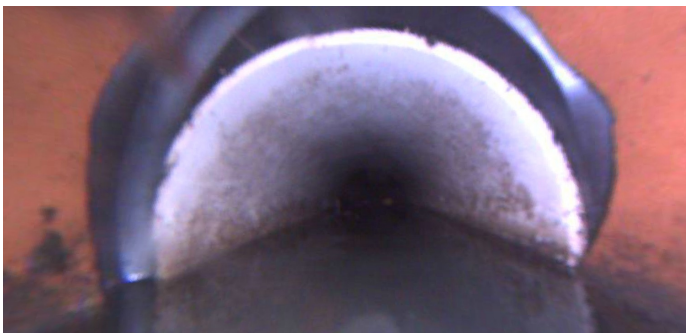
Code: **MMC**
Description: **Material Change**

Distance (ft): **57.6**
Structural Grade: **0**
O&M Grade: **0**
Clock Start/From:
Clock To:
1st Value:
2nd Value:
Value Percent:
Continuous Index:
Within 8" of Joint: **NO**
Remarks: **pvc**

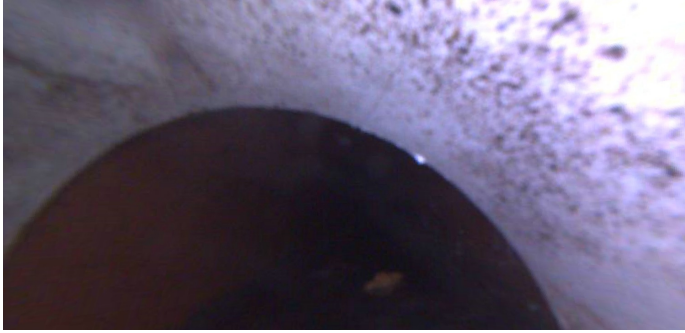
Code: **MMC**
Description: **Material Change**

Distance (ft): **61.0**
Structural Grade: **0**
O&M Grade: **0**
Clock Start/From:
Clock To:
1st Value:
2nd Value:
Value Percent:
Continuous Index:
Within 8" of Joint: **NO**
Remarks: **VCP**

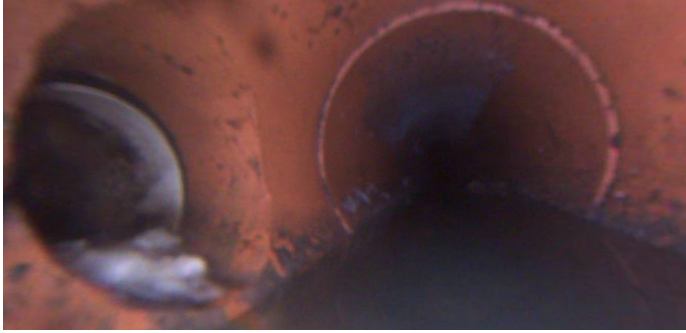
Code: **TF**
Description: **Tap Factory**

Distance (ft): **99.3**
Structural Grade: **0**
O&M Grade: **0**
Clock Start/From: **9**
Clock To:
1st Value: **4.000**
2nd Value:
Value Percent:
Continuous Index:
Within 8" of Joint:
Remarks:

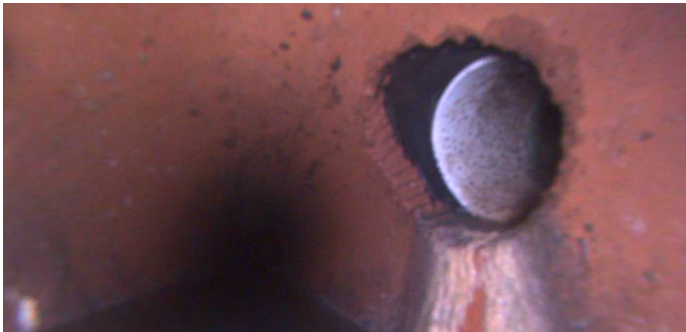
Code: **TBA**
Description: **Tap Break-in Active**

Distance (ft): **125.8**
Structural Grade: **0**
O&M Grade: **0**
Clock Start/From: **2**
Clock To:
1st Value: **4.000**
2nd Value:
Value Percent:
Continuous Index:
Within 8" of Joint:
Remarks:

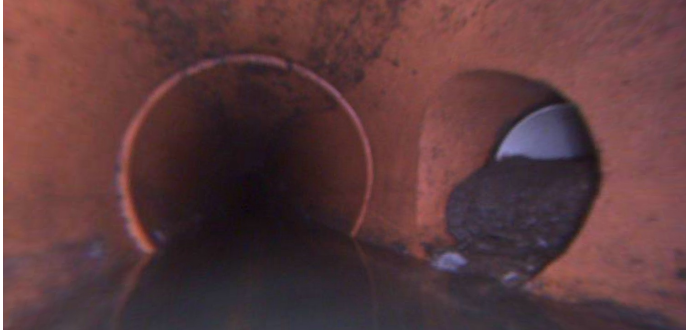
Code: **TF**
Description: **Tap Factory**

Distance (ft): **136.8**
Structural Grade: **0**
O&M Grade: **0**
Clock Start/From: **3**
Clock To:
1st Value: **4.000**
2nd Value:
Value Percent:
Continuous Index:
Within 8" of Joint:
Remarks:

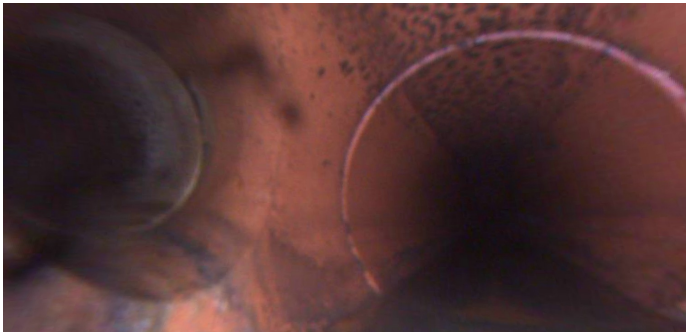
Code: **TFA**
Description: **Tap Factory Active**

Distance (ft): **156.8**
Structural Grade: **0**
O&M Grade: **0**
Clock Start/From: **9**
Clock To:
1st Value: **4.000**
2nd Value:
Value Percent:
Continuous Index:
Within 8" of Joint:
Remarks:

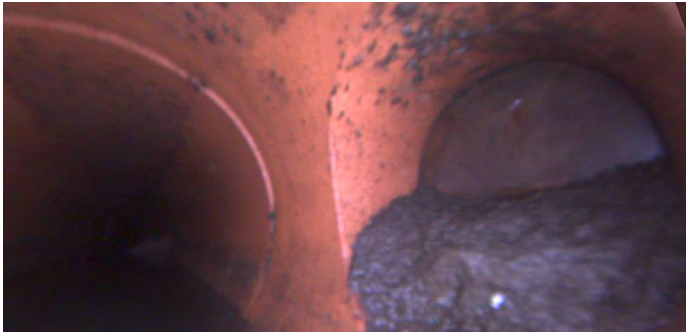
Code: **TFC**
Description: **Tap Factory Capped**

Distance (ft): **200.4**
Structural Grade: **0**
O&M Grade: **0**
Clock Start/From: **3**
Clock To:
1st Value: **4.000**
2nd Value:
Value Percent:
Continuous Index:
Within 8" of Joint:
Remarks:

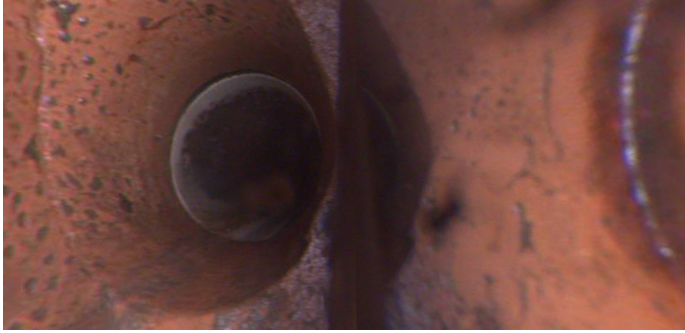
Code: **TF**
Description: **Tap Factory**

Distance (ft): **214.7**
Structural Grade: **0**
O&M Grade: **0**
Clock Start/From: **9**
Clock To:
1st Value: **4.000**
2nd Value:
Value Percent:
Continuous Index:
Within 8" of Joint:
Remarks:

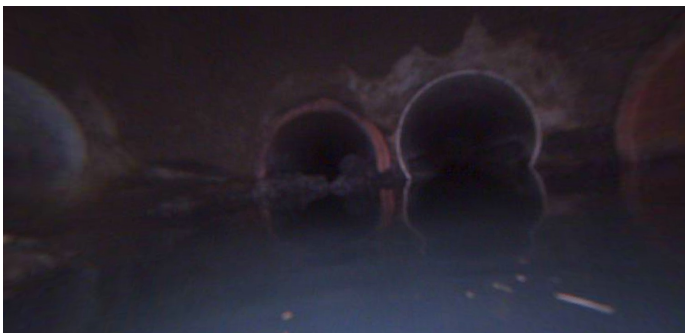
Code: **AMH**
Description: **Manhole**

Distance (ft): **312.0**
Structural Grade: **0**
O&M Grade: **0**
Clock Start/From:
Clock To:
1st Value:
2nd Value:
Value Percent:
Continuous Index:
Within 8" of Joint: **NO**
Remarks: **M-903-006**
