## Profile/Photo Observation Report

Date:	<b>03/25/2018</b>	Weather:		Coding:	<b>PACP 6.0</b>
Pipe Length (ft):	<b>359.0</b>	Owner:	<b>NA</b>	Pre Clean:	<b>Not Known</b>
P.O.#:		Surveyor:	<b>Byrd Fitzgerald</b>	PSR:	<b>P-903-011-012</b>
Customer:		Clean Date:	<b>01/01/1900</b>	Shape:	<b>C</b>

Street:	<b>SPENCER PL</b>	Flow Control:	<b>Not Controlled</b>
City:	<b>Hobart, IN</b>	Year Renewed:	
Location:	<b>Other</b>	Tape/Media #:	
Purpose:	<b>Not Known</b>	Dia/Height:	<b>10"</b>
Use:	<b>Sanitary</b>	Material:	<b>VCP</b>
Drain Area:	<b>NA</b>	Lining:	
Category:	<b>NA</b>		
Comment:

Location Details:		Direction of Survey:	<b>Downstream</b>
US MH:	<b>M-903-011</b>	DS MH:	<b>M-903-012</b>
		Total Length Surveyed (ft):	<b>350.1</b>

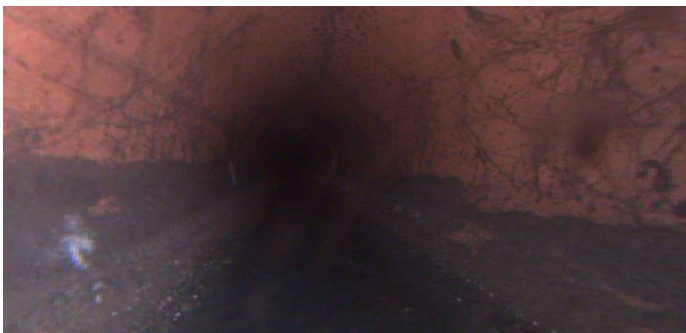
Code: **AMH**  
Description: **Manhole**

Distance (ft): **.0**  
Structural Grade: **0**  
O&M Grade: **0**  
Clock Start/From:  
Clock To:  
1st Value:  
2nd Value:  
Value Percent:  
Continuous Index:  
Within 8" of Joint: **NO**  
Remarks: **M-903-011**

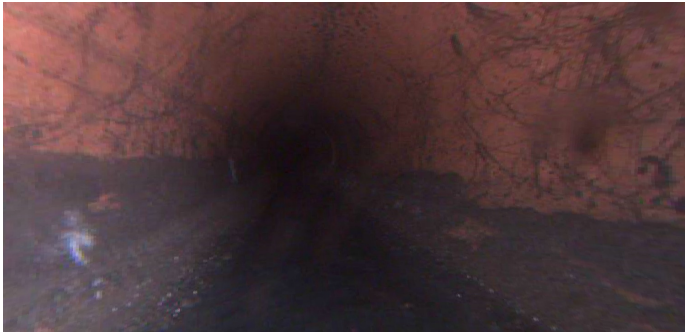
Code: **MWL**  
Description: **Water Level**

Distance (ft): **.0**  
Structural Grade: **0**  
O&M Grade: **0**  
Clock Start/From:  
Clock To:  
1st Value:  
2nd Value:  
Value Percent: **5.000**  
Continuous Index:  
Within 8" of Joint: **NO**  
Remarks:

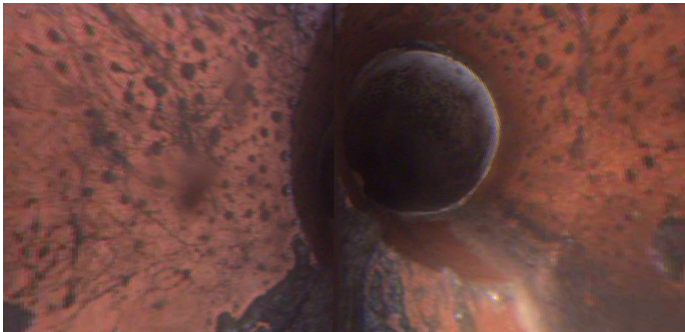
Code: **TF**  
Description: **Tap Factory**

Distance (ft): **18.1**  
Structural Grade: **0**  
O&M Grade: **0**  
Clock Start/From: **2**  
Clock To:  
1st Value: **4.000**  
2nd Value:  
Value Percent:  
Continuous Index:  
Within 8" of Joint: **YES**  
Remarks:

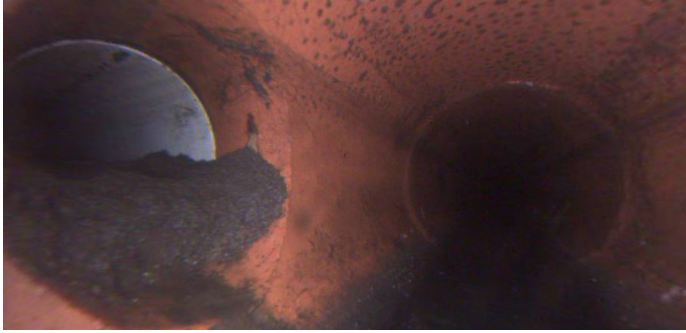
Code: **TF**  
Description: **Tap Factory**

Distance (ft): **43.4**  
Structural Grade: **0**  
O&M Grade: **0**  
Clock Start/From: **3**  
Clock To:  
1st Value: **4.000**  
2nd Value:  
Value Percent:  
Continuous Index:  
Within 8" of Joint:  
Remarks:

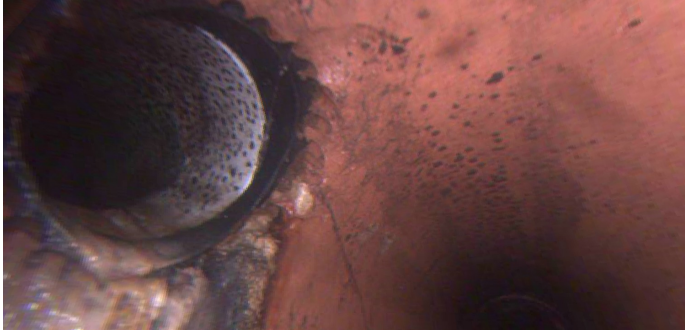
Code: **TB**  
Description: **Tap Break-in**

Distance (ft): **71.0**  
Structural Grade: **0**  
O&M Grade: **0**  
Clock Start/From: **10**  
Clock To:  
1st Value: **4.000**  
2nd Value:  
Value Percent:  
Continuous Index:  
Within 8" of Joint:  
Remarks:

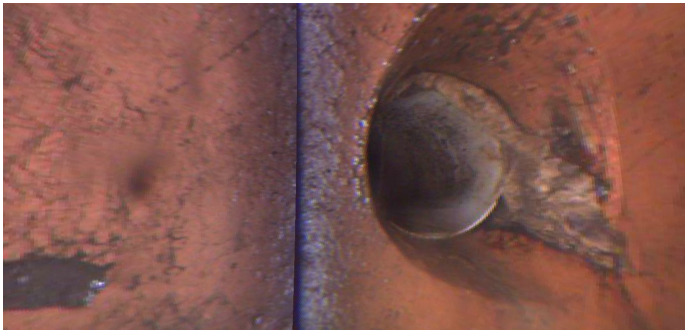
Code: **TF**  
Description: **Tap Factory**

Distance (ft): **75.9**  
Structural Grade: **0**  
O&M Grade: **0**  
Clock Start/From: **2**  
Clock To:  
1st Value: **4.000**  
2nd Value:  
Value Percent:  
Continuous Index:  
Within 8" of Joint:  
Remarks:

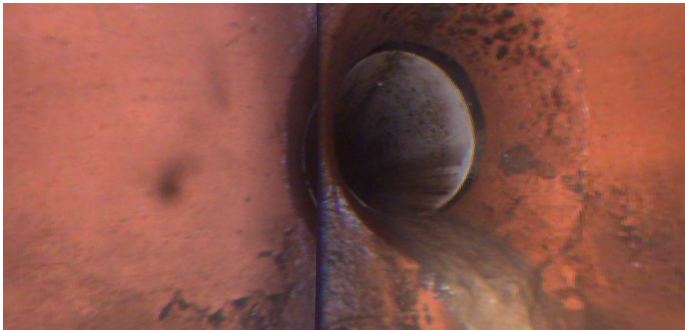
Code: **TF**  
Description: **Tap Factory**

Distance (ft): **133.7**  
Structural Grade: **0**  
O&M Grade: **0**  
Clock Start/From: **2**  
Clock To:  
1st Value: **4.000**  
2nd Value:  
Value Percent:  
Continuous Index:  
Within 8" of Joint:  
Remarks:

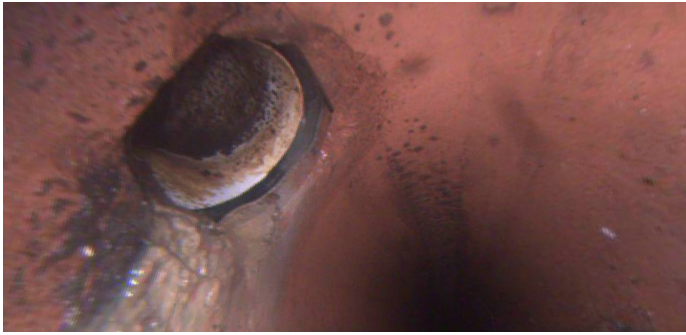
Code: **TB**  
Description: **Tap Break-in**

Distance (ft): **136.2**  
Structural Grade: **0**  
O&M Grade: **0**  
Clock Start/From: **11**  
Clock To:  
1st Value: **4.000**  
2nd Value:  
Value Percent:  
Continuous Index:  
Within 8" of Joint:  
Remarks:

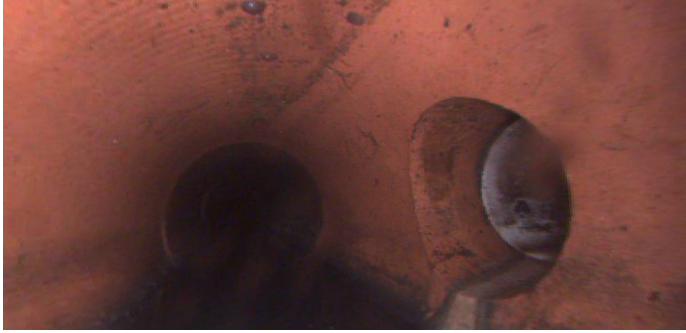
Code: **TF**  
Description: **Tap Factory**

Distance (ft): **196.6**  
Structural Grade: **0**  
O&M Grade: **0**  
Clock Start/From: **3**  
Clock To:  
1st Value: **4.000**  
2nd Value:  
Value Percent:  
Continuous Index:  
Within 8" of Joint:  
Remarks:

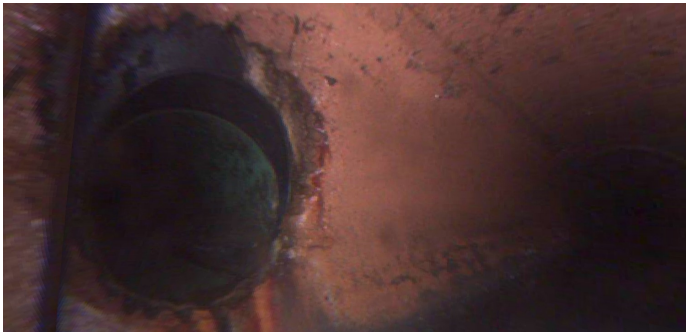
Code: **TSB**  
Description: **Tap Saddle Abandoned**

Distance (ft): **200.8**  
Structural Grade: **0**  
O&M Grade: **0**  
Clock Start/From: **3**  
Clock To:  
1st Value: **4.000**  
2nd Value:  
Value Percent:  
Continuous Index:  
Within 8" of Joint:  
Remarks:

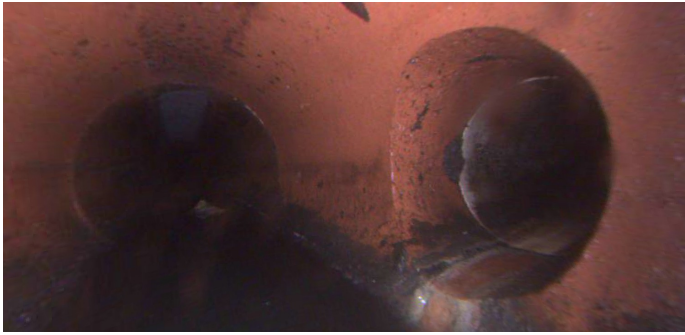
Code: **TFA**  
Description: **Tap Factory Active**

Distance (ft): **254.5**  
Structural Grade: **0**  
O&M Grade: **0**  
Clock Start/From: **3**  
Clock To:  
1st Value: **4.000**  
2nd Value:  
Value Percent:  
Continuous Index:  
Within 8" of Joint:  
Remarks:

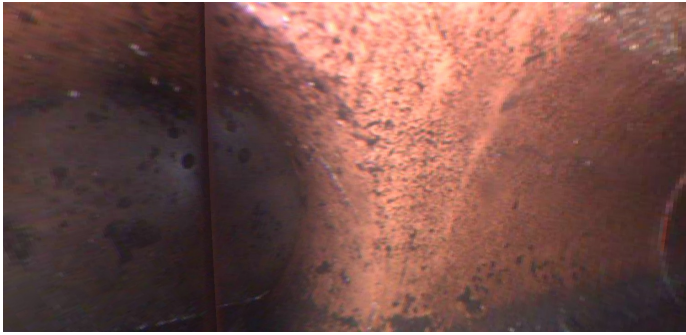
Code: **TFC**  
Description: **Tap Factory Capped**

Distance (ft): **310.5**  
Structural Grade: **0**  
O&M Grade: **0**  
Clock Start/From: **9**  
Clock To:  
1st Value: **4.000**  
2nd Value:  
Value Percent:  
Continuous Index:  
Within 8" of Joint:  
Remarks:

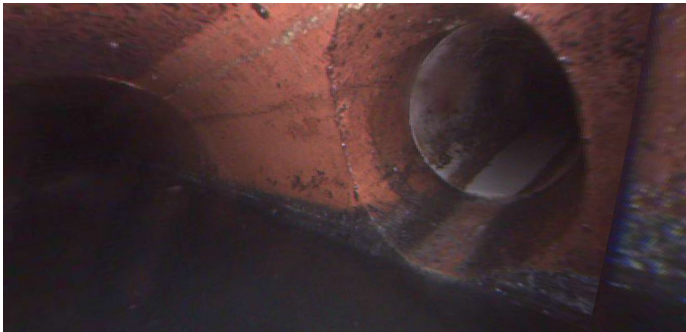
Code: **TF**  
Description: **Tap Factory**

Distance (ft): **312.1**  
Structural Grade: **0**  
O&M Grade: **0**  
Clock Start/From: **3**  
Clock To:  
1st Value: **4.000**  
2nd Value:  
Value Percent:  
Continuous Index:  
Within 8" of Joint:  
Remarks:

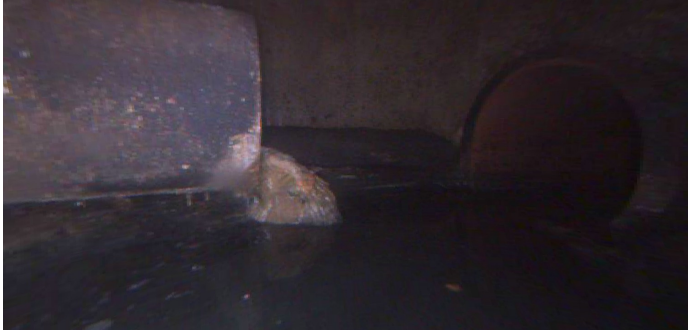
Code:	AMH
Description:	Manhole
Distance (ft):	350.1
Structural Grade:	0
O&M Grade:	0
Clock Start/From:	
Clock To:	
1st Value:	
2nd Value:	
Value Percent:	
Continuous Index:	
Within 8" of Joint:	NO
Remarks:	M-903-012
