Profile/Photo Observation Report

Date:	03/25/2018	Weather:		Coding:	PACP 6.0
Pipe Length (ft):	359.0	Owner:	NA	Pre Clean:	Not Known
P.O.#:		Surveyor:	Byrd Fitzgerald	PSR:	P-903-011-012
Customer:		Clean Date:	01/01/1900	Shape:	C

Street:	SPENCER PL	Flow Control:	Not Controlled
City:	Hobart, IN	Year Renewed:	
Location:	Other	Tape/Media #:	
Purpose:	Not Known	Dia/Height:	10"
Use:	Sanitary	Material:	VCP
Drain Area:	NA	Lining:	
Category:	NA		
Comment:

Location Details:		Direction of Survey:	Downstream
US MH:	M-903-011	DS MH:	M-903-012
		Total Length Surveyed (ft):	350.1

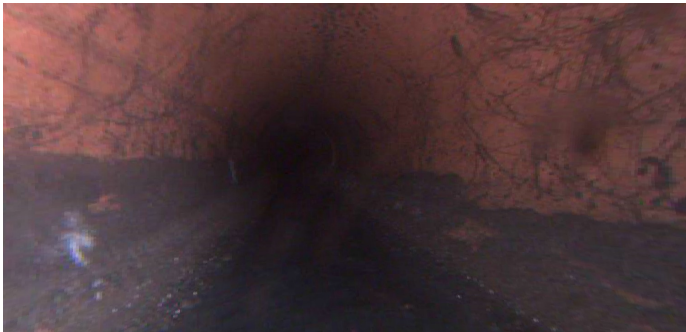
Code: **AMH**
Description: **Manhole**

Distance (ft): **.0**
Structural Grade: **0**
O&M Grade: **0**
Clock Start/From:
Clock To:
1st Value:
2nd Value:
Value Percent:
Continuous Index:
Within 8" of Joint: **NO**
Remarks: **M-903-011**

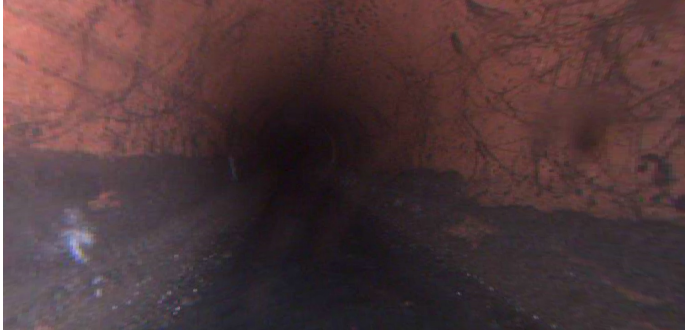
Code: **MWL**
Description: **Water Level**

Distance (ft): **.0**
Structural Grade: **0**
O&M Grade: **0**
Clock Start/From:
Clock To:
1st Value:
2nd Value:
Value Percent: **5.000**
Continuous Index:
Within 8" of Joint: **NO**
Remarks:

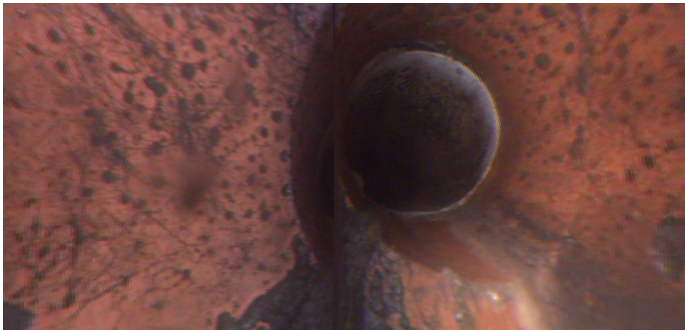
Code: **TF**
Description: **Tap Factory**

Distance (ft): **18.1**
Structural Grade: **0**
O&M Grade: **0**
Clock Start/From: **2**
Clock To:
1st Value: **4.000**
2nd Value:
Value Percent:
Continuous Index:
Within 8" of Joint: **YES**
Remarks:

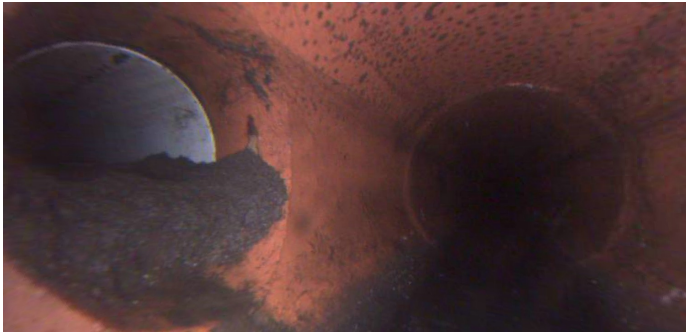
Code: **TF**
Description: **Tap Factory**

Distance (ft): **43.4**
Structural Grade: **0**
O&M Grade: **0**
Clock Start/From: **3**
Clock To:
1st Value: **4.000**
2nd Value:
Value Percent:
Continuous Index:
Within 8" of Joint:
Remarks:

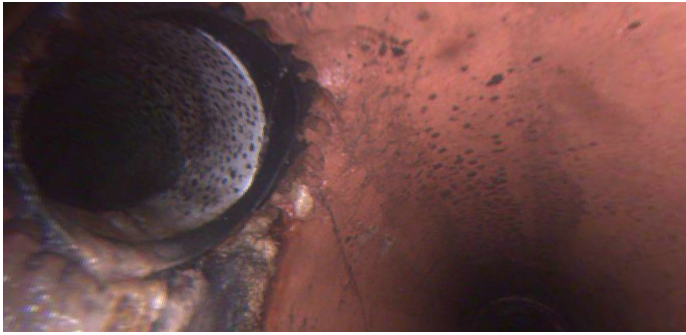
Code: **TB**
Description: **Tap Break-in**

Distance (ft): **71.0**
Structural Grade: **0**
O&M Grade: **0**
Clock Start/From: **10**
Clock To:
1st Value: **4.000**
2nd Value:
Value Percent:
Continuous Index:
Within 8" of Joint:
Remarks:

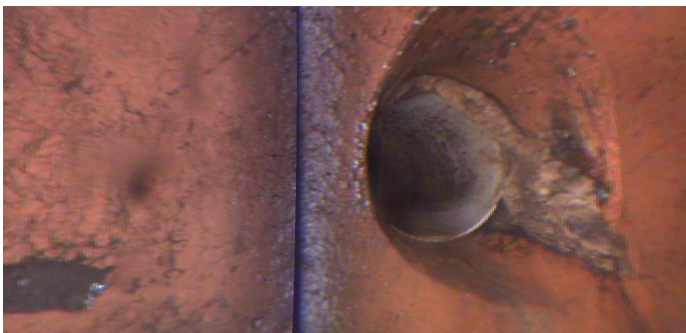
Code: **TF**
Description: **Tap Factory**

Distance (ft): **75.9**
Structural Grade: **0**
O&M Grade: **0**
Clock Start/From: **2**
Clock To:
1st Value: **4.000**
2nd Value:
Value Percent:
Continuous Index:
Within 8" of Joint:
Remarks:

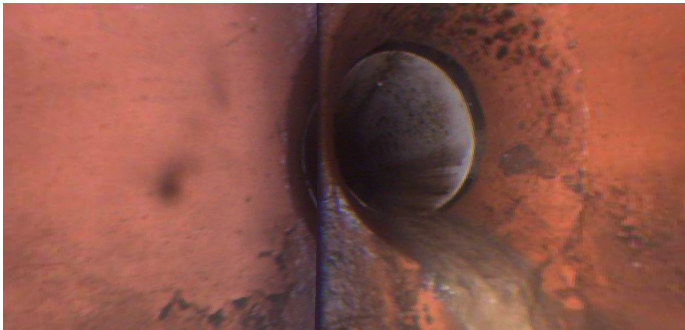
Code: **TF**
Description: **Tap Factory**

Distance (ft): **133.7**
Structural Grade: **0**
O&M Grade: **0**
Clock Start/From: **2**
Clock To:
1st Value: **4.000**
2nd Value:
Value Percent:
Continuous Index:
Within 8" of Joint:
Remarks:

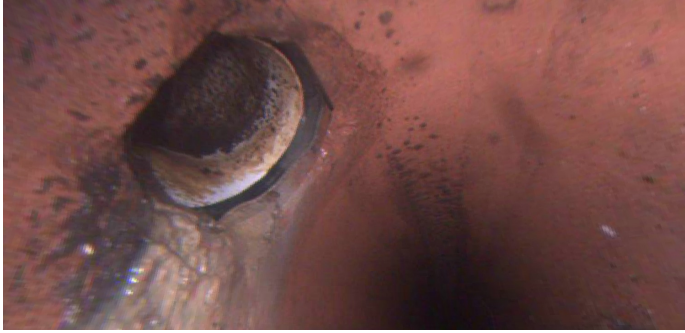
Code: **TB**
Description: **Tap Break-in**

Distance (ft): **136.2**
Structural Grade: **0**
O&M Grade: **0**
Clock Start/From: **11**
Clock To:
1st Value: **4.000**
2nd Value:
Value Percent:
Continuous Index:
Within 8" of Joint:
Remarks:

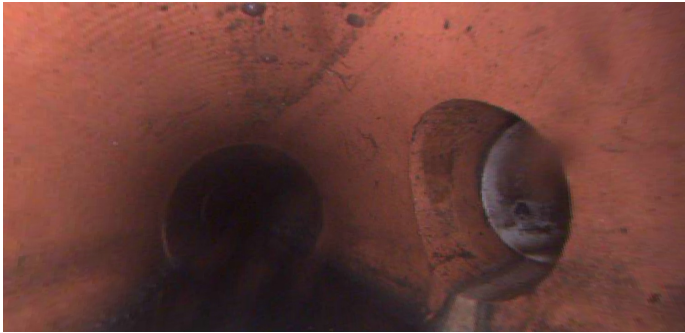
Code: **TF**
Description: **Tap Factory**

Distance (ft): **196.6**
Structural Grade: **0**
O&M Grade: **0**
Clock Start/From: **3**
Clock To:
1st Value: **4.000**
2nd Value:
Value Percent:
Continuous Index:
Within 8" of Joint:
Remarks:

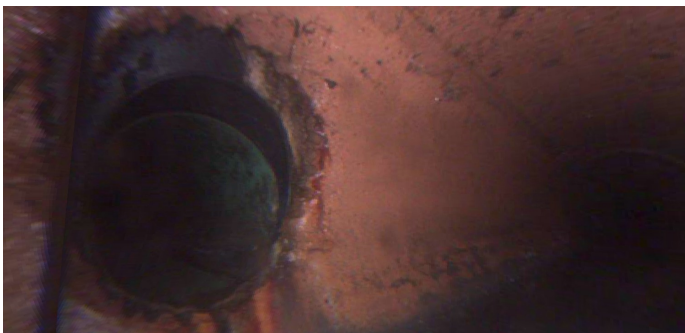
Code: **TSB**
Description: **Tap Saddle Abandoned**

Distance (ft): **200.8**
Structural Grade: **0**
O&M Grade: **0**
Clock Start/From: **3**
Clock To:
1st Value: **4.000**
2nd Value:
Value Percent:
Continuous Index:
Within 8" of Joint:
Remarks:

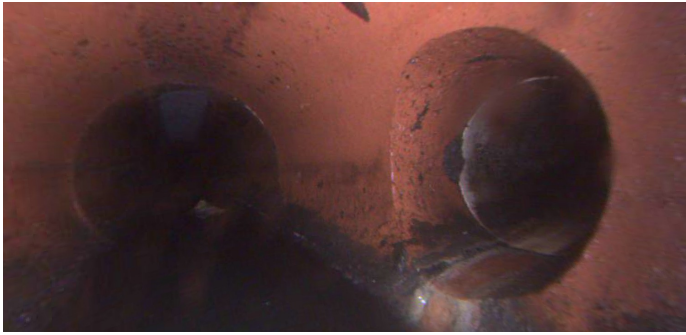
Code: **TFA**
Description: **Tap Factory Active**

Distance (ft): **254.5**
Structural Grade: **0**
O&M Grade: **0**
Clock Start/From: **3**
Clock To:
1st Value: **4.000**
2nd Value:
Value Percent:
Continuous Index:
Within 8" of Joint:
Remarks:

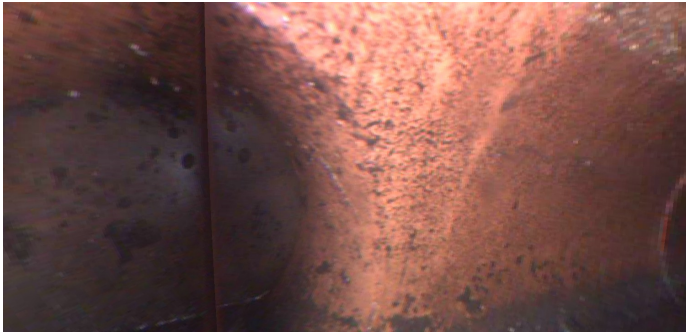
Code: **TFC**
Description: **Tap Factory Capped**

Distance (ft): **310.5**
Structural Grade: **0**
O&M Grade: **0**
Clock Start/From: **9**
Clock To:
1st Value: **4.000**
2nd Value:
Value Percent:
Continuous Index:
Within 8" of Joint:
Remarks:

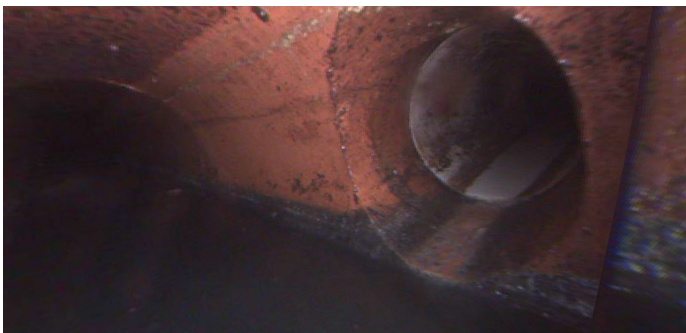
Code: **TF**
Description: **Tap Factory**

Distance (ft): **312.1**
Structural Grade: **0**
O&M Grade: **0**
Clock Start/From: **3**
Clock To:
1st Value: **4.000**
2nd Value:
Value Percent:
Continuous Index:
Within 8" of Joint:
Remarks:

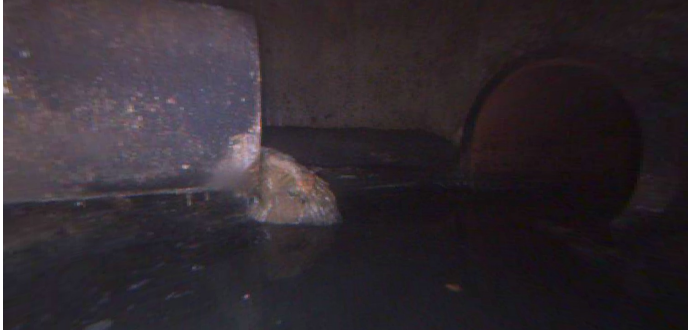
Code:	AMH
Description:	Manhole
Distance (ft):	350.1
Structural Grade:	0
O&M Grade:	0
Clock Start/From:	
Clock To:	
1st Value:	
2nd Value:	
Value Percent:	
Continuous Index:	
Within 8" of Joint:	NO
Remarks:	M-903-012
