Profile/Photo Observation Report

Date:	10/03/2018	Weather:		Coding:	PACP 6.0
Pipe Length (ft):	199.1	Owner:	NA	Pre Clean:	Not Known
P.O.#:		Surveyor:	Justin Gonzales	PSR:	P-903-014-015
Customer:		Clean Date:	01/01/1900	Shape:	C

Street:	Shelby St.	Flow Control:	Not Controlled
City:	Hobart, IN	Year Renewed:	
Location:	Light Highway	Tape/Media #:	
Purpose:	Routine Assessment	Dia/Height:	8"
Use:	Sanitary	Material:	VCP
Drain Area:	NA	Lining:	
Category:	NA		
Comment:

Location Details:		Direction of Survey:	Downstream
US MH:	M-903-015	DS MH:	M-903-014
		Total Length Surveyed (ft):	192.8

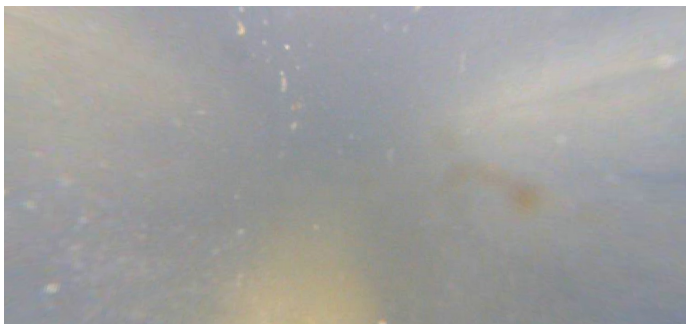
Code: **AMH**
Description: **Manhole**

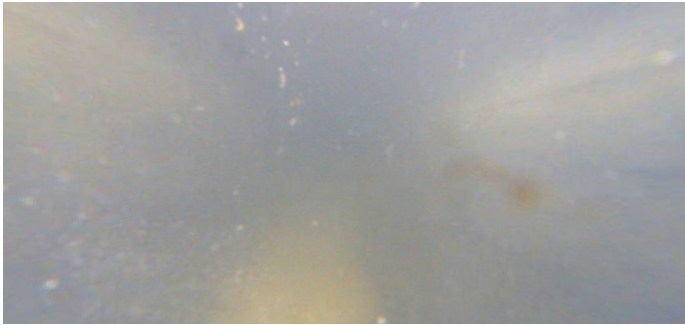
Code:	MWL
Description:	Water Level

Distance (ft):	.0
Structural Grade:	0
O&M Grade:	0
Clock Start/From:	
Clock To:	
1st Value:	
2nd Value:	
Value Percent:	100.000
Continuous Index:	
Within 8" of Joint:	NO
Remarks:

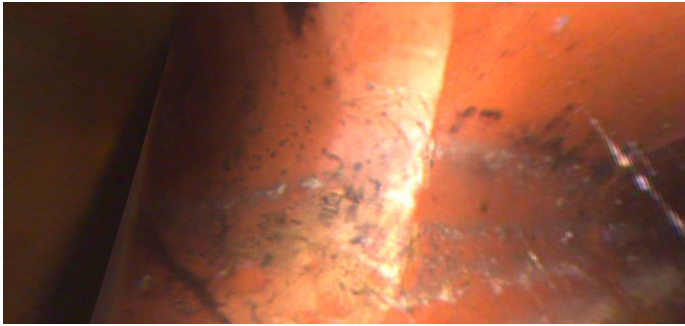
Code: **TF**
Description: **Tap Factory**

Distance (ft): **55.3**
Structural Grade: **0**
O&M Grade: **0**
Clock Start/From: **3**
Clock To:
1st Value: **4.000**
2nd Value:
Value Percent:
Continuous Index:
Within 8" of Joint:
Remarks:

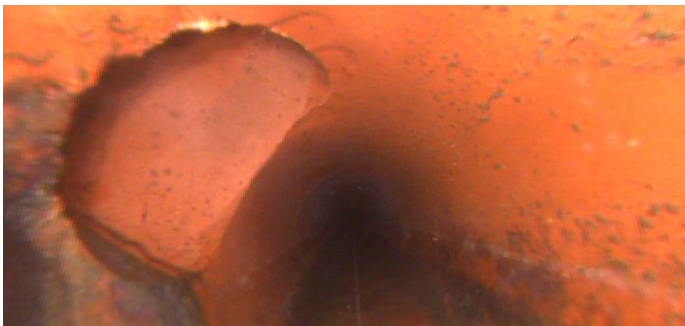
Code: **TF**
Description: **Tap Factory**

Distance (ft): **112.2**
Structural Grade: **0**
O&M Grade: **0**
Clock Start/From: **2**
Clock To:
1st Value: **4.000**
2nd Value:
Value Percent:
Continuous Index:
Within 8" of Joint:
Remarks:

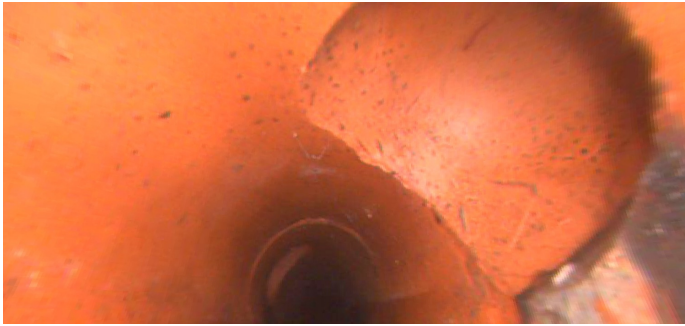
Code: **TF**
Description: **Tap Factory**

Distance (ft): **114.1**
Structural Grade: **0**
O&M Grade: **0**
Clock Start/From: **10**
Clock To:
1st Value: **4.000**
2nd Value:
Value Percent:
Continuous Index:
Within 8" of Joint:
Remarks:

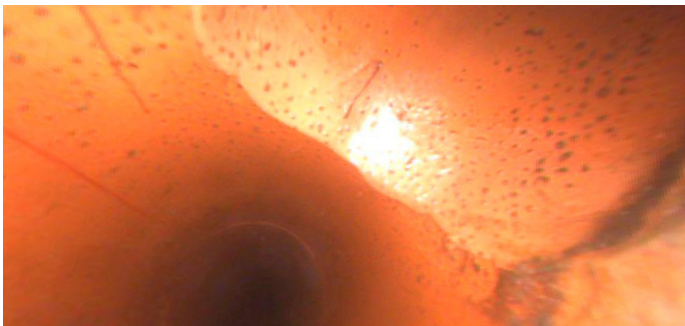
Code: **TF**
Description: **Tap Factory**

Distance (ft): **186.7**
Structural Grade: **0**
O&M Grade: **0**
Clock Start/From: **10**
Clock To:
1st Value: **4.000**
2nd Value:
Value Percent:
Continuous Index:
Within 8" of Joint:
Remarks:

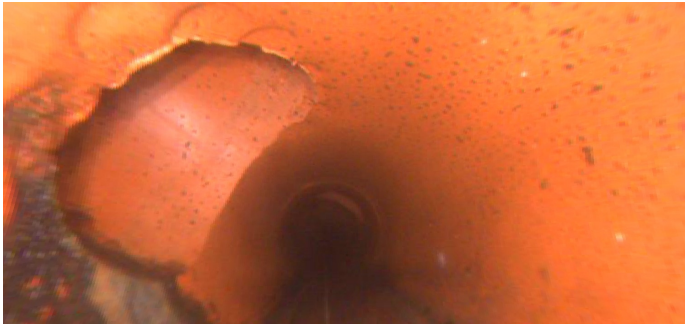
Code: **TF**
Description: **Tap Factory**

Distance (ft): **189.1**
Structural Grade: **0**
O&M Grade: **0**
Clock Start/From: **2**
Clock To:
1st Value: **4.000**
2nd Value:
Value Percent:
Continuous Index:
Within 8" of Joint:
Remarks:
