## Profile/Photo Observation Report

Street:	<b>brandit st</b>	Flow Control:	<b>Not Controlled</b>
City:	<b>Hobart, IN</b>	Year Renewed:	
Location:	<b>Other</b>	Tape/Media #:	
Purpose:	<b>Not Known</b>	Dia/Height:	<b>10"</b>
Use:	<b>Sanitary</b>	Material:	<b>PVC</b>
Drain Area:	<b>NA</b>	Lining:	
Category:	<b>NA</b>		
Comment:

Location Details:		Direction of Survey:	<b>Downstream</b>
US MH:	<b>M-903-022</b>	DS MH:	<b>M-903-023</b>
		Total Length Surveyed (ft):	<b>73.1</b>

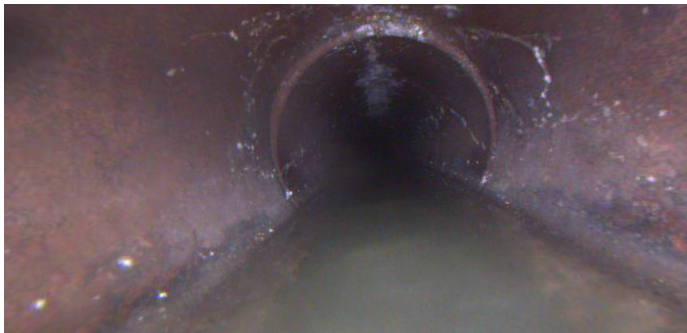
Position	Code	Observation	Video (sec)	Grade
1	AMH	Manhole	10	NA
2	MWL	Water Level	21	NA
3	CM	Crack Multiple	35	S 3
4	TF	Tap Factory	99	NA
5	CM	Crack Multiple	118	S 3
6	TFA	Tap Factory Active	201	NA
7	IW	Infil Weeper	220	M 2
8	MSA	Abandoned Survey	238	NA
