Profile/Photo Observation Report

| Street: | E RAND ST | Flow Control: | Not Controlled |
| City: | Hobart, IN | Year Renewed: | |

| US MH: | M-903-025 | DS MH: | M-903-028 |

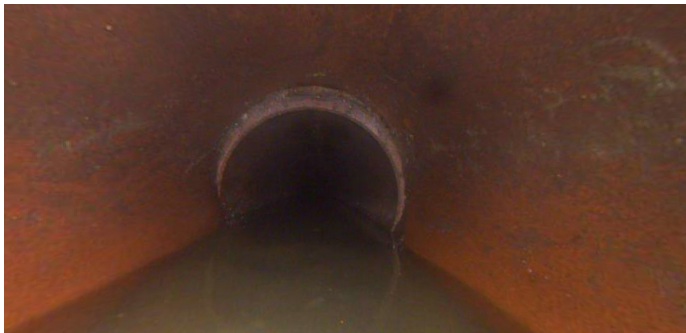
| Code: | MWL |

| Position | Code | Observation | Video (sec) | Grade |
|---|---|---|---|---|
| .0 | MWL | Water Level | 21 | NA |

| Description: | Water Level |
