Profile/Photo Observation Report

Date:	03/12/2024	Weather:		Coding:	PACP 7.0
Pipe Length (ft):	139.2	Owner:	City of Hobart	Pre Clean:	Heavy Cleaning
P.O.#:		Surveyor:	S. Bucklin	PSR:	M-903-029-M-803-013
Customer:	City of Hobart	Clean Date:	06/01/2023	Shape:	C

Location Details:		Direction of Survey:	Downstream
US MH:	M-903-029	DS MH:	M-803-013
		Total Length Surveyed (ft):	138.9

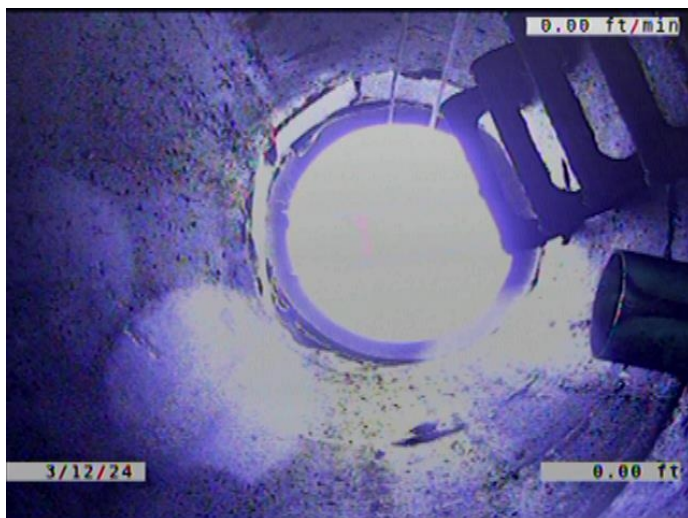
Code: **AMH**
 Description: **Manhole**

Distance (ft): **.0**
 Structural Grade: **0**
 O&M Grade: **0**
 Clock Start/From:
 Clock To:
 1st Value:
 2nd Value:
 Value Percent:
 Continuous Index:
 Within 8" of Joint: **NO**
 Remarks: **M-903-029**

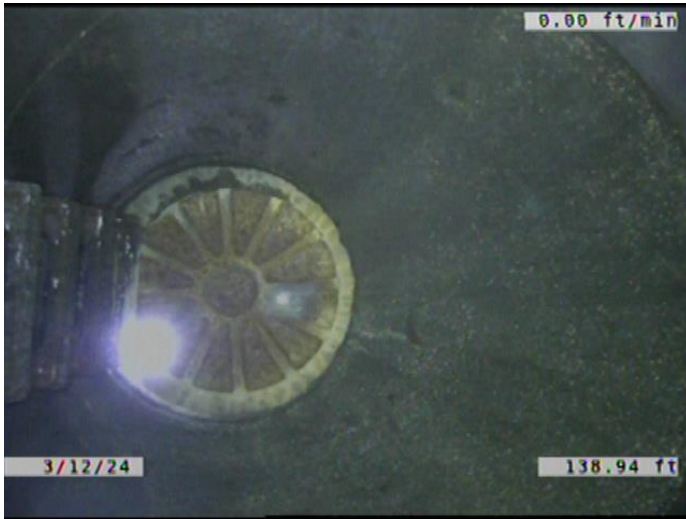
Code:	AMH
Description:	Manhole
Distance (ft):	138.9
Structural Grade:	0
O&M Grade:	0
Clock Start/From:	
Clock To:	
1st Value:	
2nd Value:	
Value Percent:	
Continuous Index:	
Within 8" of Joint:	NO
Remarks:	M-803-013
