Profile/Photo Observation Report

Date:	03/22/2018	Weather:		Coding:	PACP 6.0
Pipe Length (ft):	216.2	Owner:	NA	Pre Clean:	Not Known
P.O.#:		Surveyor:	Selasie Honu	PSR:	P-903-035-034
Customer:		Clean Date:	01/01/1900	Shape:	C

Street:	n hobart rd	Flow Control:	Not Controlled
City:	Hobart, IN	Year Renewed:	
Location:	Other	Tape/Media #:	
Purpose:	Not Known	Dia/Height:	10"
Use:	Sanitary	Material:	VCP
Drain Area:	NA	Lining:	
Category:	NA		
Comment:

Location Details:		Direction of Survey:	Downstream
US MH:	M-903-034	DS MH:	M-903-035
		Total Length Surveyed (ft):	45.3

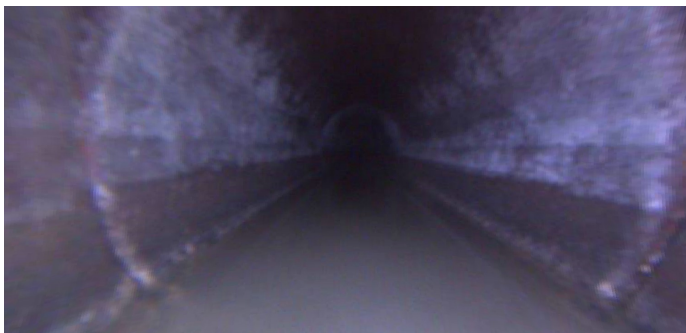
Code: **AMH**
Description: **Manhole**

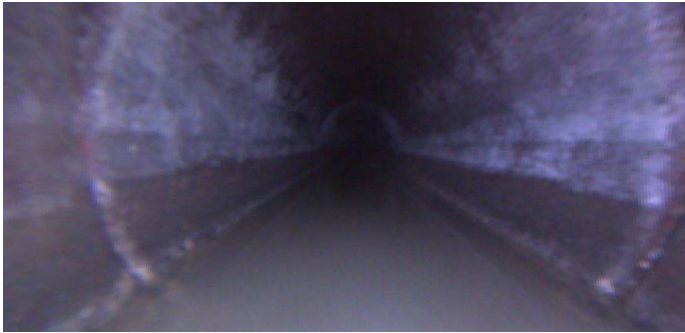
Code:	MWL
Description:	Water Level

Distance (ft):	.0
Structural Grade:	0
O&M Grade:	0
Clock Start/From:	
Clock To:	
1st Value:	
2nd Value:	
Value Percent:	5.000
Continuous Index:	
Within 8" of Joint:	NO
Remarks:
