## Profile/Photo Observation Report

Street:	<b>37th ave</b>	Flow Control:	<b>Not Controlled</b>
City:	<b>Hobart, IN</b>	Year Renewed:	
Location:	<b>Other</b>	Tape/Media #:	
Purpose:	<b>Not Known</b>	Dia/Height:	<b>10"</b>
Use:	<b>Sanitary</b>	Material:	<b>PVC</b>
Drain Area:	<b>NA</b>	Lining:	
Category:	<b>NA</b>		
Comment:

Location Details:		Direction of Survey:	<b>Upstream</b>
US MH:	<b>M-903-038</b>	DS MH:	<b>M-903-039</b>
		Total Length Surveyed (ft):	<b>182.4</b>

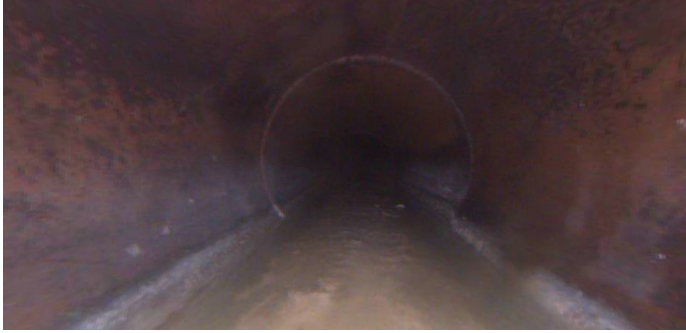
Code: **AMH**  
Description: **Manhole**

Distance (ft): **.0**  
Structural Grade: **0**  
O&M Grade: **0**  
Clock Start/From:  
Clock To:  
1st Value:  
2nd Value:  
Value Percent:  
Continuous Index:  
Within 8" of Joint: **NO**  
Remarks: **M-903-039**

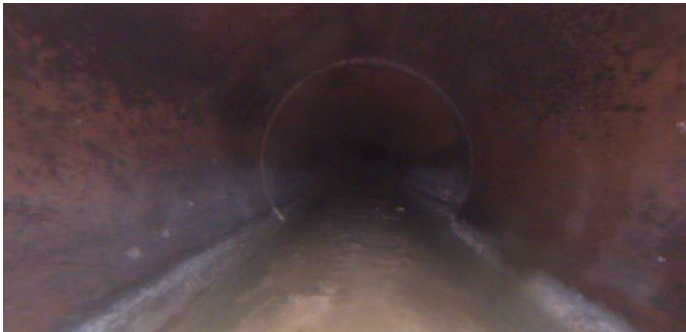
Code: **MWL**  
Description: **Water Level**

Distance (ft): **.0**  
Structural Grade: **0**  
O&M Grade: **0**  
Clock Start/From:  
Clock To:  
1st Value:  
2nd Value:  
Value Percent: **5.000**  
Continuous Index:  
Within 8" of Joint: **NO**  
Remarks:

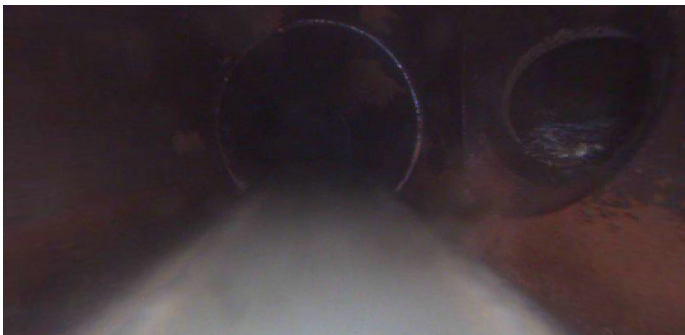
Code: **TF**  
Description: **Tap Factory**

Distance (ft): **68.8**  
Structural Grade: **0**  
O&M Grade: **0**  
Clock Start/From: **3**  
Clock To:  
1st Value: **4.000**  
2nd Value:  
Value Percent:  
Continuous Index:  
Within 8" of Joint:  
Remarks:

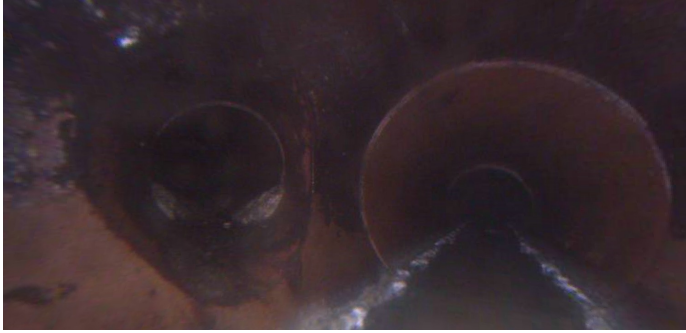
Code: **TF**  
Description: **Tap Factory**

Distance (ft): **161.8**  
Structural Grade: **0**  
O&M Grade: **0**  
Clock Start/From: **9**  
Clock To:  
1st Value: **4.000**  
2nd Value:  
Value Percent:  
Continuous Index:  
Within 8" of Joint:  
Remarks:

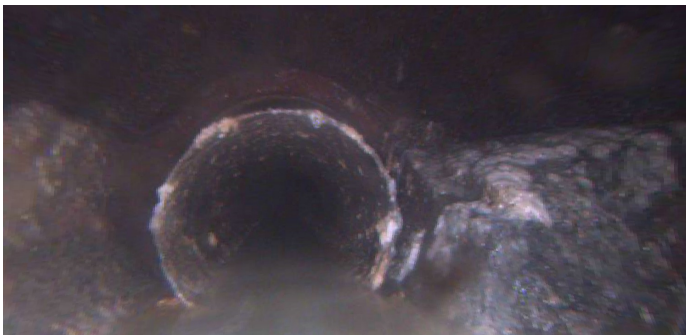
Code: **AMH**  
Description: **Manhole**

Distance (ft): **182.4**  
Structural Grade: **0**  
O&M Grade: **0**  
Clock Start/From:  
Clock To:  
1st Value:  
2nd Value:  
Value Percent:  
Continuous Index:  
Within 8" of Joint: **NO**  
Remarks: **M-903-038**
