Profile/Photo Observation Report

Date:	03/21/2018	Weather:		Coding:	PACP 6.0
Pipe Length (ft):	278.5	Owner:	NA	Pre Clean:	Not Known
P.O.#:		Surveyor:	Selasie Honu	PSR:	P-903-042-041
Customer:		Clean Date:	01/01/1900	Shape:	C

Street:	38th pl	Flow Control:	Not Controlled
City:	Hobart, IN	Year Renewed:	
Location:	Other	Tape/Media #:	
Purpose:	Not Known	Dia/Height:	10"
Use:	Sanitary	Material:	VCP
Drain Area:	NA	Lining:	
Category:	NA		
Comment:			
Location Details:		Direction of Survey:	Upstream
US MH:	M-903-041	DS MH:	M-903-042
		Total Length Surveyed (ft):	272.8

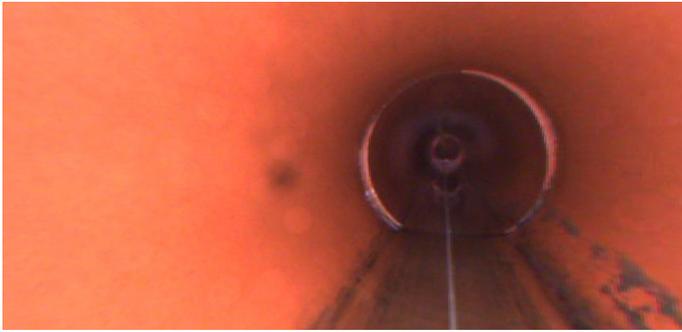
Code: **MGO**
Description: **General Observation**

Distance (ft): **5.3**
Structural Grade: **0**
O&M Grade: **0**
Clock Start/From:
Clock To:
1st Value:
2nd Value:
Value Percent:
Continuous Index:
Within 8" of Joint: **NO**
Remarks: **switched to rear view**

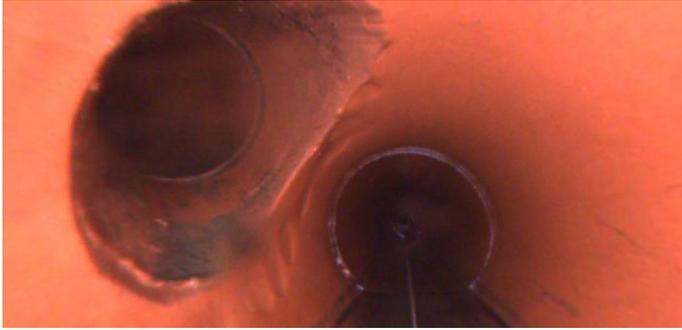
Code: **TF**
Description: **Tap Factory**

Distance (ft): **16.2**
Structural Grade: **0**
O&M Grade: **0**
Clock Start/From: **2**
Clock To:
1st Value: **4.000**
2nd Value:
Value Percent:
Continuous Index:
Within 8" of Joint:
Remarks:

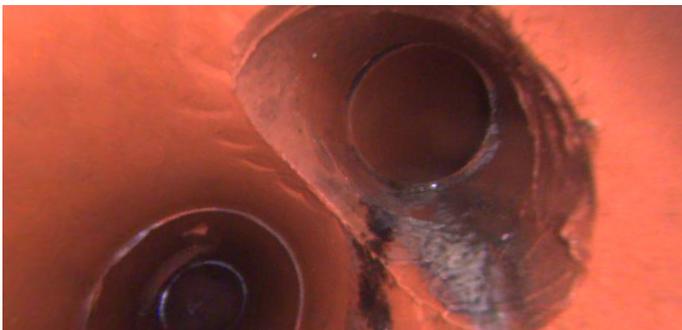
Code: **TF**
Description: **Tap Factory**

Distance (ft): **18.2**
Structural Grade: **0**
O&M Grade: **0**
Clock Start/From: **10**
Clock To:
1st Value: **4.000**
2nd Value:
Value Percent:
Continuous Index:
Within 8" of Joint:
Remarks:

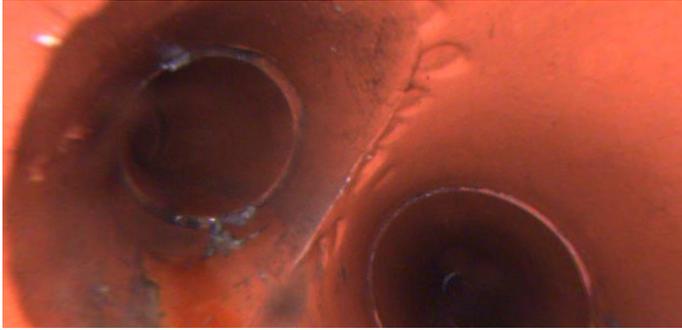
Code: **TF**
Description: **Tap Factory**

Distance (ft): **63.4**
Structural Grade: **0**
O&M Grade: **0**
Clock Start/From: **2**
Clock To:
1st Value: **4.000**
2nd Value:
Value Percent:
Continuous Index:
Within 8" of Joint:
Remarks:

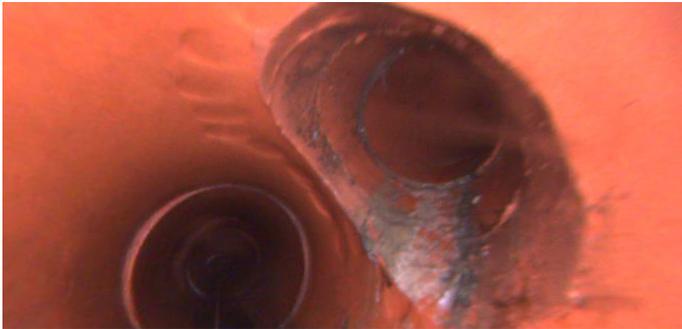
Code: **TF**
Description: **Tap Factory**

Distance (ft): **65.7**
Structural Grade: **0**
O&M Grade: **0**
Clock Start/From: **10**
Clock To:
1st Value: **4.000**
2nd Value:
Value Percent:
Continuous Index:
Within 8" of Joint:
Remarks:

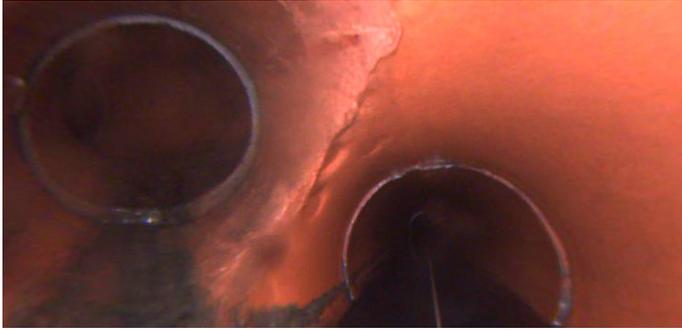
Code: **TFA**
Description: **Tap Factory Active**

Distance (ft): **121.6**
Structural Grade: **0**
O&M Grade: **0**
Clock Start/From: **2**
Clock To:
1st Value: **4.000**
2nd Value:
Value Percent:
Continuous Index:
Within 8" of Joint:
Remarks:

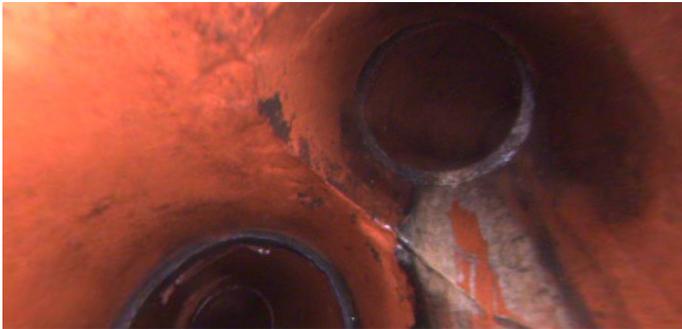
Code: **TF**
Description: **Tap Factory**

Distance (ft): **123.7**
Structural Grade: **0**
O&M Grade: **0**
Clock Start/From: **10**
Clock To:
1st Value: **4.000**
2nd Value:
Value Percent:
Continuous Index:
Within 8" of Joint:
Remarks:

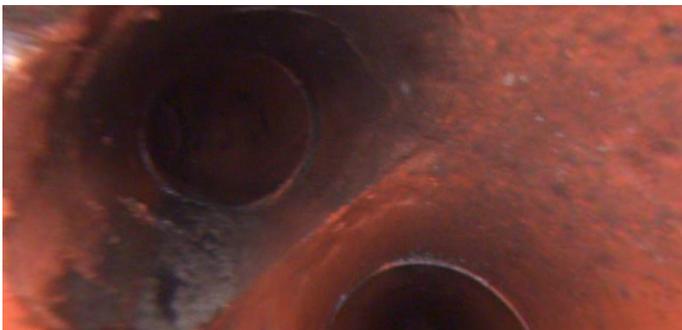
Code: **TF**
Description: **Tap Factory**

Distance (ft): **196.9**
Structural Grade: **0**
O&M Grade: **0**
Clock Start/From: **1**
Clock To:
1st Value: **4.000**
2nd Value:
Value Percent:
Continuous Index:
Within 8" of Joint:
Remarks:

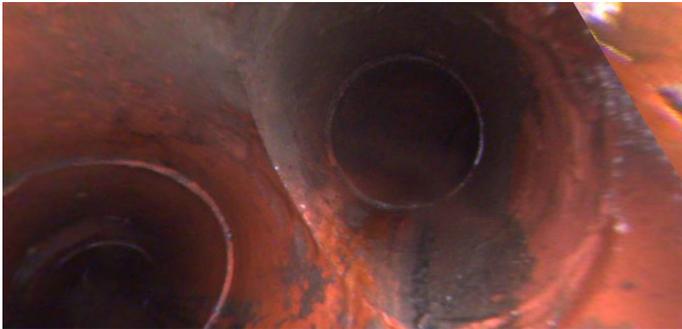
Code: **TF**
Description: **Tap Factory**

Distance (ft): **198.8**
Structural Grade: **0**
O&M Grade: **0**
Clock Start/From: **10**
Clock To:
1st Value: **4.000**
2nd Value:
Value Percent:
Continuous Index:
Within 8" of Joint:
Remarks:

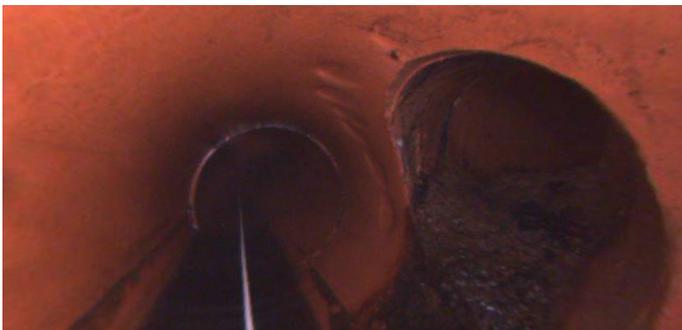
Code: **TFA**
Description: **Tap Factory Active**

Distance (ft): **249.6**
Structural Grade: **0**
O&M Grade: **0**
Clock Start/From: **9**
Clock To:
1st Value: **4.000**
2nd Value:
Value Percent:
Continuous Index:
Within 8" of Joint:
Remarks:

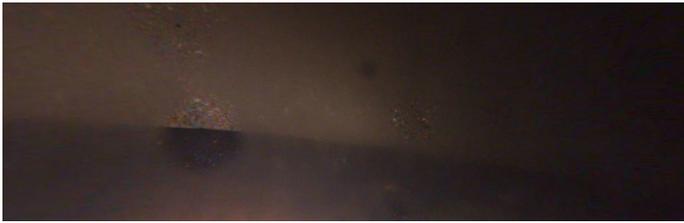
Code:	AMH
Description:	Manhole
Distance (ft):	272.8
Structural Grade:	0
O&M Grade:	0
Clock Start/From:	
Clock To:	
1st Value:	
2nd Value:	
Value Percent:	
Continuous Index:	
Within 8" of Joint:	NO
Remarks:	M-903-041
