Profile/Photo Observation Report

Date:	03/20/2018	Weather:		Coding:	PACP 6.0
Pipe Length (ft):	212.0	Owner:	NA	Pre Clean:	Not Known
P.O.#:		Surveyor:	JUSTIN GONZALES	PSR:	P-903-052-053
Customer:		Clean Date:	01/01/1900	Shape:	C

Street:	OFF E 38TH PL	Flow Control:	Not Controlled
City:	Hobart, IN	Year Renewed:	
Location:	Other	Tape/Media #:	
Purpose:	Not Known	Dia/Height:	10"
Use:	Sanitary	Material:	PVC
Drain Area:	NA	Lining:	
Category:	NA		
Comment:

Location Details:		Direction of Survey:	Upstream
US MH:	M-903-053	DS MH:	M-903-052
		Total Length Surveyed (ft):	173.8

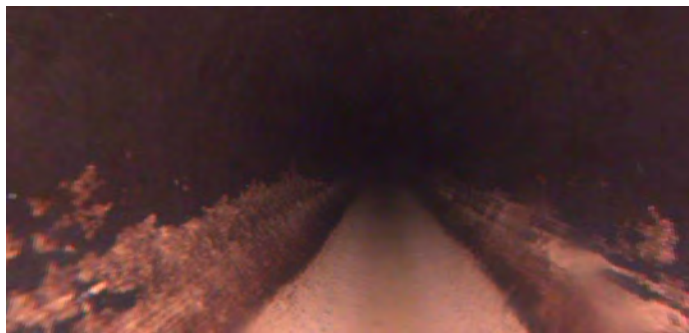
Code: **AMH**
 Description: **Manhole**
 Distance (ft): **.0**
 Structural Grade: **0**
 O&M Grade: **0**
 Clock Start/From:
 Clock To:
 1st Value:
 2nd Value:
 Value Percent:
 Continuous Index:
 Within 8" of Joint: **NO**
 Remarks: **M-903-052**

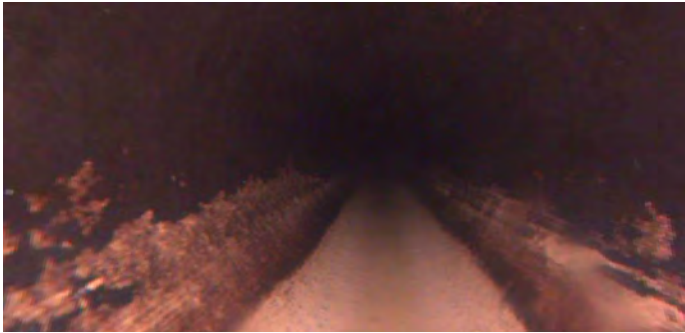
Code:	MWL
Description:	Water Level

Distance (ft):	.0
Structural Grade:	0
O&M Grade:	0
Clock Start/From:	
Clock To:	
1st Value:	
2nd Value:	
Value Percent:	10.000
Continuous Index:	
Within 8" of Joint:	NO
Remarks:
