## Profile/Photo Observation Report

Street:	<b>37th ave</b>	Flow Control:	<b>Not Controlled</b>
City:	<b>Hobart, IN</b>	Year Renewed:	
Location:	<b>Other</b>	Tape/Media #:	
Purpose:	<b>Not Known</b>	Dia/Height:	<b>10"</b>
Use:	<b>Sanitary</b>	Material:	<b>PVC</b>
Drain Area:	<b>NA</b>	Lining:	
Category:	<b>NA</b>		
Comment:

Location Details:		Direction of Survey:	<b>Upstream</b>
US MH:	<b>M-903-060</b>	DS MH:	<b>M-903-059</b>
		Total Length Surveyed (ft):	<b>312.9</b>

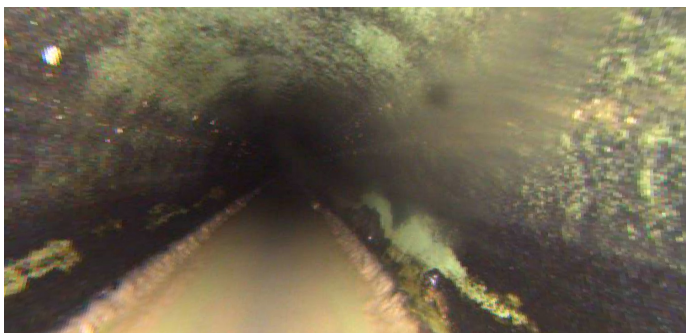
Code: **AMH**  
Description: **Manhole**

Distance (ft): **.0**  
Structural Grade: **0**  
O&M Grade: **0**  
Clock Start/From:  
Clock To:  
1st Value:  
2nd Value:  
Value Percent:  
Continuous Index:  
Within 8" of Joint: **NO**  
Remarks: **M-903-059**

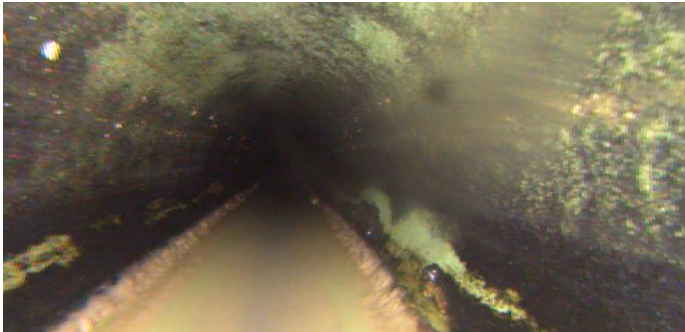
Code:	<b>MWL</b>
Description:	<b>Water Level</b>

Distance (ft):	<b>.0</b>
Structural Grade:	<b>0</b>
O&M Grade:	<b>0</b>
Clock Start/From:	
Clock To:	
1st Value:	
2nd Value:	
Value Percent:	<b>10.000</b>
Continuous Index:	
Within 8" of Joint:	<b>NO</b>
Remarks:

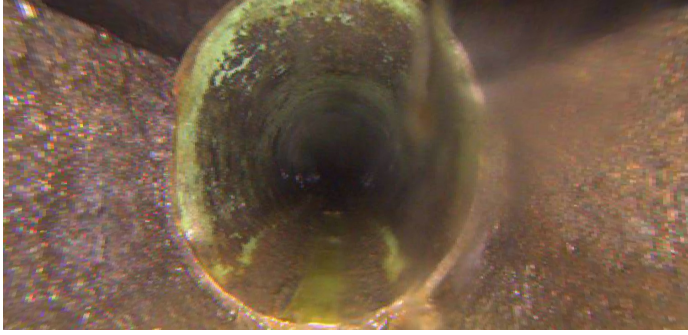
Code:	<b>AMH</b>
Description:	<b>Manhole</b>
Distance (ft):	<b>312.9</b>
Structural Grade:	<b>0</b>
O&M Grade:	<b>0</b>
Clock Start/From:	
Clock To:	
1st Value:	
2nd Value:	
Value Percent:	
Continuous Index:	
Within 8" of Joint:	<b>NO</b>
Remarks:	<b>M-903-060</b>
