Profile/Photo Observation Report

Date:	05/04/2018	Weather:		Coding:	PACP 4.2
Pipe Length (ft):	151.0	Owner:	City of Hobart	Pre Clean:	No Pre-Cleaning
P.O.#:	2004	Surveyor:	SAN	PSR:	P-904-009-010
Customer:	Red Zone	Clean Date:		Shape:	C

Street:	Fraser Ln	Flow Control:	Not Controlled
City:	Hobart In	Year Renewed:	
Location:	Easement/Right of Way	Tape/Media #:	Deliverable 1
Purpose:	Routine Assessment	Dia/Height:	18"
Use:	Sanitary	Material:	VCP
Drain Area:	Northeast	Lining:	
Category:	NA		
Comment:	447-1		
Location Details:	Edge of field	Direction of Survey:	Downstream
US MH:	M-904-009	DS MH:	M-804-010
		Total Length Surveyed (ft):	100.0

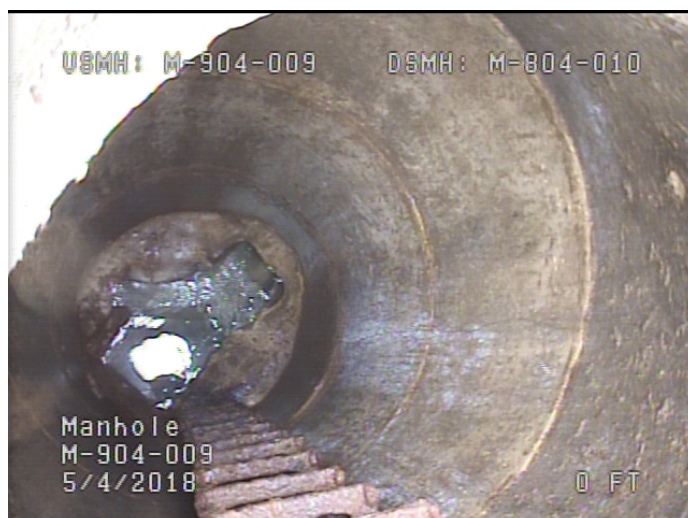
Code: **AMH**
 Description: **Manhole**

Distance (ft): **.0**
 Structural Grade: **0**
 O&M Grade: **0**
 Clock Start/From:
 Clock To:
 1st Value:
 2nd Value:
 Value Percent:
 Continuous Index:
 Within 8" of Joint: **NO**
 Remarks: **M-904-009**

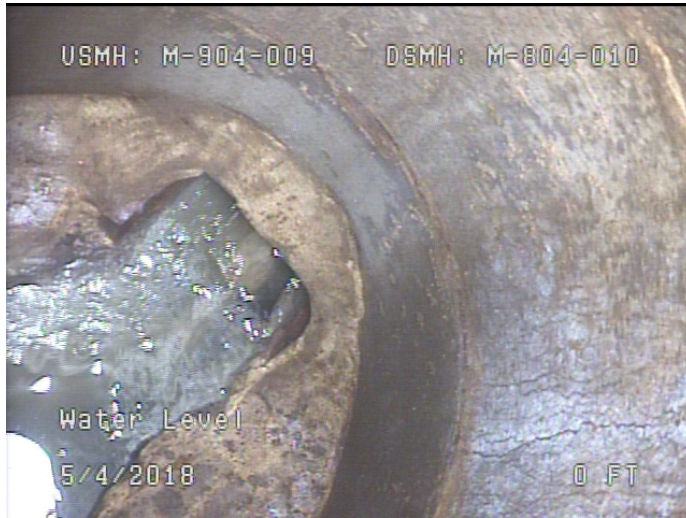
Code:	MWL
Description:	Water Level
Distance (ft):	.0
Structural Grade:	0
O&M Grade:	0
Clock Start/From:	
Clock To:	
1st Value:	
2nd Value:	
Value Percent:	15.000
Continuous Index:	
Within 8" of Joint:	NO
Remarks:

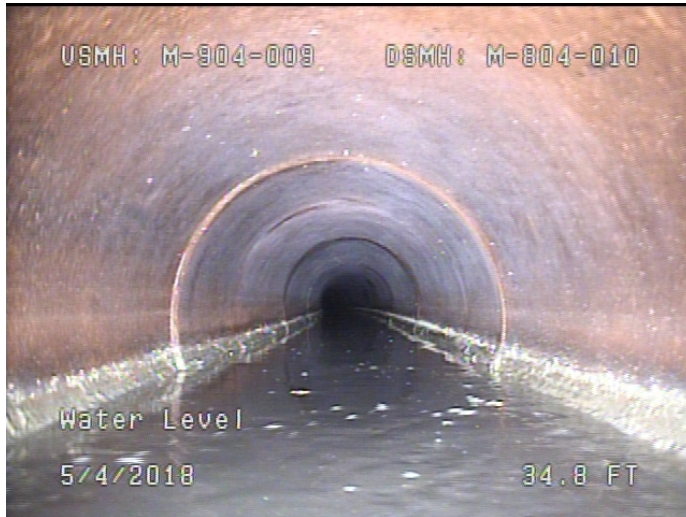
Code: **MWL**
 Description: **Water Level**

Distance (ft): **34.8**
 Structural Grade: **0**
 O&M Grade: **0**
 Clock Start/From:
 Clock To:
 1st Value:
 2nd Value:
 Value Percent: **25.000**
 Continuous Index:
 Within 8" of Joint: **NO**
 Remarks:
