Profile/Photo Observation Report

| Street: | CLEVELAND TERR | Flow Control: | Not Controlled |
| City: | Hobart, IN | Year Renewed: | |

| US MH: | M-904-033 | DS MH: | M-904-032 |

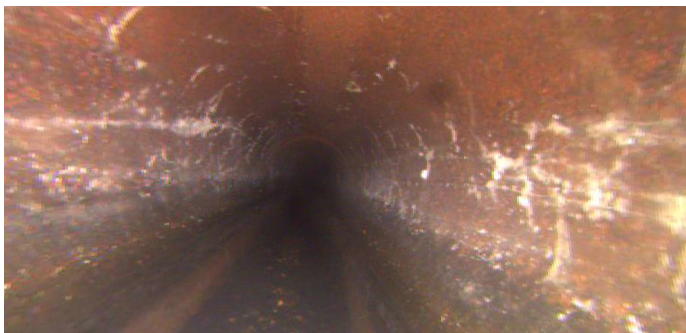
Code: **AMH**
Description: **Manhole**

Distance (ft): **.0**
Structural Grade: **0**
O&M Grade: **0**
Clock Start/From:
Clock To:
1st Value:
2nd Value:
Value Percent:
Continuous Index:
Within 8" of Joint: **NO**
Remarks: **M-904-032**

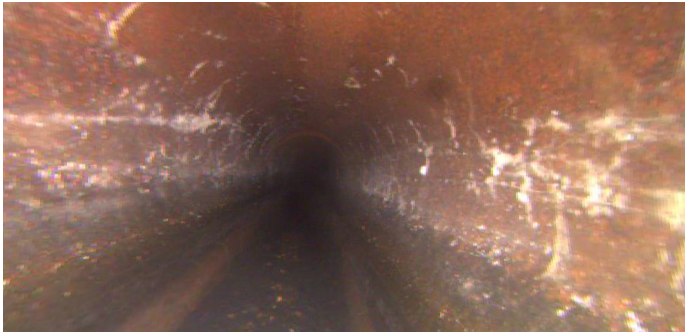
| Code: | MWL |
| Description: | Water Level |

| Distance (ft): | .0 |
| Value Percent: | 5.000 |

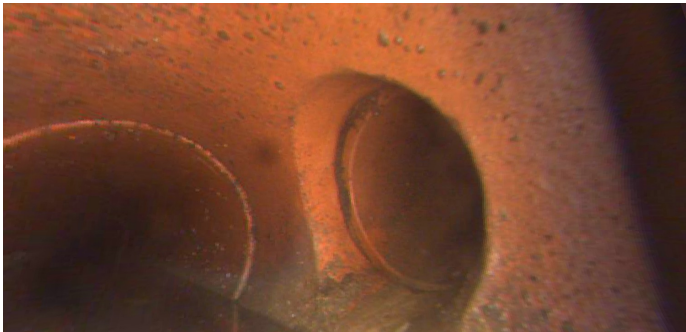
Code: **TF**
Description: **Tap Factory**

Distance (ft): **64.1**
Structural Grade: **0**
O&M Grade: **0**
Clock Start/From: **3**
Clock To:
1st Value: **4.000**
2nd Value:
Value Percent:
Continuous Index:
Within 8" of Joint:
Remarks:

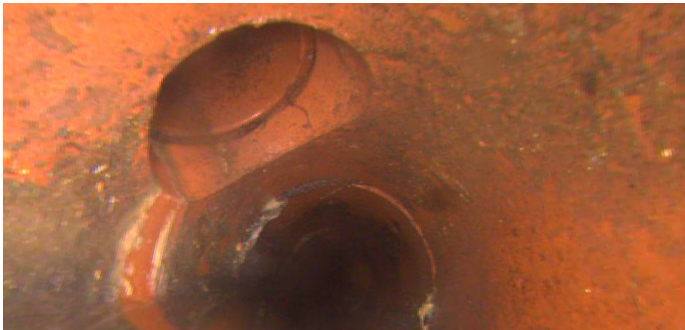
Code: **TF**
Description: **Tap Factory**

Distance (ft): **106.3**
Structural Grade: **0**
O&M Grade: **0**
Clock Start/From: **9**
Clock To:
1st Value: **4.000**
2nd Value:
Value Percent:
Continuous Index:
Within 8" of Joint:
Remarks:

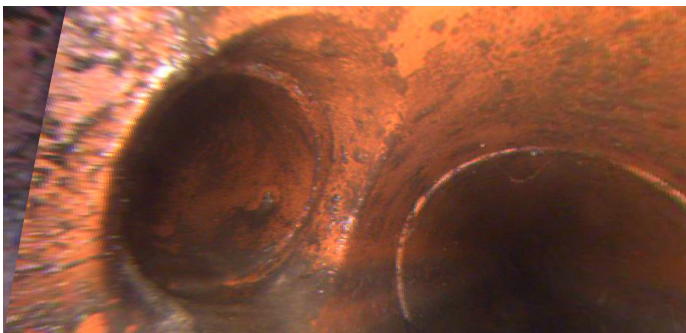
Code: **TF**
Description: **Tap Factory**

Distance (ft): **108.0**
Structural Grade: **0**
O&M Grade: **0**
Clock Start/From: **9**
Clock To:
1st Value: **4.000**
2nd Value:
Value Percent:
Continuous Index:
Within 8" of Joint:
Remarks:

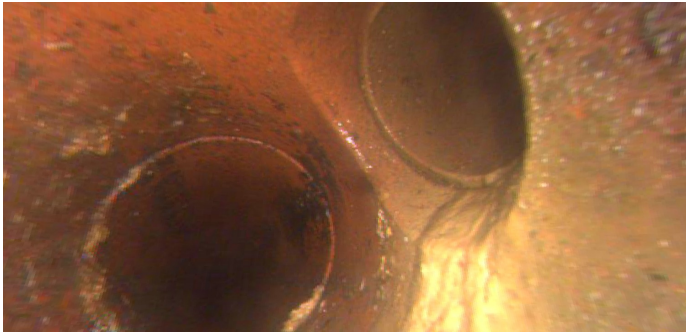
Code: **TF**
Description: **Tap Factory**

Distance (ft): **144.6**
Structural Grade: **0**
O&M Grade: **0**
Clock Start/From: **3**
Clock To:
1st Value: **4.000**
2nd Value:
Value Percent:
Continuous Index:
Within 8" of Joint:
Remarks:

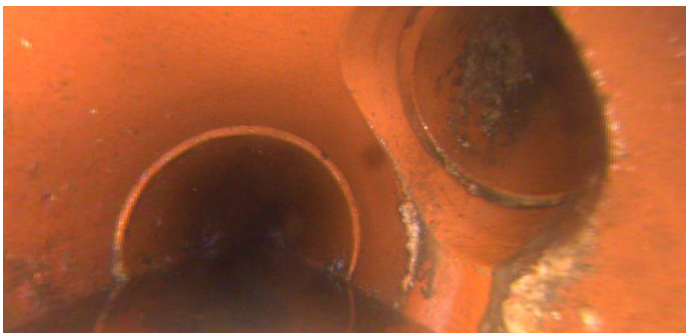
Code: **TF**
Description: **Tap Factory**

Distance (ft): **156.7**
Structural Grade: **0**
O&M Grade: **0**
Clock Start/From: **2**
Clock To:
1st Value: **4.000**
2nd Value:
Value Percent:
Continuous Index:
Within 8" of Joint:
Remarks:

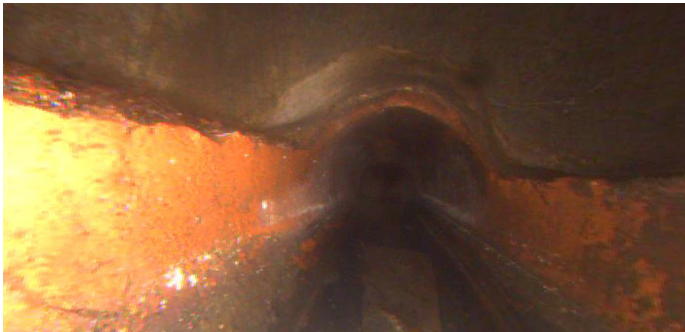
Code: **AMH**
Description: **Manhole**

Distance (ft): **243.9**
Structural Grade: **0**
O&M Grade: **0**
Clock Start/From:
Clock To:
1st Value:
2nd Value:
Value Percent:
Continuous Index:
Within 8" of Joint: **NO**
Remarks: **M-904-033**
