Profile/Photo Observation Report

Date:	10/05/2018	Weather:		Coding:	PACP 6.0
Pipe Length (ft):	241.6	Owner:	NA	Pre Clean:	Not Known
P.O.#:		Surveyor:	Justin Gonzales	PSR:	P-904-048-047
Customer:		Clean Date:	01/01/1900	Shape:	C

Street:	RUSH ST & HICKEY PL	Flow Control:	Not Controlled
City:	Hobart, IN	Year Renewed:	
Location:	Light Highway	Tape/Media #:	
Purpose:	Routine Assessment	Dia/Height:	10"
Use:	Sanitary	Material:	VCP
Drain Area:	NA	Lining:	
Category:	NA		
Comment:

Location Details:		Direction of Survey:	Downstream
US MH:	M-904-047	DS MH:	M-904-048
		Total Length Surveyed (ft):	237.8

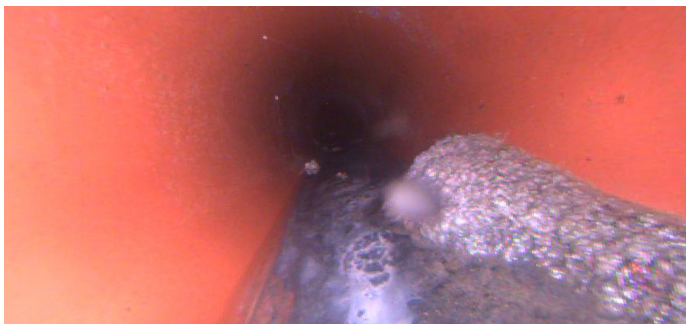
Code: **AMH**
Description: **Manhole**

Distance (ft): **.0**
Structural Grade: **0**
O&M Grade: **0**
Clock Start/From:
Clock To:
1st Value:
2nd Value:
Value Percent:
Continuous Index:
Within 8" of Joint: **NO**
Remarks: **M-904-047**

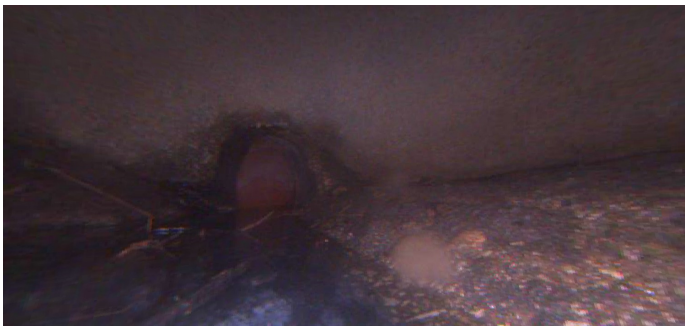
Code: **AMH**
Description: **Manhole**

Distance (ft): **237.8**
Structural Grade: **0**
O&M Grade: **0**
Clock Start/From:
Clock To:
1st Value:
2nd Value:
Value Percent:
Continuous Index:
Within 8" of Joint: **NO**
Remarks: **M-904-048**
