Profile/Photo Observation Report

Date:	03/05/2024	Weather:		Coding:	PACP 7.0
Pipe Length (ft):	184.0	Owner:	City of Hobart	Pre Clean:	Heavy Cleaning
P.O.#:		Surveyor:	S. Bucklin	PSR:	P-905-020-066
Customer:	City of Hobart	Clean Date:	10/14/2022	Shape:	C

Street:	SR-130	Flow Control:	Not Controlled
City:	Hobart, IN	Year Renewed:	
Location:	Parking Lot	Tape/Media #:	
Purpose:	Sewer System Evaluation Survey (SS	Dia/Height:	6"
Use:	Sanitary Sewage Pipe	Material:	VCP
Drain Area:		Lining:	None
Category:	NA		
Comment:			
Location Details:		Direction of Survey:	Upstream
US MH:	M-905-020	DS MH:	M-805-066
		Total Length Surveyed (ft):	183.1

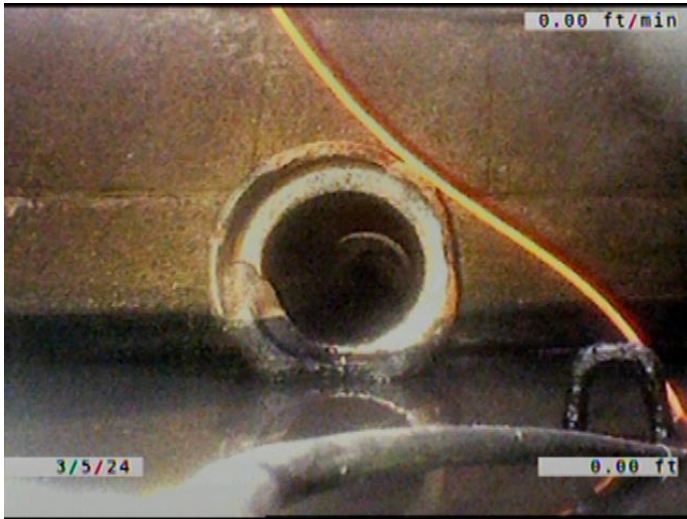
Code: **AMH**
Description: **Manhole**

Distance (ft): **.0**
Structural Grade: **0**
O&M Grade: **0**
Clock Start/From:
Clock To:
1st Value:
2nd Value:
Value Percent:
Continuous Index:
Within 8" of Joint: **NO**
Remarks: **M-805-066**

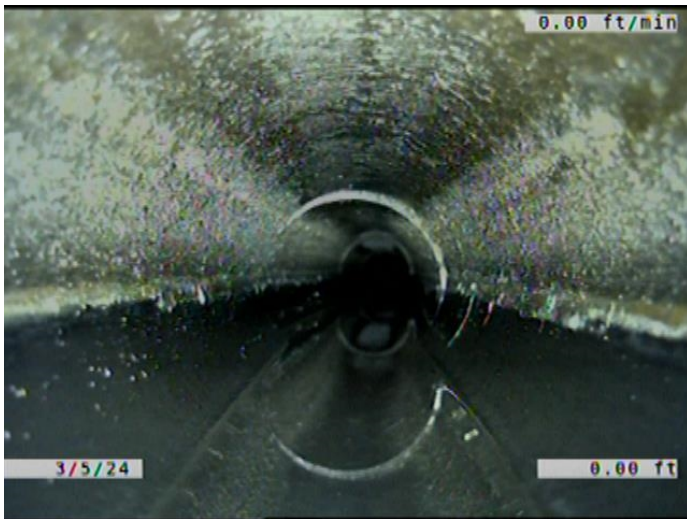
Code: **MWL**
Description: **Miscellaneous Water Level**

Distance (ft): **.0**
Structural Grade: **0**
O&M Grade: **0**
Clock Start/From:
Clock To:
1st Value:
2nd Value:
Value Percent: **5.000**
Continuous Index:
Within 8" of Joint: **NO**
Remarks:

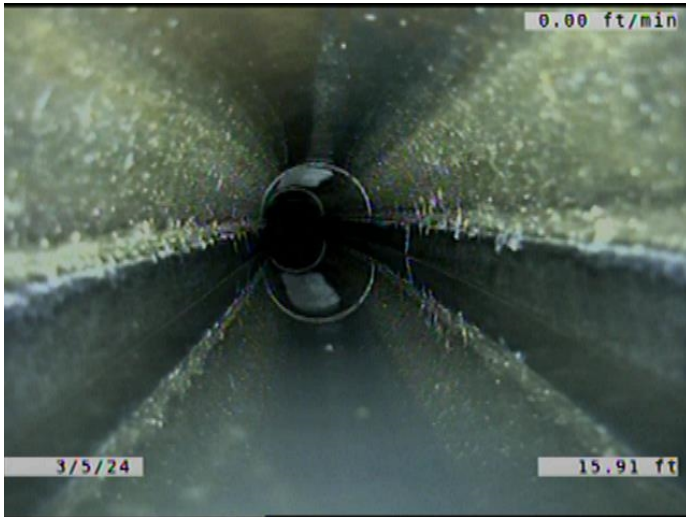
Code: **LL**
Description: **Line Left**

Distance (ft): **15.9**
Structural Grade: **0**
O&M Grade: **1**
Clock Start/From:
Clock To:
1st Value:
2nd Value:
Value Percent: **5.000**
Continuous Index:
Within 8" of Joint: **NO**
Remarks:

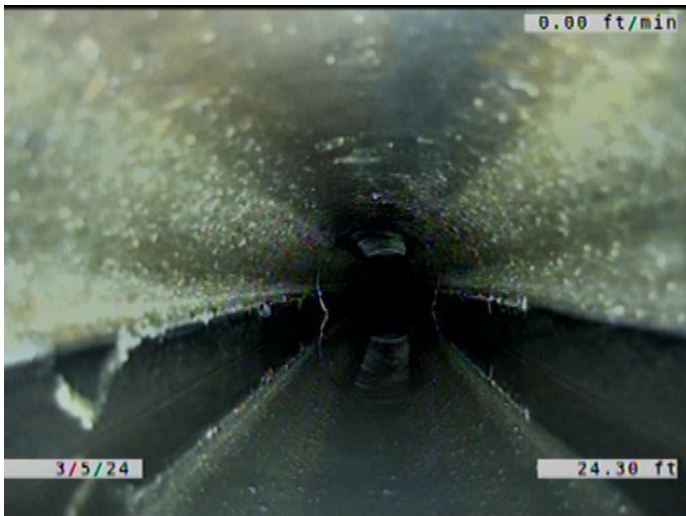
Code: **LR**
Description: **Line Right**

Distance (ft): **24.3**
Structural Grade: **0**
O&M Grade: **1**
Clock Start/From:
Clock To:
1st Value:
2nd Value:
Value Percent: **5.000**
Continuous Index:
Within 8" of Joint: **NO**
Remarks:

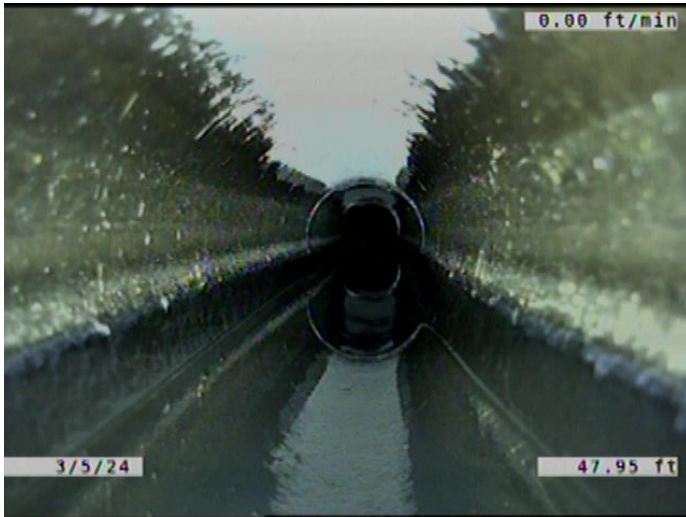
Code: **LR**
Description: **Line Right**

Distance (ft): **47.9**
Structural Grade: **0**
O&M Grade: **1**
Clock Start/From:
Clock To:
1st Value:
2nd Value:
Value Percent: **5.000**
Continuous Index:
Within 8" of Joint: **NO**
Remarks:

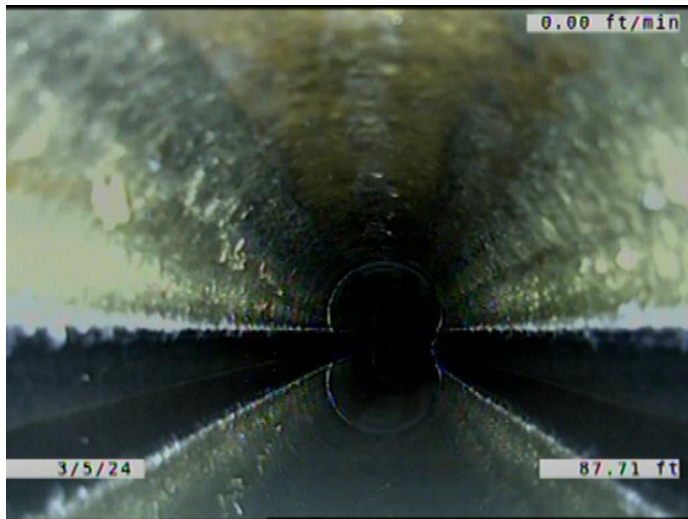
Code: **LR**
 Description: **Line Right**

Distance (ft): **87.7**
 Structural Grade: **0**
 O&M Grade: **1**
 Clock Start/From:
 Clock To:
 1st Value:
 2nd Value:
 Value Percent: **5.000**
 Continuous Index:
 Within 8" of Joint: **NO**
 Remarks:

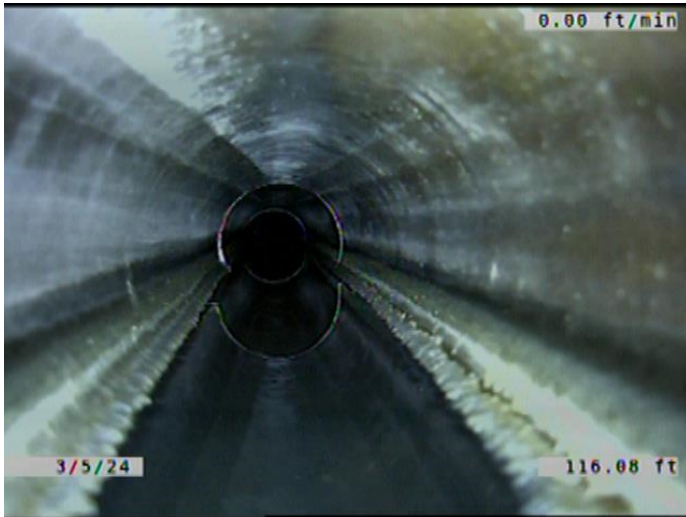
Code: **LL**
Description: **Line Left**

Distance (ft): **116.1**
Structural Grade: **0**
O&M Grade: **1**
Clock Start/From:
Clock To:
1st Value:
2nd Value:
Value Percent: **10.000**
Continuous Index:
Within 8" of Joint: **NO**
Remarks:

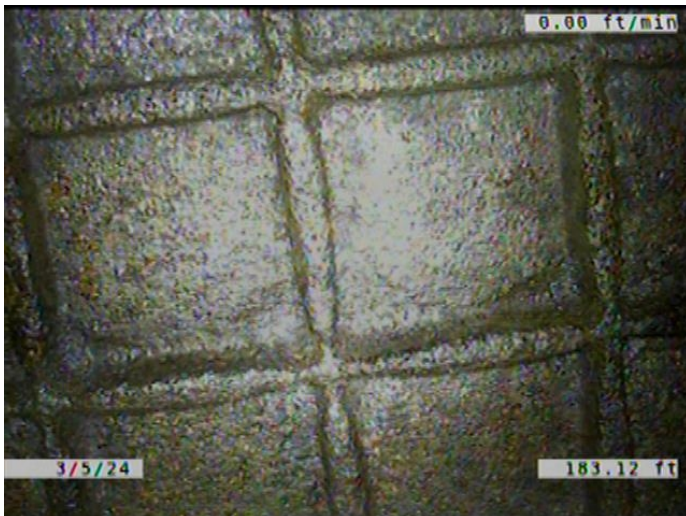
Code: **AMH**
Description: **Manhole**

Distance (ft): **183.1**
Structural Grade: **0**
O&M Grade: **0**
Clock Start/From:
Clock To:
1st Value:
2nd Value:
Value Percent:
Continuous Index:
Within 8" of Joint: **NO**
Remarks: **M-905-020**
