Profile/Photo Observation Report

Street:	E 10TH ST & SULLIVAN ST	Flow Control:	Not Controlled
City:	Hobart, IN	Year Renewed:	
Location:	Sidewalk	Tape/Media #:	
Purpose:	Maintenance Related	Dia/Height:	8"
Use:	Sanitary	Material:	VCP
Drain Area:	NA	Lining:	Cured in Place
Category:	NA		
Comment:	possible roots at joint at 133'.		
Location Details:		Direction of Survey:	Downstream
US MH:	M-906-002	DS MH:	M-906-003
		Total Length Surveyed (ft):	134.6

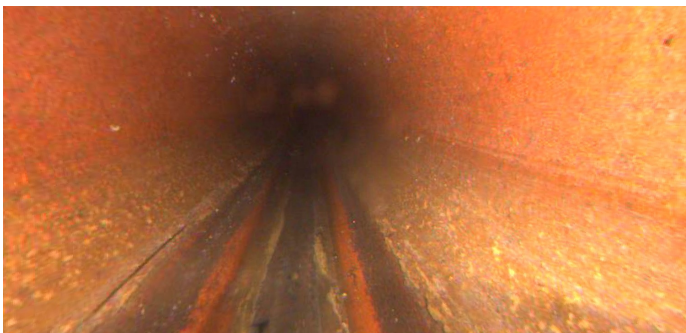
Code: **MSA**
Description: **Abandoned Survey**

Distance (ft): **134.6**
Structural Grade: **0**
O&M Grade: **0**
Clock Start/From:
Clock To:
1st Value:
2nd Value:
Value Percent:
Continuous Index:
Within 8" of Joint: **NO**
Remarks: **ROOTS**
