## Profile/Photo Observation Report

Street:	<b>S HOBART RD</b>	Flow Control:	<b>Not Controlled</b>
City:	<b>Hobart, IN</b>	Year Renewed:	
Location:	<b>Light Highway</b>	Tape/Media #:	
Purpose:	<b>Maintenance Related</b>	Dia/Height:	<b>12"</b>
Use:	<b>Sanitary</b>	Material:	<b>PVC</b>
Drain Area:	<b>NA</b>	Lining:	<b>Cured in Place</b>
Category:	<b>NA</b>		
Comment:	<b>Flow direction wrong. Reverse setup.</b>

Location Details:		Direction of Survey:	<b>Downstream</b>
US MH:	<b>M-907-005</b>	DS MH:	<b>M-808-031</b>
		Total Length Surveyed (ft):	<b>413.6</b>

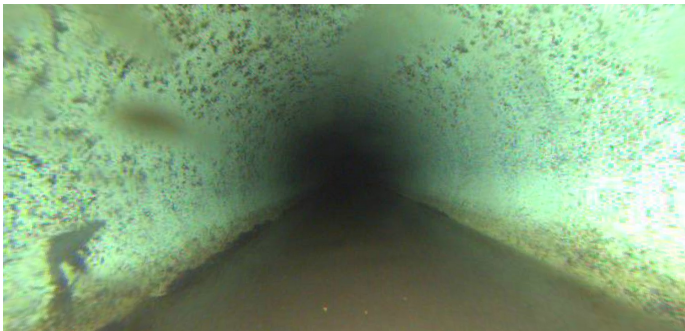
Code: **AMH**  
Description: **Manhole**

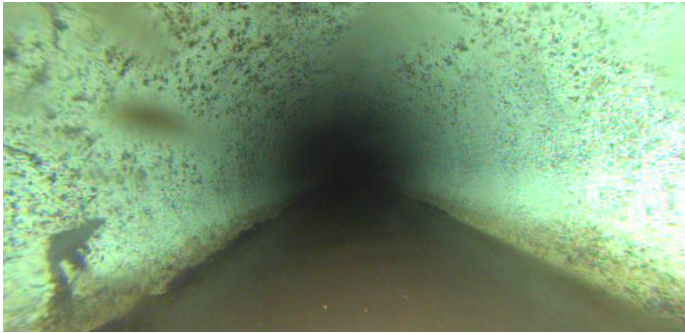
Code:	<b>MWL</b>
Description:	<b>Water Level</b>

Distance (ft):	<b>.0</b>
Structural Grade:	<b>0</b>
O&M Grade:	<b>0</b>
Clock Start/From:	
Clock To:	
1st Value:	
2nd Value:	
Value Percent:	<b>20.000</b>
Continuous Index:	
Within 8" of Joint:	<b>NO</b>
Remarks:

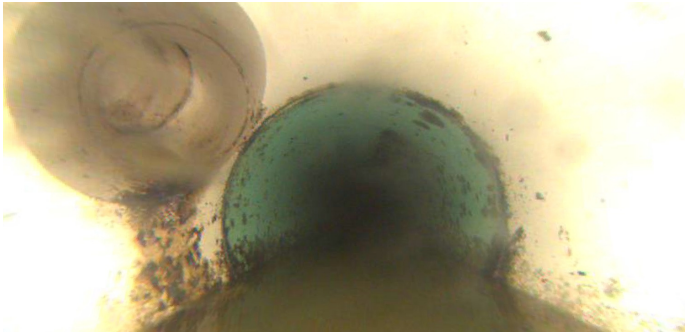
Code: **TF**  
Description: **Tap Factory**

Distance (ft): **220.4**  
Structural Grade: **0**  
O&M Grade: **0**  
Clock Start/From: **10**  
Clock To:  
1st Value: **4.000**  
2nd Value:  
Value Percent:  
Continuous Index:  
Within 8" of Joint:  
Remarks:
