## Profile/Photo Observation Report

Date:	<b>04/11/2018</b>	Weather:		Coding:	<b>PACP 6.0</b>
Pipe Length (ft):	<b>358.7</b>	Owner:	<b>NA</b>	Pre Clean:	<b>Not Known</b>
P.O.#:		Surveyor:	<b>Jen Costello</b>	PSR:	<b>P-907-006-007</b>
Customer:		Clean Date:	<b>01/01/1900</b>	Shape:	<b>C</b>

Street:	<b>S HOBART RD</b>	Flow Control:	<b>Not Controlled</b>
City:	<b>Hobart, IN</b>	Year Renewed:	
Location:	<b>Ditch</b>	Tape/Media #:	
Purpose:	<b>Maintenance Related</b>	Dia/Height:	<b>12"</b>
Use:	<b>Sanitary</b>	Material:	<b>PVC</b>
Drain Area:	<b>NA</b>	Lining:	<b>Cured in Place</b>
Category:	<b>NA</b>		
Comment:	<b>battery at 350'-flow incorrect</b>		
Location Details:		Direction of Survey:	<b>Upstream</b>
US MH:	<b>M-907-007</b>	DS MH:	<b>M-907-006</b>
		Total Length Surveyed (ft):	<b>351.3</b>

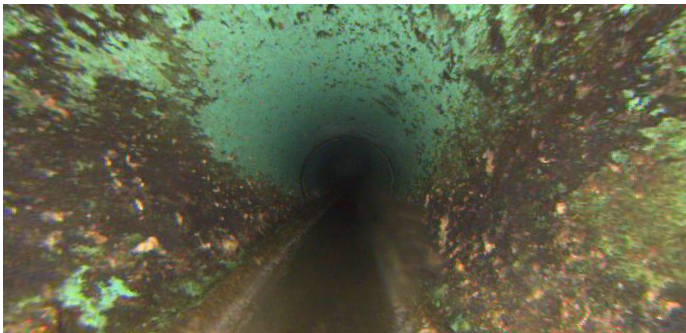
Position	Code	Observation	Video (sec)	Grade
.0	AMH	Manhole	10	NA
.0	MWL	Water Level	21	NA
.0	DAGS(S01)	Deposits Attached Grease	32	M 2
67.0	TF	Tap Factory	180	NA
104.2	TF	Tap Factory	269	NA
312.7	TF	Tap Factory	702	NA
351.3	MSA	Abandoned Survey	792	NA
351.3	DAGS(F01)	Deposits Attached Grease	803	M 2
