## Profile/Photo Observation Report

Date:	<b>09/18/2021</b>	Weather:		Coding:	<b>PACP 7.0</b>
Pipe Length (ft):	<b>328.9</b>	Owner:	<b>City of Hobart</b>	Pre Clean:	<b>Light Cleaning</b>
P.O.#:	<b>YES502259</b>	Surveyor:	<b>S. Bucklin</b>	PSR:	<b>P-503-045-062</b>
Customer:	<b>City of Hobart</b>	Clean Date:	<b>08/25/2021</b>	Shape:	<b>C</b>

Street:	<b>North Wisconsin Street</b>	Flow Control:	<b>Not Controlled</b>
City:	<b>Hobart, IN</b>	Year Renewed:	
Location:	<b>Easement/Right of Way</b>	Tape/Media #:	
Purpose:	<b>Routine Assessment</b>	Dia/Height:	<b>10"</b>
Use:	<b>Sanitary Sewage Pipe</b>	Material:	<b>VCP</b>
Drain Area:		Lining:	<b>None</b>
Category:	<b>NA</b>		
Comment:

Location Details:	<b>JUST OFF THE SW CORNER OF THE C</b>	Direction of Survey:	<b>Downstream</b>
US MH:	<b>M-503-062</b>	DS MH:	<b>M-503-045</b>
		Total Length Surveyed (ft):	<b>328.9</b>

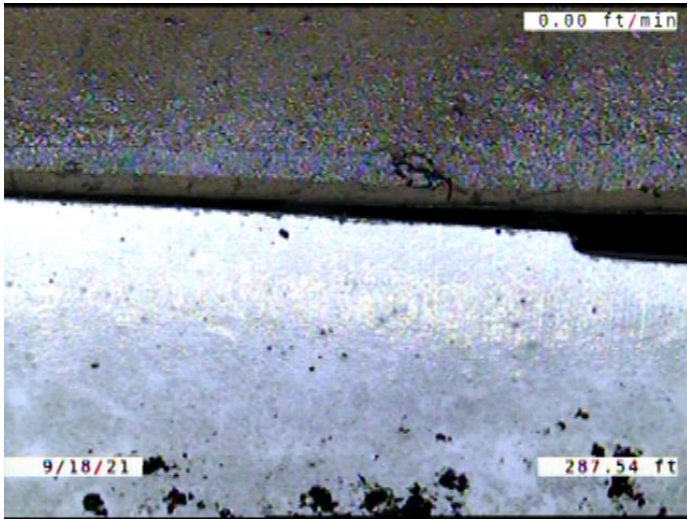
Code: **TFD**  
 Description: **Tap Factory Defective**

Distance (ft): **256.1**  
 Structural Grade: **0**  
 O&M Grade: **3**  
 Clock Start/From: **1**  
 Clock To:  
 1st Value: **4.000**  
 2nd Value:  
 Value Percent:  
 Continuous Index:  
 Within 8" of Joint: **YES**  
 Remarks: **ENCRUSTATION ALL AROUND THE TAP CONNECTION**

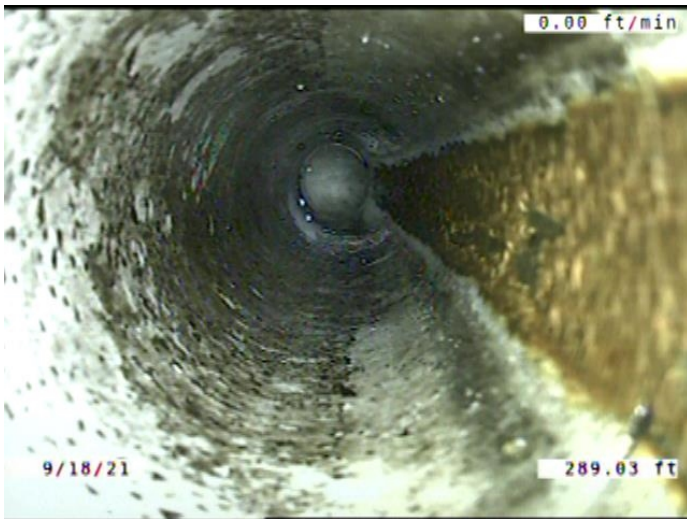
Code: **MMC**  
 Description: **Miscellaneous Material Change**

Distance (ft): **287.5**  
 Structural Grade: **0**  
 O&M Grade: **0**  
 Clock Start/From:  
 Clock To:  
 1st Value:  
 2nd Value:  
 Value Percent:  
 Continuous Index:  
 Within 8" of Joint: **NO**  
 Remarks: **VCP TO PVC**

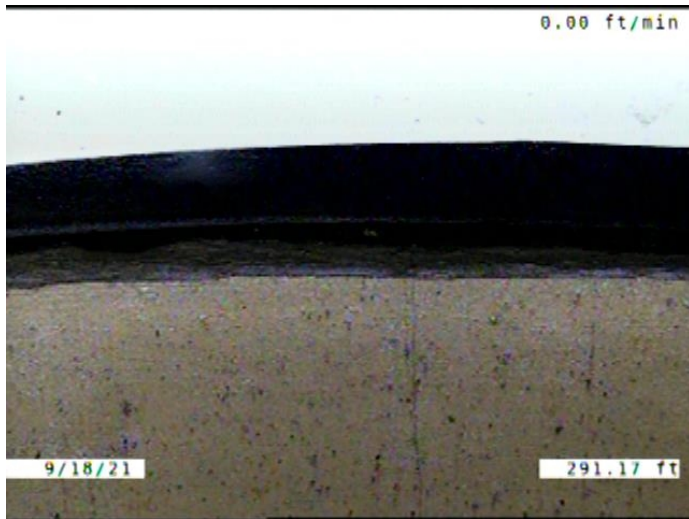
Code: **TF**  
 Description: **Tap Factory**

Distance (ft): **289.0**  
 Structural Grade: **0**  
 O&M Grade: **0**  
 Clock Start/From: **2**  
 Clock To:  
 1st Value: **4.000**  
 2nd Value:  
 Value Percent:  
 Continuous Index:  
 Within 8" of Joint: **YES**  
 Remarks:
