Profile/Photo Observation Report

Date:	01/29/2025	Weather:		Coding:	PACP 7.0
Pipe Length (ft):		Owner:	City of Hobart	Pre Clean:	No Pre-Cleaning
P.O.#:	YES502259	Surveyor:	S. Bucklin	PSR:	M-507-004.1-LS007
Customer:	City of Hobart	Clean Date:		Shape:	C

Street:	Delaware St.	Flow Control:	Not Controlled
City:	Hobart, IN	Year Renewed:	
Location:	Easement/Right of Way	Tape/Media #:	
Purpose:	Sewer System Evaluation Survey (SS	Dia/Height:	15"
Use:	Sanitary Sewage Pipe	Material:	DIP
Drain Area:		Lining:	None
Category:	NA		
Comment:

Location Details:		Direction of Survey:	Downstream
US MH:	M-507-004.1	DS MH:	LS007
		Total Length Surveyed (ft):	73.0

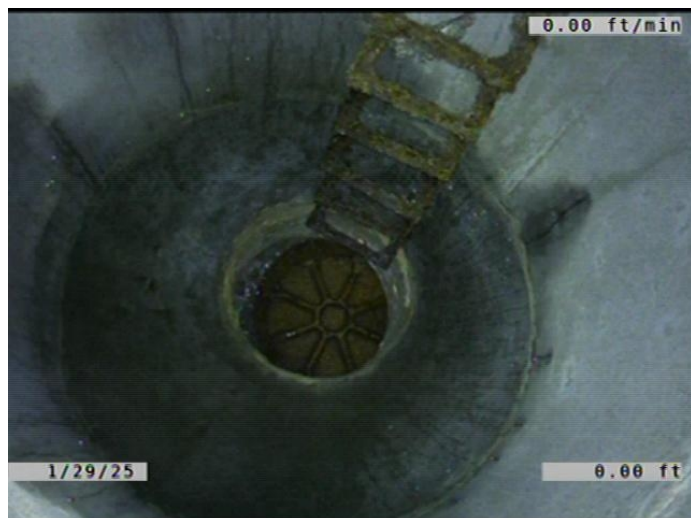
Code: **AMH**
 Description: **Manhole**

Distance (ft): **.0**
 Structural Grade: **0**
 O&M Grade: **0**
 Clock Start/From:
 Clock To:
 1st Value:
 2nd Value:
 Value Percent:
 Continuous Index:
 Within 8" of Joint: **NO**
 Remarks: **M-507-004.1**

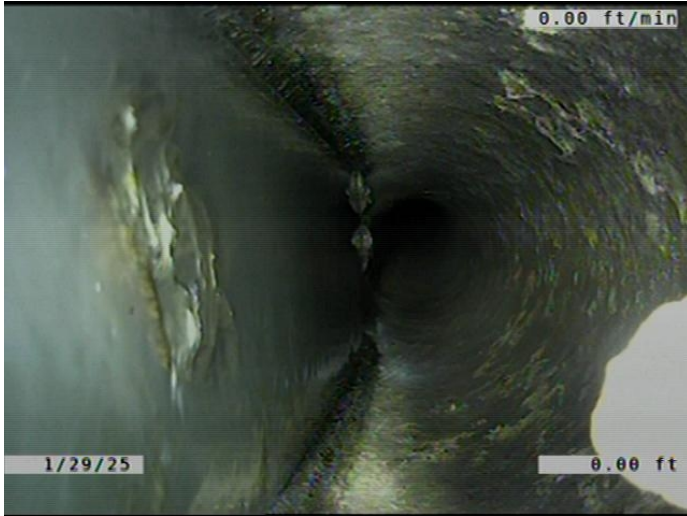
Code:	MWL
Description:	Miscellaneous Water Level
Distance (ft):	.0
Structural Grade:	0
O&M Grade:	0
Clock Start/From:	
Clock To:	
1st Value:	
2nd Value:	
Value Percent:	35.000
Continuous Index:	
Within 8" of Joint:	NO
Remarks:

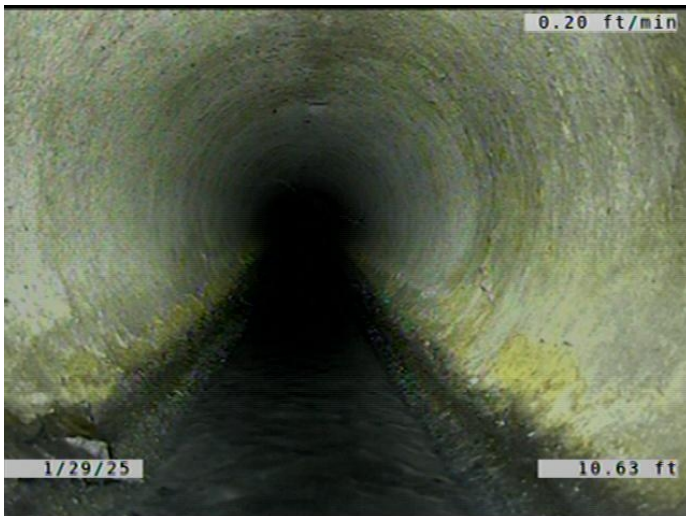
Code:	MWL
Description:	Miscellaneous Water Level
Distance (ft):	10.6
Structural Grade:	0
O&M Grade:	0
Clock Start/From:	
Clock To:	
1st Value:	
2nd Value:	
Value Percent:	10.000
Continuous Index:	
Within 8" of Joint:	NO
Remarks:

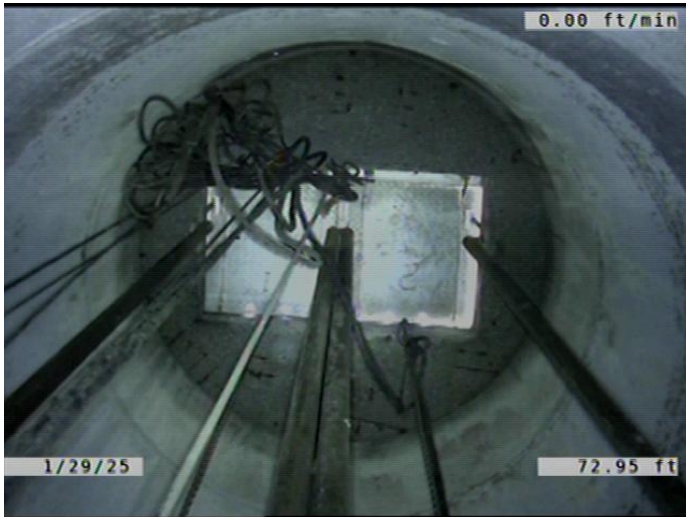
Code:	AWW
Description:	Access Point Wet Well
Distance (ft):	73.0
Structural Grade:	0
O&M Grade:	0
Clock Start/From:	
Clock To:	
1st Value:	
2nd Value:	
Value Percent:	
Continuous Index:	
Within 8" of Joint:	NO
Remarks:	LS007
