Profile/Photo Observation Report

Date:	11/10/2021	Weather:		Coding:	PACP 7.0
Pipe Length (ft):	219.1	Owner:	City of Hobart	Pre Clean:	No Pre-Cleaning
P.O.#:	YES502259	Surveyor:	Steven Bucklin	PSR:	M-604-057.1-M-604-057
Customer:	City of Hobart, IN (Red	Clean Date:		Shape:	C

Street:	North Connection Street	Flow Control:	Not Controlled
City:	City of Hobart	Year Renewed:	
Location:	Alley	Tape/Media #:	
Purpose:	Routine Assessment	Dia/Height:	8"
Use:	Sanitary Sewage Pipe	Material:	CP
Drain Area:		Lining:	None
Category:	NA		
Comment:			
Location Details:		Direction of Survey:	Upstream
US MH:	M-604-057.1	DS MH:	M-604-057
		Total Length Surveyed (ft):	219.1

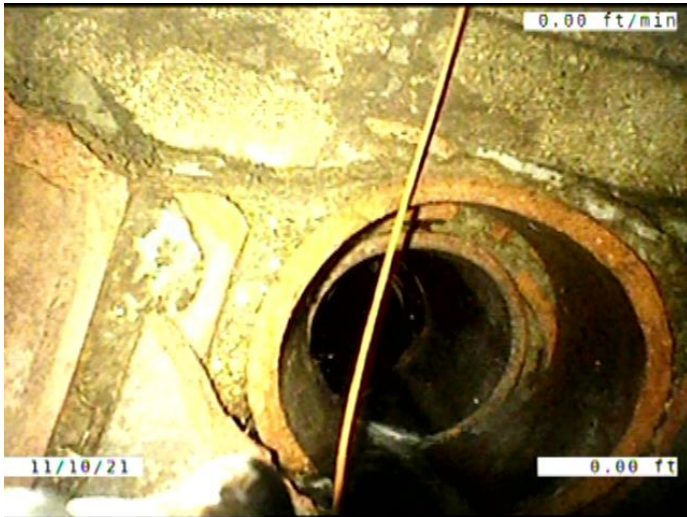
Code: **AMH**
 Description: **Manhole**

Distance (ft): **.0**
 Structural Grade: **0**
 O&M Grade: **0**
 Clock Start/From:
 Clock To:
 1st Value:
 2nd Value:
 Value Percent:
 Continuous Index:
 Within 8" of Joint: **NO**
 Remarks: **M-604-057**

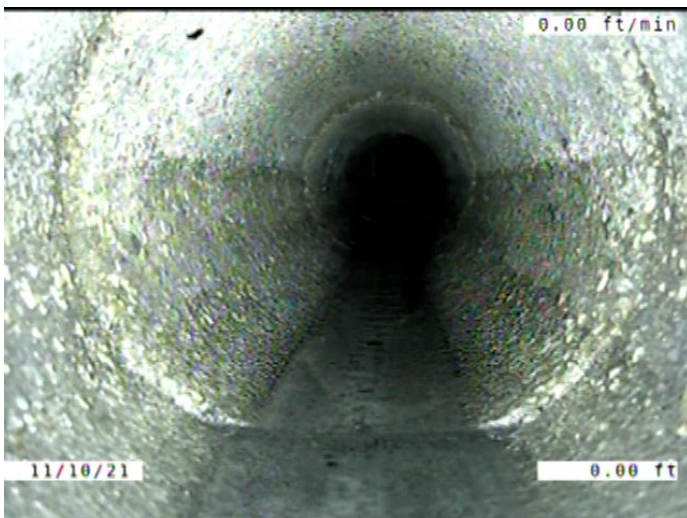
Code: **MWL**
 Description: **Miscellaneous Water Level**

Distance (ft): **.0**
 Structural Grade: **0**
 O&M Grade: **0**
 Clock Start/From:
 Clock To:
 1st Value:
 2nd Value:
 Value Percent: **5.000**
 Continuous Index:
 Within 8" of Joint: **NO**
 Remarks:

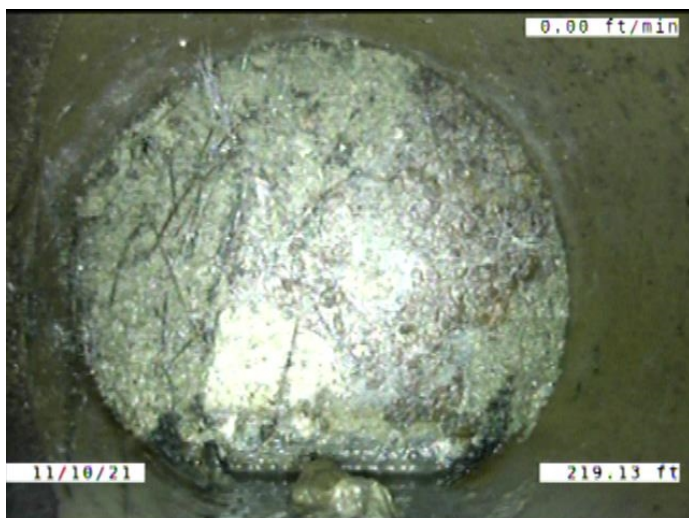
Code:	AEP
Description:	Access Point End of Pipe
Distance (ft):	219.1
Structural Grade:	0
O&M Grade:	0
Clock Start/From:	
Clock To:	
1st Value:	
2nd Value:	
Value Percent:	
Continuous Index:	
Within 8" of Joint:	NO
Remarks:	UNK M-604-057.1
