# Profile/Photo Observation Report

Date:	<b>02/01/2025</b>	Weather:		Coding:	<b>PACP 7.0</b>
Pipe Length (ft):		Owner:	<b>City of Hobart</b>	Pre Clean:	<b>Heavy Cleaning</b>
P.O.#:	<b>YES502259</b>	Surveyor:	<b>S. Bucklin</b>	PSR:	<b>M-902-008-M-902-008.1</b>
Customer:	<b>City of Hobart</b>	Clean Date:	<b>08/22/2023</b>	Shape:	<b>C</b>

Street:	<b>East 34th Lane</b>	Flow Control:	<b>Not Controlled</b>
City:	<b>Hobart, IN</b>	Year Renewed:	
Location:	<b>Local rural streets with light traffic, t</b>	Tape/Media #:	
Purpose:	<b>Sewer System Evaluation Survey (SS</b>	Dia/Height:	<b>10"</b>
Use:	<b>Sanitary Sewage Pipe</b>	Material:	<b>VCP</b>
Drain Area:		Lining:	<b>None</b>
Category:	<b>NA</b>		
Comment:			
Location Details:		Direction of Survey:	<b>Downstream</b>
US MH:	<b>M-902-008</b>	DS MH:	<b>M-902-008.1</b>
		Total Length Surveyed (ft):	<b>225.5</b>

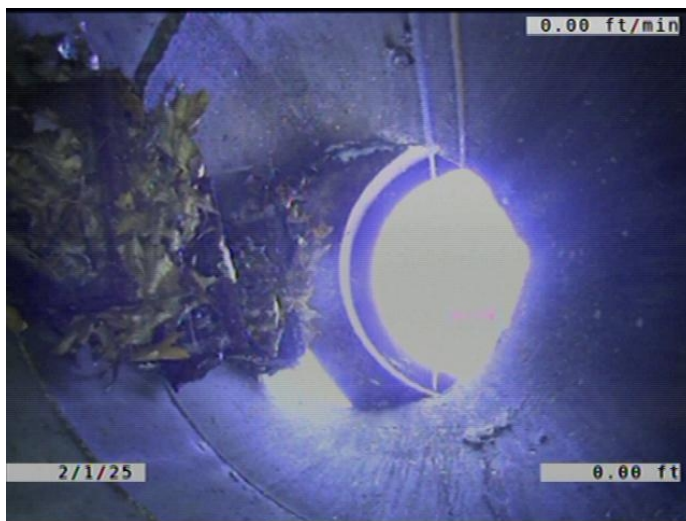
Code: **AMH**  
Description: **Manhole**

Distance (ft): **.0**  
Structural Grade: **0**  
O&M Grade: **0**  
Clock Start/From:  
Clock To:  
1st Value:  
2nd Value:  
Value Percent:  
Continuous Index:  
Within 8" of Joint: **NO**  
Remarks: **M-902-008**

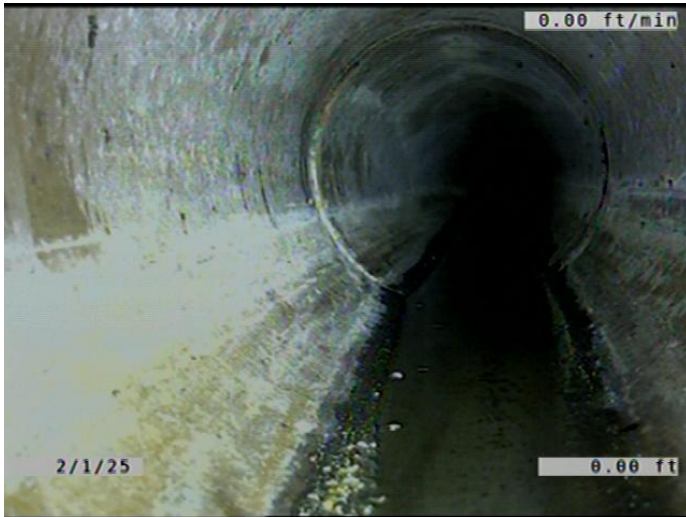
Code: **MWL**  
Description: **Miscellaneous Water Level**

Distance (ft): **.0**  
Structural Grade: **0**  
O&M Grade: **0**  
Clock Start/From:  
Clock To:  
1st Value:  
2nd Value:  
Value Percent: **5.000**  
Continuous Index:  
Within 8" of Joint: **NO**  
Remarks:

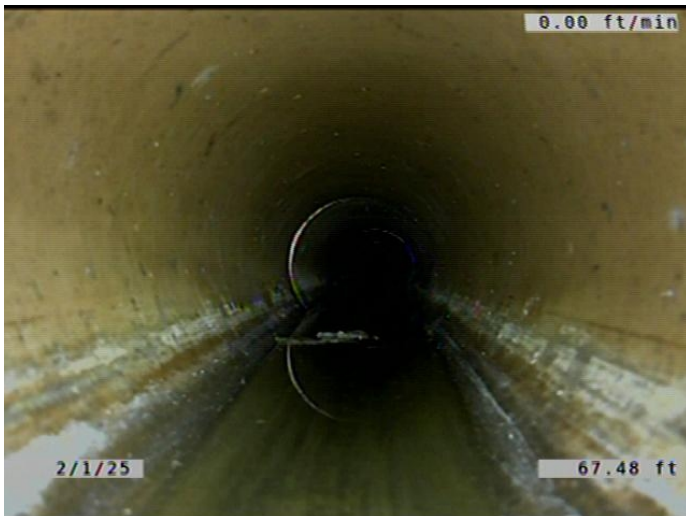
Code: **MWL**  
Description: **Miscellaneous Water Level**

Distance (ft): **67.5**  
Structural Grade: **0**  
O&M Grade: **0**  
Clock Start/From:  
Clock To:  
1st Value:  
2nd Value:  
Value Percent: **15.000**  
Continuous Index:  
Within 8" of Joint: **NO**  
Remarks:

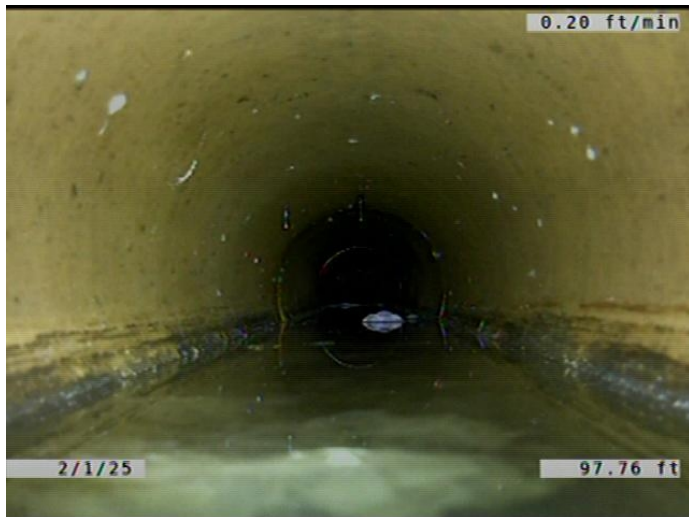
Code: **MWL**  
 Description: **Miscellaneous Water Level**

Distance (ft): **97.8**  
 Structural Grade: **0**  
 O&M Grade: **0**  
 Clock Start/From:  
 Clock To:  
 1st Value:  
 2nd Value:  
 Value Percent: **25.000**  
 Continuous Index:  
 Within 8" of Joint: **NO**  
 Remarks:

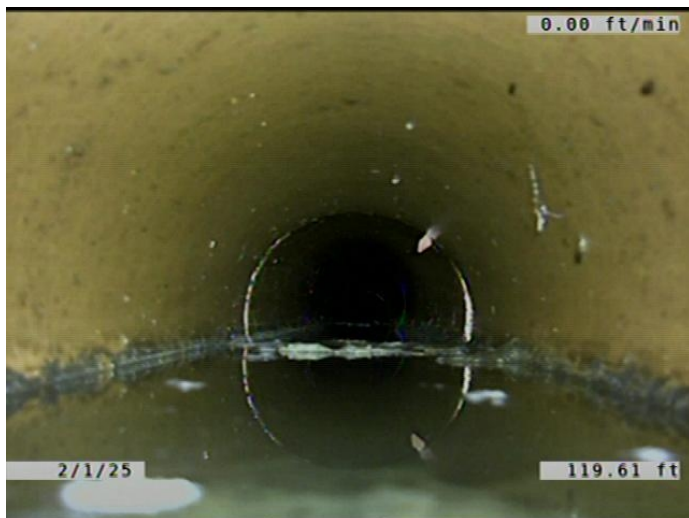
Code: **MWL**  
Description: **Miscellaneous Water Level**

Distance (ft): **119.6**  
Structural Grade: **0**  
O&M Grade: **0**  
Clock Start/From:  
Clock To:  
1st Value:  
2nd Value:  
Value Percent: **35.000**  
Continuous Index:  
Within 8" of Joint: **NO**  
Remarks:

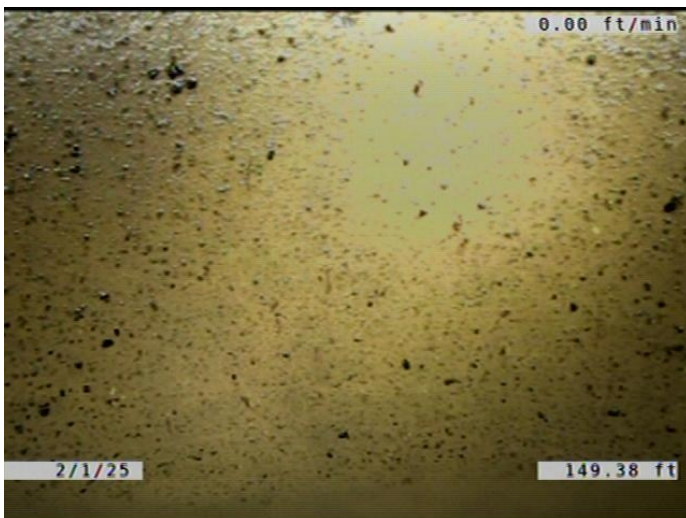
Code: **MWL**  
Description: **Miscellaneous Water Level**

Distance (ft): **149.4**  
Structural Grade: **0**  
O&M Grade: **0**  
Clock Start/From:  
Clock To:  
1st Value:  
2nd Value:  
Value Percent: **50.000**  
Continuous Index:  
Within 8" of Joint: **NO**  
Remarks:

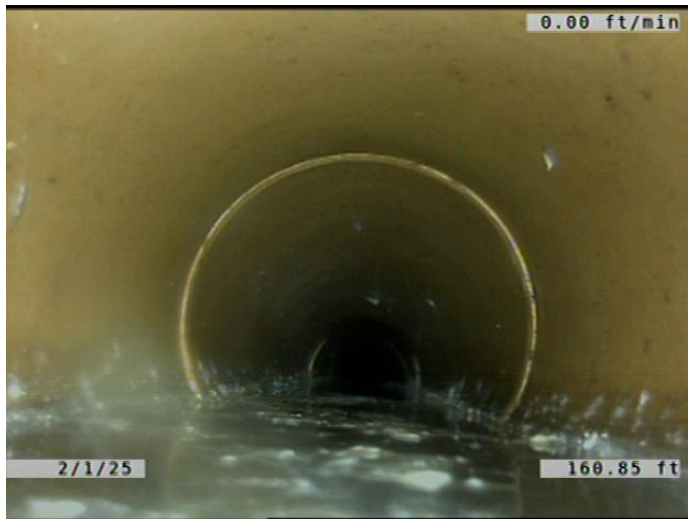
Code: **MWL**  
Description: **Miscellaneous Water Level**

Distance (ft): **160.8**  
Structural Grade: **0**  
O&M Grade: **0**  
Clock Start/From:  
Clock To:  
1st Value:  
2nd Value:  
Value Percent: **35.000**  
Continuous Index:  
Within 8" of Joint: **NO**  
Remarks:

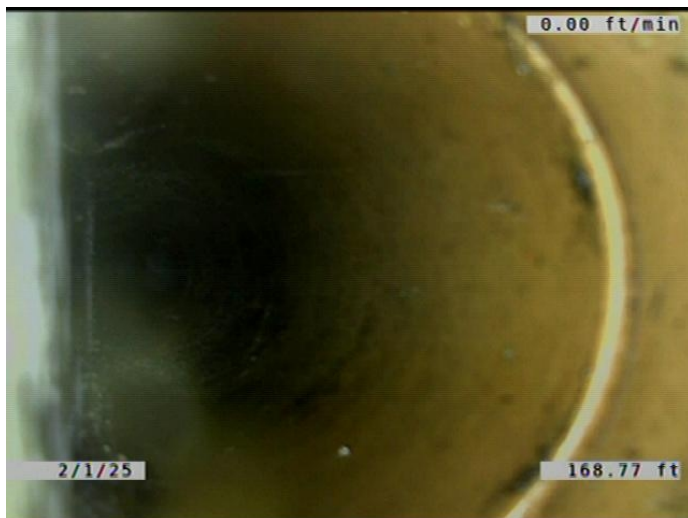
Code: **TFC**  
Description: **Tap Factory Capped**

Distance (ft): **168.8**  
Structural Grade: **0**  
O&M Grade: **0**  
Clock Start/From: **9**  
Clock To:  
1st Value: **6.000**  
2nd Value:  
Value Percent:  
Continuous Index:  
Within 8" of Joint: **YES**  
Remarks:

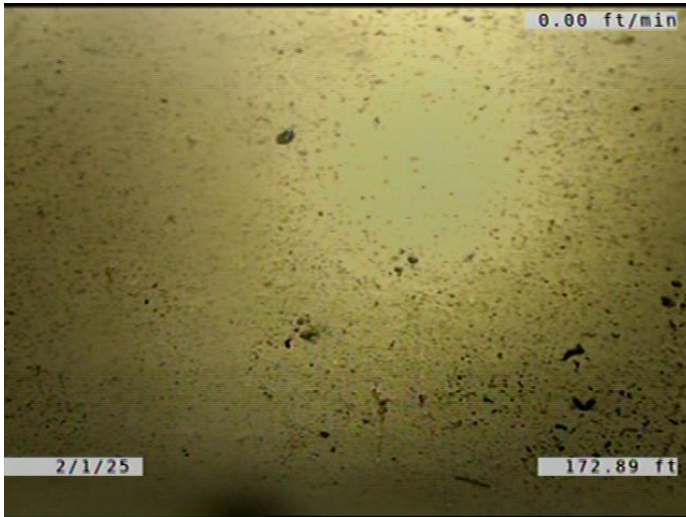
Code: **MWL**  
 Description: **Miscellaneous Water Level**

Distance (ft): **172.9**  
 Structural Grade: **0**  
 O&M Grade: **0**  
 Clock Start/From:  
 Clock To:  
 1st Value:  
 2nd Value:  
 Value Percent: **45.000**  
 Continuous Index:  
 Within 8" of Joint: **NO**  
 Remarks:

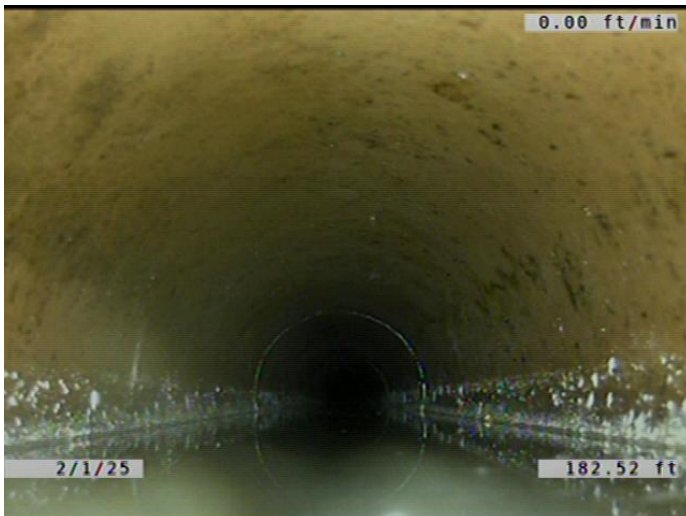
Code: **MWL**  
 Description: **Miscellaneous Water Level**

Distance (ft): **182.5**  
 Structural Grade: **0**  
 O&M Grade: **0**  
 Clock Start/From:  
 Clock To:  
 1st Value:  
 2nd Value:  
 Value Percent: **35.000**  
 Continuous Index:  
 Within 8" of Joint: **NO**  
 Remarks:

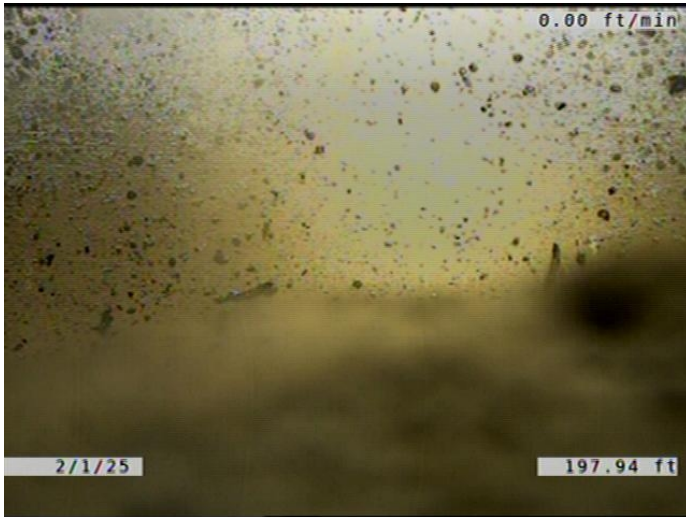
Code: **MWL**  
Description: **Miscellaneous Water Level**

Distance (ft): **197.9**  
Structural Grade: **0**  
O&M Grade: **0**  
Clock Start/From:  
Clock To:  
1st Value:  
2nd Value:  
Value Percent: **50.000**  
Continuous Index:  
Within 8" of Joint: **NO**  
Remarks:

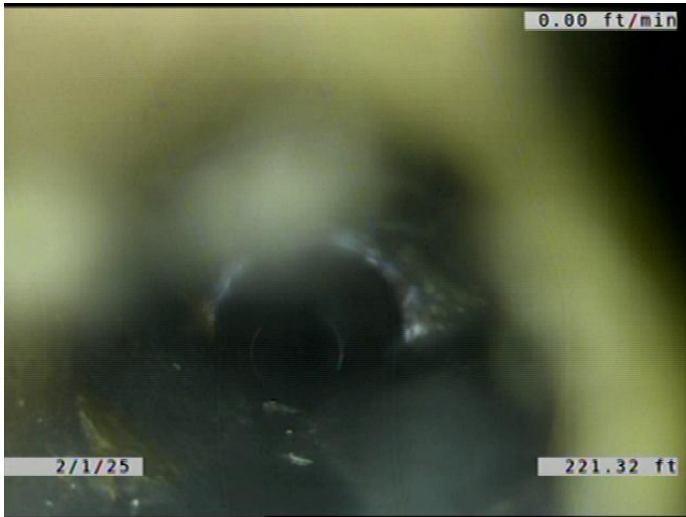
Code: **MWL**  
 Description: **Miscellaneous Water Level**

Distance (ft): **221.3**  
 Structural Grade: **0**  
 O&M Grade: **0**  
 Clock Start/From:  
 Clock To:  
 1st Value:  
 2nd Value:  
 Value Percent: **5.000**  
 Continuous Index:  
 Within 8" of Joint: **NO**  
 Remarks:

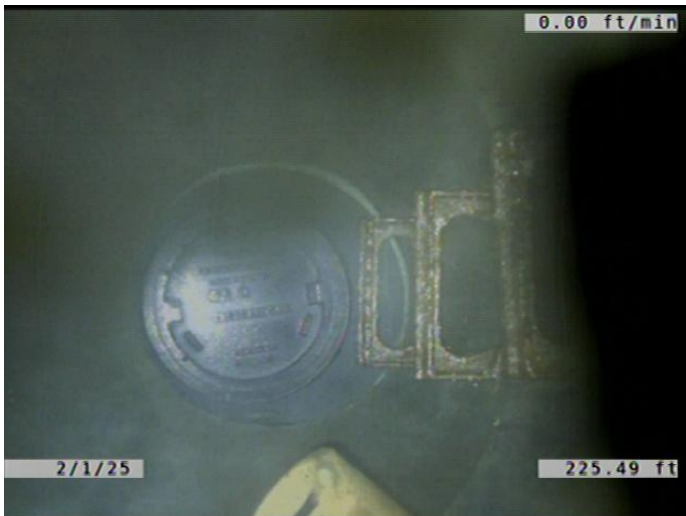
Code: **AMH**  
 Description: **Manhole**

Distance (ft): **225.5**  
 Structural Grade: **0**  
 O&M Grade: **0**  
 Clock Start/From:  
 Clock To:  
 1st Value:  
 2nd Value:  
 Value Percent:  
 Continuous Index:  
 Within 8" of Joint: **NO**  
 Remarks: **M-902-008.1**
