Profile/Photo Observation Report

Date:	02/22/2024	Weather:		Coding:	PACP 7.0
Pipe Length (ft):	2.5	Owner:	City of Hobart	Pre Clean:	Heavy Cleaning
P.O.#:	YES502259	Surveyor:	S. Bucklin	PSR:	P-604-116.2 (East)-116
Customer:	City of Hobart	Clean Date:	02/22/2024	Shape:	C

Street:	W CLEVELAND AVE	Flow Control:	Not Controlled
City:	Hobart, IN	Year Renewed:	
Location:	Local rural streets with light traffic, t	Tape/Media #:	
Purpose:	Maintenance Related	Dia/Height:	10"
Use:	Sanitary Sewage Pipe	Material:	CP
Drain Area:		Lining:	None
Category:	NA		
Comment:			
Location Details:		Direction of Survey:	Upstream
US MH:	M-604-116.2 (EAST)	DS MH:	M-604-116
		Total Length Surveyed (ft):	2.1

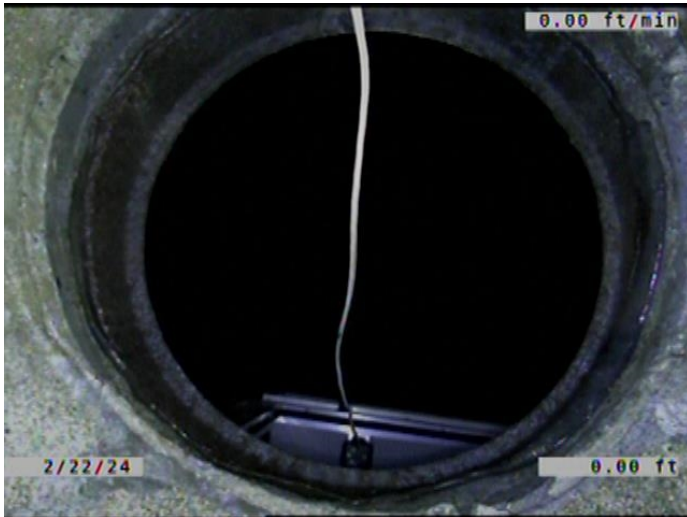
Code: **AMH**
Description: **Manhole**

Distance (ft): **.0**
Structural Grade: **0**
O&M Grade: **0**
Clock Start/From:
Clock To:
1st Value:
2nd Value:
Value Percent:
Continuous Index:
Within 8" of Joint: **NO**
Remarks: **M-604-116**
