Profile/Photo Observation Report

Date:	03/05/2024	Weather:		Coding:	PACP 7.0
Pipe Length (ft):	215.0	Owner:	City of Hobart	Pre Clean:	Heavy Cleaning
P.O.#:		Surveyor:	S. Bucklin	PSR:	P-805-066.1-066.2
Customer:	City of Hobart	Clean Date:	10/17/2022	Shape:	C

Street:	SR-130	Flow Control:	Not Controlled
City:	Hobart, IN	Year Renewed:	
Location:	Parking Lot	Tape/Media #:	
Purpose:	Sewer System Evaluation Survey (SS	Dia/Height:	6"
Use:	Sanitary Sewage Pipe	Material:	VCP
Drain Area:		Lining:	None
Category:	NA		
Comment:			
Location Details:		Direction of Survey:	Downstream
US MH:	M-805-066.1	DS MH:	M-805-066.2
		Total Length Surveyed (ft):	211.4

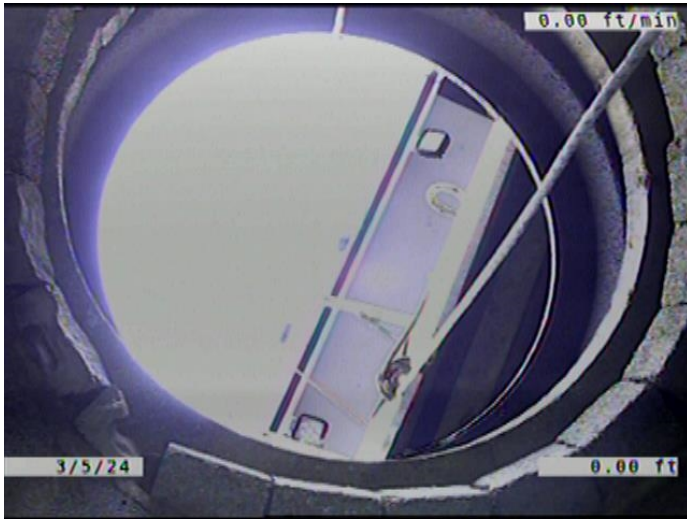
Code: **AMH**
Description: **Manhole**

Distance (ft): **.0**
Structural Grade: **0**
O&M Grade: **0**
Clock Start/From:
Clock To:
1st Value:
2nd Value:
Value Percent:
Continuous Index:
Within 8" of Joint: **NO**
Remarks: **M-805-066.1**

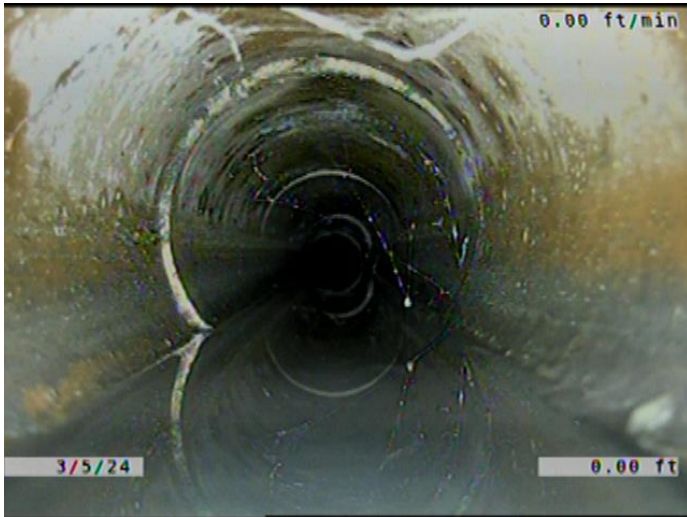
Code: **MWL**
Description: **Miscellaneous Water Level**

Distance (ft): **.0**
Structural Grade: **0**
O&M Grade: **0**
Clock Start/From:
Clock To:
1st Value:
2nd Value:
Value Percent: **10.000**
Continuous Index:
Within 8" of Joint: **NO**
Remarks:
