Profile/Photo Observation Report

Date:	12/11/2024	Weather:		Coding:	PACP 7.0
Pipe Length (ft):	196.0	Owner:	City of Hobart	Pre Clean:	Heavy Cleaning
P.O.#:	YES502259	Surveyor:	S. Bucklin	PSR:	P-507-028-027
Customer:	City of Hobart	Clean Date:	09/27/2024	Shape:	C

Street:	South Dekalb Street	Flow Control:	Not Controlled
City:	Hobart, IN	Year Renewed:	
Location:	Sidewalk	Tape/Media #:	
Purpose:	Sewer System Evaluation Survey (SS)	Dia/Height:	10"
Use:	Sanitary Sewage Pipe	Material:	VCP
Drain Area:		Lining:	None
Category:	NA		
Comment:			
Location Details:		Direction of Survey:	Downstream
US MH:	M-507-027	DS MH:	M-507-028
		Total Length Surveyed (ft):	191.9

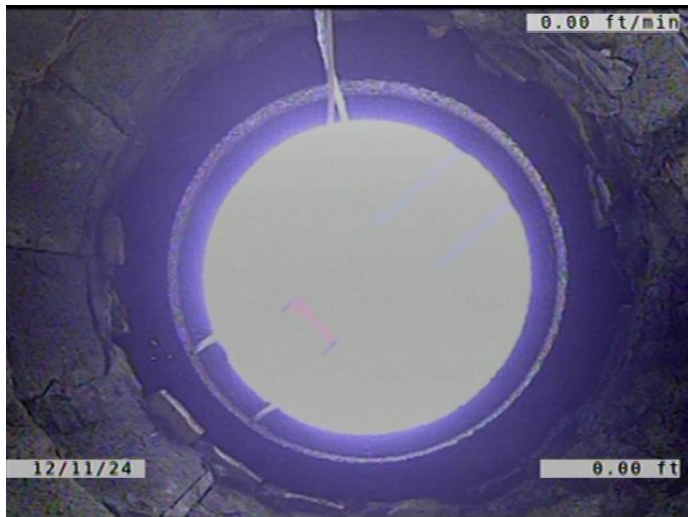
Code: **AMH**
Description: **Manhole**

Distance (ft): **.0**
Structural Grade: **0**
O&M Grade: **0**
Clock Start/From:
Clock To:
1st Value:
2nd Value:
Value Percent:
Continuous Index:
Within 8" of Joint: **NO**
Remarks: **M-507-027**

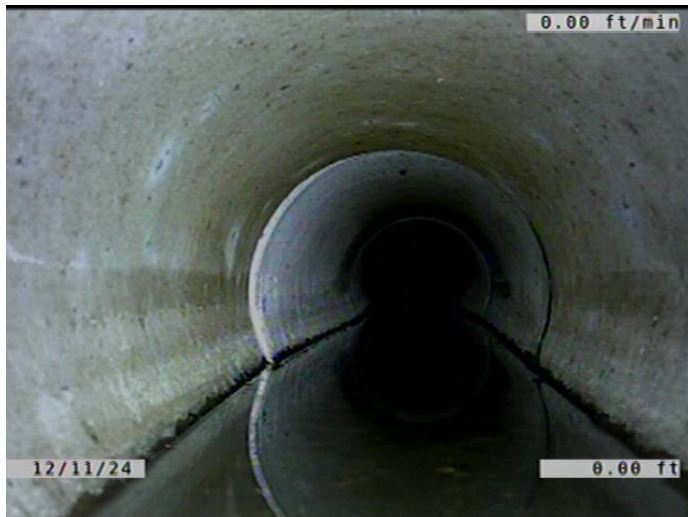
Code: **MWL**
Description: **Miscellaneous Water Level**

Distance (ft): **.0**
Structural Grade: **0**
O&M Grade: **0**
Clock Start/From:
Clock To:
1st Value:
2nd Value:
Value Percent: **10.000**
Continuous Index:
Within 8" of Joint: **NO**
Remarks:

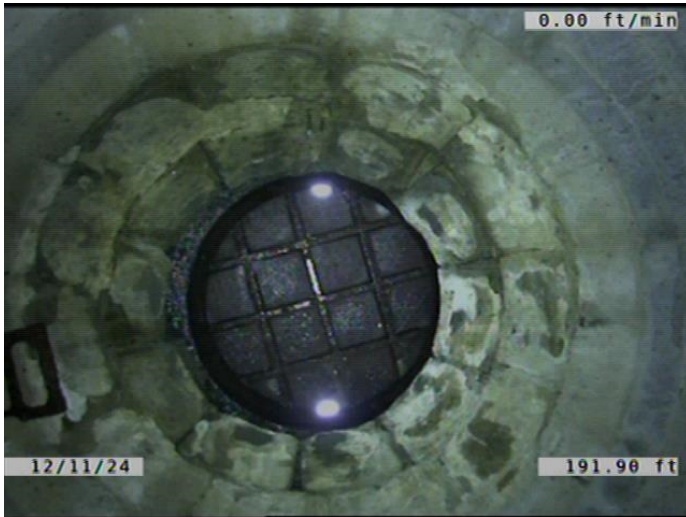
Code:	AMH
Description:	Manhole
Distance (ft):	191.9
Structural Grade:	0
O&M Grade:	0
Clock Start/From:	
Clock To:	
1st Value:	
2nd Value:	
Value Percent:	
Continuous Index:	
Within 8" of Joint:	NO
Remarks:	M-507-028
