Profile/Photo Observation Report

Date:	12/05/2024	Weather:		Coding:	PACP 7.0
Pipe Length (ft):	296.0	Owner:	City of Hobart	Pre Clean:	Heavy Cleaning
P.O.#:	YES502259	Surveyor:	S. Bucklin	PSR:	P-507-075-074
Customer:	City of Hobart	Clean Date:	09/07/2024	Shape:	C

Street:	West 11th Street	Flow Control:	Not Controlled
City:	Hobart, IN	Year Renewed:	
Location:	Easement/Right of Way	Tape/Media #:	
Purpose:	Sewer System Evaluation Survey (SS)	Dia/Height:	10"
Use:	Sanitary Sewage Pipe	Material:	VCP
Drain Area:		Lining:	None
Category:	NA		
Comment:			
Location Details:		Direction of Survey:	Downstream
US MH:	M-507-075	DS MH:	M-507-074.1
		Total Length Surveyed (ft):	211.7

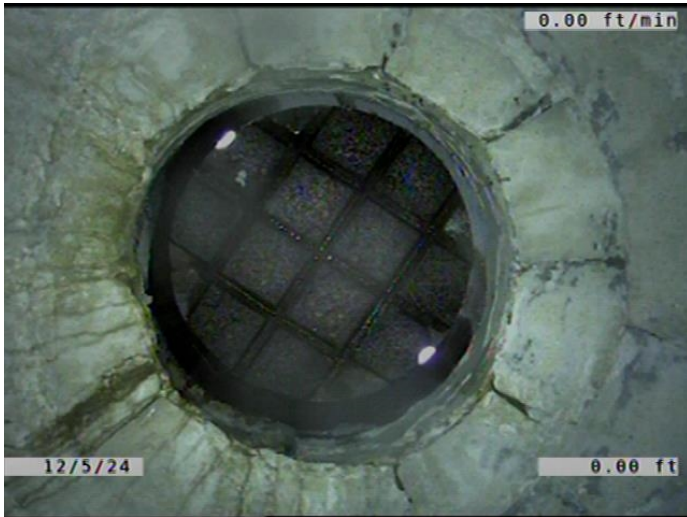
Code: **AMH**
Description: **Manhole**

Distance (ft): **.0**
Structural Grade: **0**
O&M Grade: **0**
Clock Start/From:
Clock To:
1st Value:
2nd Value:
Value Percent:
Continuous Index:
Within 8" of Joint: **NO**
Remarks: **M-507-075**

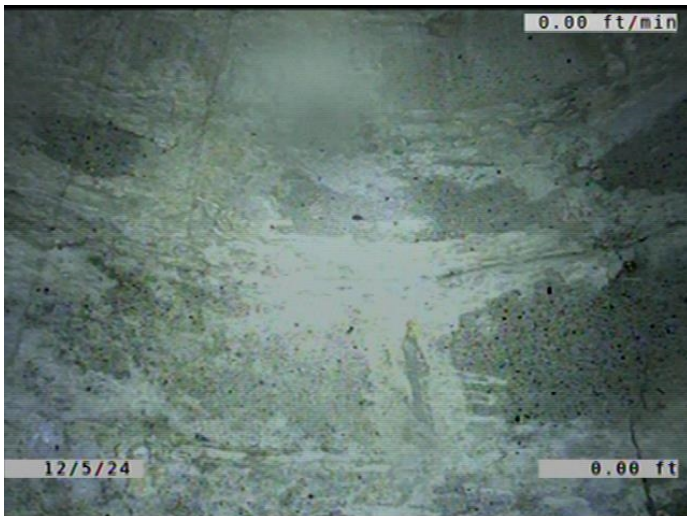
Code: **MWL**
Description: **Miscellaneous Water Level**

Distance (ft): **.0**
Structural Grade: **0**
O&M Grade: **0**
Clock Start/From:
Clock To:
1st Value:
2nd Value:
Value Percent: **5.000**
Continuous Index:
Within 8" of Joint: **NO**
Remarks:

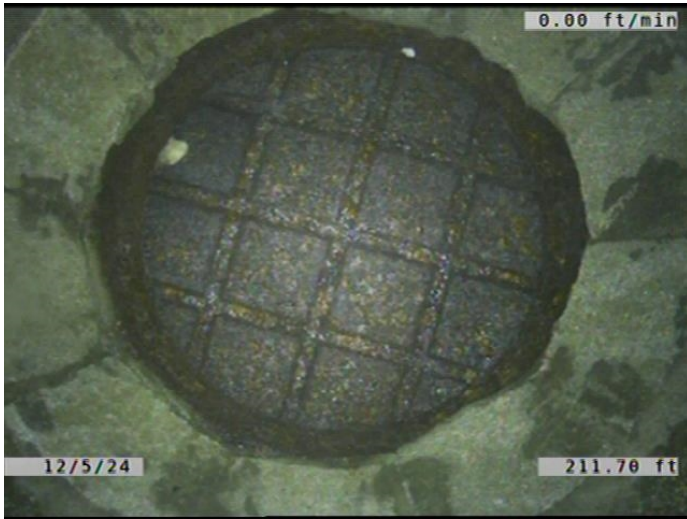
Code:	AMH
Description:	Manhole
Distance (ft):	211.7
Structural Grade:	0
O&M Grade:	0
Clock Start/From:	
Clock To:	
1st Value:	
2nd Value:	
Value Percent:	
Continuous Index:	
Within 8" of Joint:	NO
Remarks:	M-507-074.1
