Profile/Photo Observation Report

Date:	12/12/2024	Weather:		Coding:	PACP 7.0
Pipe Length (ft):	394.0	Owner:	City of Hobart	Pre Clean:	Heavy Cleaning
P.O.#:	YES502259	Surveyor:	S. Bucklin	PSR:	P-507-084-087
Customer:	City of Hobart	Clean Date:	09/16/2024	Shape:	C

Street:	West 10th Place	Flow Control:	Not Controlled
City:	Hobart, IN	Year Renewed:	
Location:	Local rural streets with light traffic, t	Tape/Media #:	
Purpose:	Sewer System Evaluation Survey (SS	Dia/Height:	8"
Use:	Sanitary Sewage Pipe	Material:	PVC
Drain Area:		Lining:	None
Category:	NA		
Comment:			
Location Details:		Direction of Survey:	Downstream
US MH:	M-507-087	DS MH:	M-507-084
		Total Length Surveyed (ft):	381.6

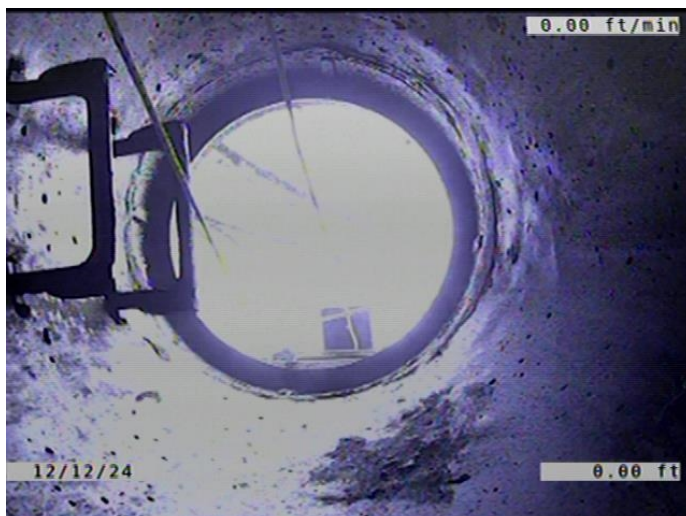
Code: **AMH**
 Description: **Manhole**

Distance (ft): **.0**
 Structural Grade: **0**
 O&M Grade: **0**
 Clock Start/From:
 Clock To:
 1st Value:
 2nd Value:
 Value Percent:
 Continuous Index:
 Within 8" of Joint: **NO**
 Remarks: **M-507-087**

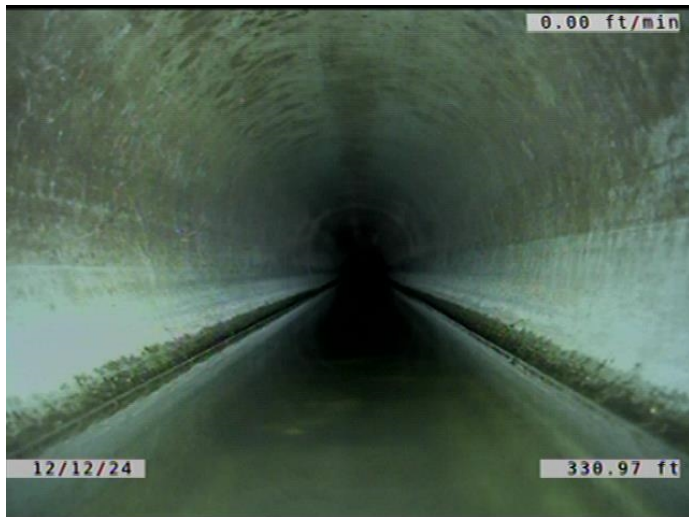
Code: **MWL**
Description: **Miscellaneous Water Level**

Distance (ft): **331.0**
Structural Grade: **0**
O&M Grade: **0**
Clock Start/From:
Clock To:
1st Value:
2nd Value:
Value Percent: **15.000**
Continuous Index:
Within 8" of Joint: **NO**
Remarks:
