Profile/Ph	noto Observatio	n Report			RedZor
Date:	03/23/2018	Weather:		Coding:	PACP 6.0
Pipe Length (ft	t): 339.2	Owner:	NA	Pre Clean:	Not Known
P.O.#:		Surveyor:	Jen Costello	PSR:	P-203-041-051
Customer:		Clean Date:	01/01/1900	Shape:	С
Street:	W 38TH AVE		Flow Control:	Not Controlled	l
City:	Hobart, IN		Year Renewed:		
Location:	Other		Tape/Media #:		
Purpose:	Not Known		Dia/Height:	12"	
Use:	Sanitary		Material:	VCP	
Drain Area:	NA		Lining:		
Category:	NA				
Comment:					
Location Detai	ils:		Direction of Sur	vey: Downstream	
US MH:	M-203-051	DS MH:	M-203-041	Total Length Surveyed (ft)): 67.7
D&M Index:	2.00	O&M Quick:	270	00 O&M Rating:	14.00
Structural Index	. 0.00	Structural Q	uick: 000		0.00
Overall Index:	2.00	Overall Quic			14.00

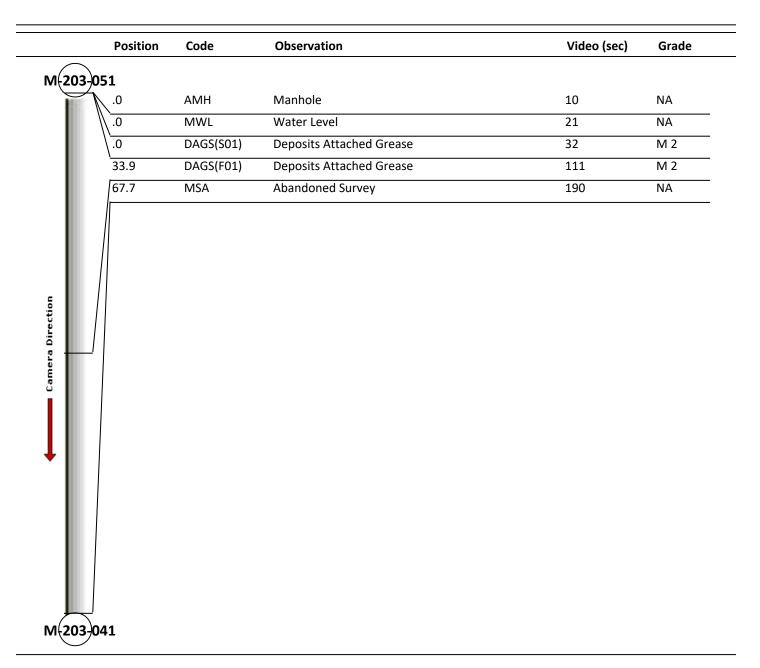
Code: Description:	AMH Manhole
Distance (ft):	.0
Structural Grade:	0
O&M Grade:	0
Clock Start/From:	
Clock To:	
1st Value:	
2nd Value:	
Value Percent:	
Continuous Index:	
Within 8" of Joint:	NO
Remarks:	M-203-051
