Profile/Pho	oto Observatior	n Report			RedZon
Date:	03/23/2018	Weather:		Coding:	PACP 6.0
Pipe Length (ft)	: <b>182.8</b>	Owner:	NA	Pre Clean:	No Pre-Cleaning
P.O.#:		Surveyor:	Jen Costello	PSR:	P-208-012-013
Customer:		Clean Date:	01/01/1900	Shape:	С
Street:	FOXCROFT STREET	Г	Flow Control:	Not Controlle	d
City:	Hobart, IN		Year Renewed:		
Location:	Light Highway		Tape/Media #:		
Purpose:	Routine Assessme	ent	Dia/Height:	12"	
Use:	Sanitary		Material:	VCP	
Drain Area:	NA		Lining:		
Category:	NA				
Comment:	R_M at 17 ft debri	is and rocks in the	tracks\nFlow direc	tion wrong	
Location Details	5:		Direction of Surve	y: Upstream	
US MH:	M-208-013	DS MH:	M-208-012	Total Length Surveyed (f	t): <b>18.7</b>
0&M Index:	2.20	O&M Quick:	3124	O&M Rating:	11.00
structural Index:	0.00	Structural Qui	ck: 0000		0.00
Overall Index:	2.20	Overall Quick:	3124	Overall Rating:	11.00

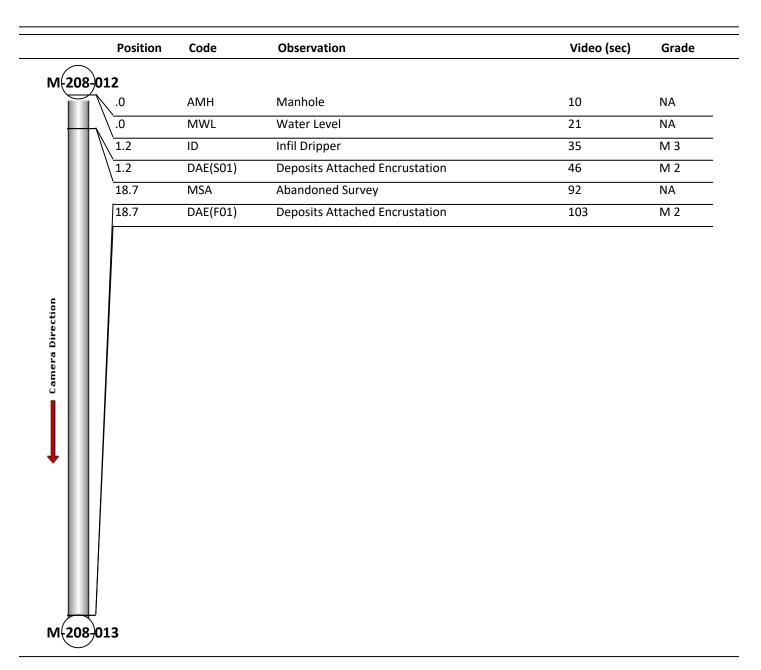
Code: Description:	AMH Manhole
Distance (ft):	.0
Structural Grade:	0
O&M Grade:	0
Clock Start/From:	
Clock To:	
1st Value:	
2nd Value:	
Value Percent:	
Continuous Index:	
Within 8" of Joint:	NO
Remarks:	M-208-012
