Profile/Ph	oto Observation	n Report				RedZone
Date:	03/22/2018	Weather:			Coding:	PACP 6.0
Pipe Length (ft	): <b>138.8</b>	Owner:	NA		Pre Clean:	No Pre-Cleaning
P.O.#:		Surveyor:	Selasie Ho	onu	PSR:	P-208-027-026
Customer:		Clean Date	: <b>01/01/19</b>	00	Shape:	С
Street:	OFF MINNESOTA S	ST	Flow Control:		Not Controlled	
City:	Hobart, IN		Year Renew	ved:		
Location:	Light Highway		Tape/Medi	a #:		
Purpose:	Routine Assessme	nt	Dia/Height:		8"	
Use:	Sanitary		Material:		PVC	
Drain Area:	NA		Lining:			
Category:	NA					
Comment:	Flow direction wro	ong				
Location Detai	ls:		Direction o	f Survey:	Upstream	
US MH:	M-208-026	DS MH:	M-208-027	Тс	otal Length Surveyed (ft)	: <b>130.6</b>
0&M Index:	0.00	O&M Quick	:	0000	O&M Rating:	0.00
Structural Index:	0.00	Structural C	uick:	0000	Structural Rating:	0.00
Overall Index:	0.00	Overall Quid	ck:	0000	Overall Rating:	0.00

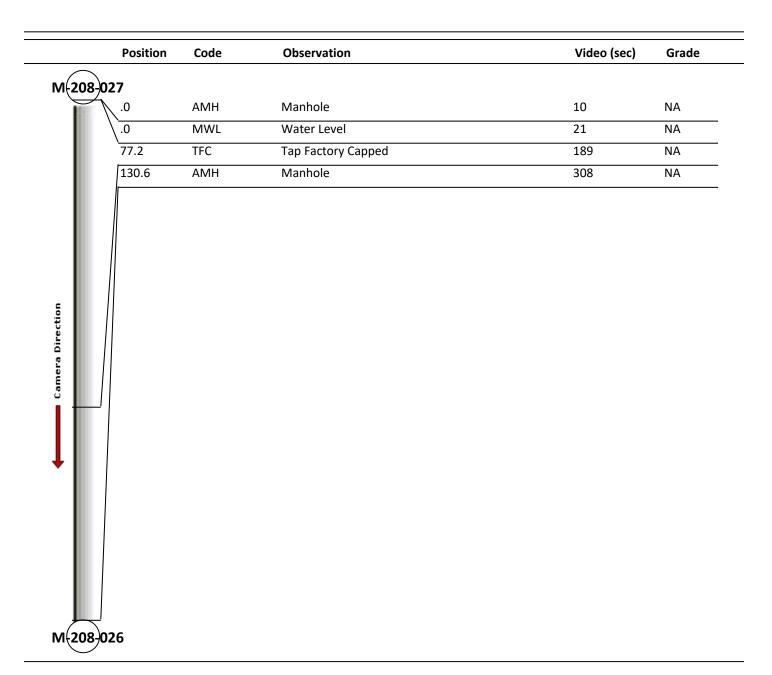
Code:	АМН
Description:	Manhole
Distance (ft):	.0
Structural Grade:	0
O&M Grade:	0
Clock Start/From:	
Clock To:	
1st Value:	
2nd Value:	
Value Percent:	
Continuous Index:	
Within 8" of Joint:	NO
Remarks:	M-208-027
