Profile/Ph	oto Observatio	n Report				RedZone
Date:	03/21/2018	Weather:			Coding:	PACP 6.0
Pipe Length (ft)): 356.9	Owner:	NA		Pre Clean:	No Pre-Cleaning
P.O.#:		Surveyor:	Selasie H	lonu	PSR:	P-308-011-010
Customer:		Clean Date	e: 01/01/1	900	Shape:	C
Street:	AMBER DR & DIA	AMBER DR & DIAMOND DR F		rol:	Not Controlled	
City:	Hobart, IN		Year Rene	wed:		
Location:	Light Highway		Tape/Med	lia #:		
Purpose:	Routine Assessme	ent	Dia/Heigh	t:	8"	
Use:	Sanitary		Material:		PVC	
Drain Area:	NA		Lining:			
Category:	NA					
Comment:	Flow direction wr	ong				
Location Detail	s:		Direction	of Survey:	Upstream	
US MH:	M-308-010	DS MH:	M-308-011	Т	otal Length Surveyed (ft)	: 345.7
D&M Index:	0.00	O&M Quicl	k:	0000	O&M Rating:	0.00
Structural Index:	0.00	Structural (Quick:	0000	Structural Rating:	0.00
Overall Index:	0.00	Overall Qui	ick:	0000	Overall Rating:	0.00

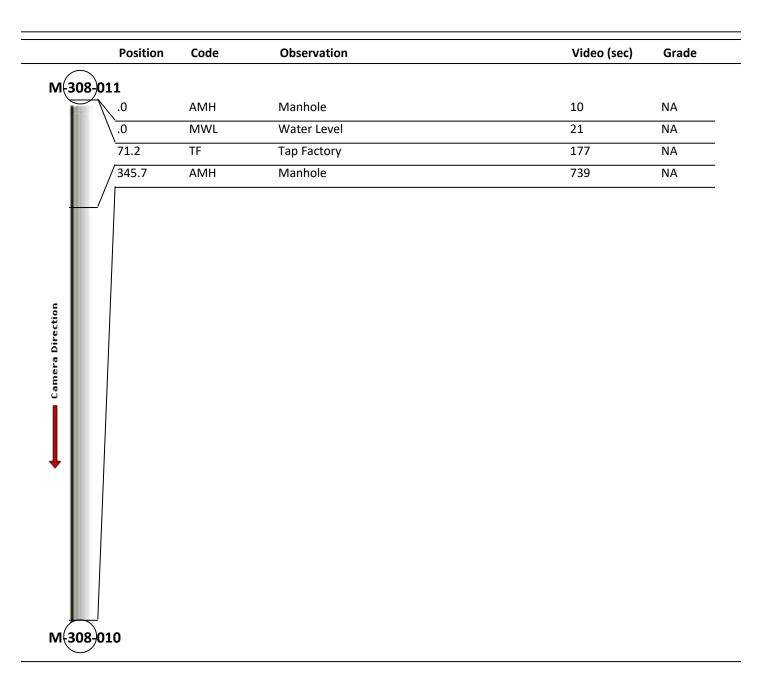
Code: Description:	AMH Manhole
Distance (ft):	.0
Structural Grade:	0
O&M Grade:	0
Clock Start/From:	
Clock To:	
1st Value:	
2nd Value:	
Value Percent:	
Continuous Index:	
Within 8" of Joint:	NO
Remarks:	M-308-011
