Profile/Ph	oto Observation	Report				RedZone
Date:	03/21/2018	Weather:			Coding:	PACP 6.0
Pipe Length (ft): 44.3	Owner:	NA		Pre Clean:	No Pre-Cleaning
P.O.#:		Surveyor:	Selasie Ho	onu	PSR:	P-308-027-026
Customer:		Clean Date:	01/01/19	00	Shape:	С
Street:	FOXCROFT STREET		Flow Contro	ol:	Not Controlled	
City:	Hobart, IN		Year Renew	ved:		
Location:	Light Highway		Tape/Medi	a #:		
Purpose:	Routine Assessmen	nt	Dia/Height:	:	8"	
Use:	Sanitary		Material:		PVC	
Drain Area:	NA		Lining:			
Category:	NA					
Comment:	Flow direction wro	ng				
Location Detail	S:		Direction o	f Survey:	Downstream	
US MH:	M-308-026	DS MH:	M-308-027	Т	otal Length Surveyed (ft)	: 46.1
D&M Index:	0.00	O&M Quick:	:	0000	O&M Rating:	0.00
Structural Index:	0.00	 Structural Q	uick:	0000	Structural Rating:	0.00
Overall Index:	0.00	Overall Quic	:k:	0000	Overall Rating:	0.00

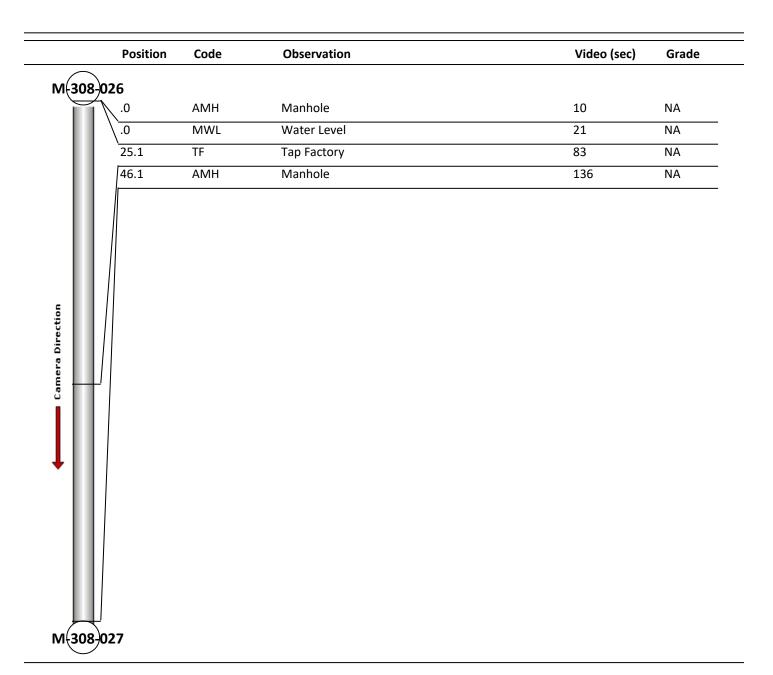
Code: Description:	AMH Manhole
Distance (ft):	.0
Structural Grade:	0
O&M Grade:	0
Clock Start/From:	
Clock To:	
1st Value:	
2nd Value:	
Value Percent:	
Continuous Index:	
Within 8" of Joint:	NO
Remarks:	M-308-026
