Profile/Ph	oto Observatio	n Report			RedZone
Date:	03/28/2018	Weather:		Coding:	PACP 6.0
Pipe Length (ft): 246.0	Owner:	NA	Pre Clean:	No Pre-Cleaning
P.O.#:		Surveyor:	Selasie Honu	PSR:	
Customer:		Clean Date:	01/01/1900	Shape:	c
Street:	FOXCROFT STREE	Т	Flow Control:	Not Controlled	
City:	Hobart, IN		Year Renewed:		
Location:	Woods		Tape/Media #:		
Purpose:	Routine Assessme	ent	Dia/Height:	12"	
Use:	Sanitary		Material:	VCP	
Drain Area:	NA		Lining:		
Category:	NA				
Comment:	F_S_R_M at 1 ft debris				
Location Detai	ls:		Direction of Surve	y: Upstream	
US MH:	M-507-019	DS MH:	M-507-019A	Total Length Surveyed (ft)	: 3.0
0&M Index:	3.00	O&M Quick:	3100	O&M Rating:	3.00
tructural Index:	2.00	Structural Qui	ck: 2100		2.00
Overall Index:	2.50	Overall Quick:	3121	Overall Rating:	5.00

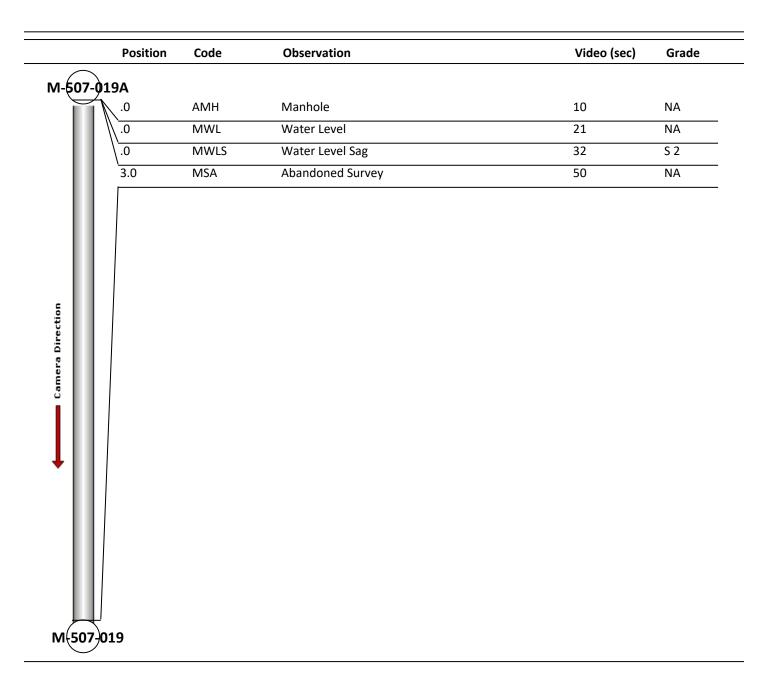
Code: Description:	AMH Manhole
Distance (ft):	.0
Structural Grade:	0
O&M Grade:	0
Clock Start/From:	
Clock To:	
1st Value:	
2nd Value:	
Value Percent:	
Continuous Index:	
Within 8" of Joint:	NO
Remarks:	M-507-019A

Code: MWL Description: Water Level

Distance (ft): .0 Structural Grade: 0 O&M Grade: 0 Clock Start/From: Clock To: 1st Value: 2nd Value: Value Percent: 5.000 Continuous Index: Within 8" of Joint: NO Remarks:

Code:	MWLS	
Description:	Water Level Sag	
	-	
Distance (ft):	.0	
Structural Grade:	2	
O&M Grade:	3	
Clock Start/From:		
Clock To:		
1st Value:		
2nd Value:		
Value Percent:	10.000	
Continuous Index:		
Within 8" of Joint:	NO	
Remarks:

Code: Description: MSA Abandoned Survey

Distance (ft):	3.0
Structural Grade:	0
O&M Grade:	0
Clock Start/From:	
Clock To:	
1st Value:	
2nd Value:	
Value Percent:	
Continuous Index:	
Within 8" of Joint:	NO
Remarks:	camera stopped
