Profile/Ph	oto Observation	Report				RedZone
Date: Pipe Length (ft) P.O.#: Customer:	03/26/2018 1: 56.8	Weather: Owner: Surveyor: Clean Date:	NA Byrd Fitzger 01/01/1900		Coding: Pre Clean: PSR: Shape:	PACP 6.0 No Pre-Cleaning P-507-081-050 C
Street:	FOXCROFT STREET		Flow Control:		Not Controlled	
City:	Hobart, IN		Year Renewe	d:		
Location:	Light Highway		Tape/Media	# :		
Purpose:	Routine Assessment	t	Dia/Height:		8"	
Use:	Sanitary		Material:		PVC	
Drain Area:	NA		Lining:			
Category:	NA					
Comment:						
Location Detail	s:		Direction of S	urvey:	Downstream	
US MH:	M-507-081	DS MH:	M-507-050		Total Length Surveyed (ft)	56.9
0&M Index:	2.00	O&M Quick:	:	2300	O&M Rating:	6.00
tructural Index:	0.00		ıick:	0000	Structural Rating:	0.00
Overall Index:	2.00	Overall Quick	<: 2	2300	Overall Rating:	6.00

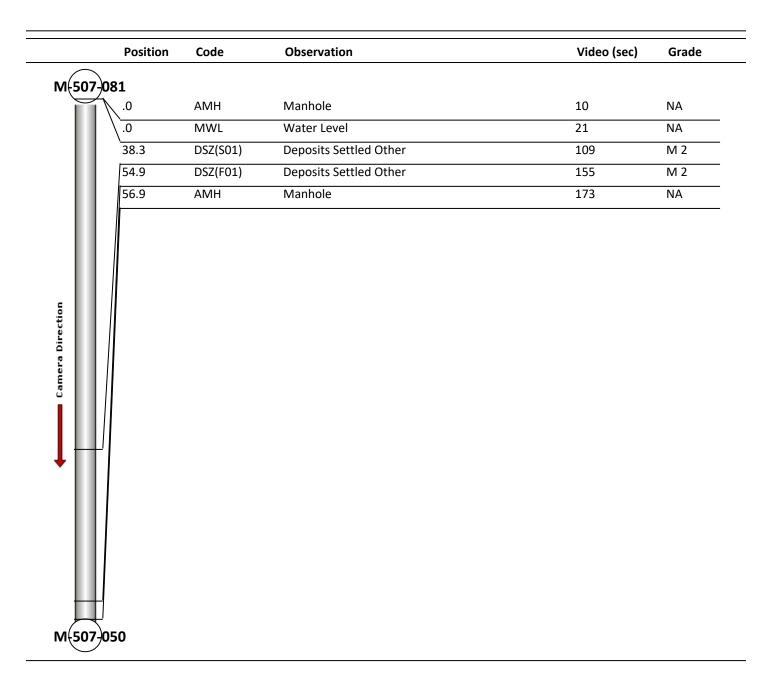
Code: Description:	AMH Manhole
Distance (ft):	.0
Structural Grade:	0
O&M Grade:	0
Clock Start/From:	
Clock To:	
1st Value:	
2nd Value:	
Value Percent:	
Continuous Index:	
Within 8" of Joint:	NO
Remarks:	M-507-081
