Date:	04/11/2018	Weather:			Coding:	PACP 6.0
Pipe Length (ft)	: <b>97.6</b>	Owner:	NA		Pre Clean:	Not Known
P.O.#:		Surveyor:	Jen Costello		PSR:	P-603-026-003
Customer:		Clean Date:	01/01/1900		Shape:	С
Street:	W 40th ave		Flow Control:		Not Controlled	
City:	Hobart, IN		Year Renewed	:		
Location:	Other		Tape/Media #			
Purpose:	Not Known		Dia/Height:		8"	
Use:	Sanitary		Material:		VCP	
Drain Area:	NA		Lining:			
Category:	NA					
Comment:						
Location Details	5:		Direction of Su	irvey:	Upstream	
US MH:	M-603-003	DS MH:	M-603-026	Total	Length Surveyed (ft)	76.7
0&M Index:	2.00	O&M Quick:	2:	L00	O&M Rating:	2.00
Structural Index:	5.00	Structural Qu	uick: 5	L00	Structural Rating:	5.00
Overall Index:	3.50	Overall Quic		121	Overall Rating:	7.00

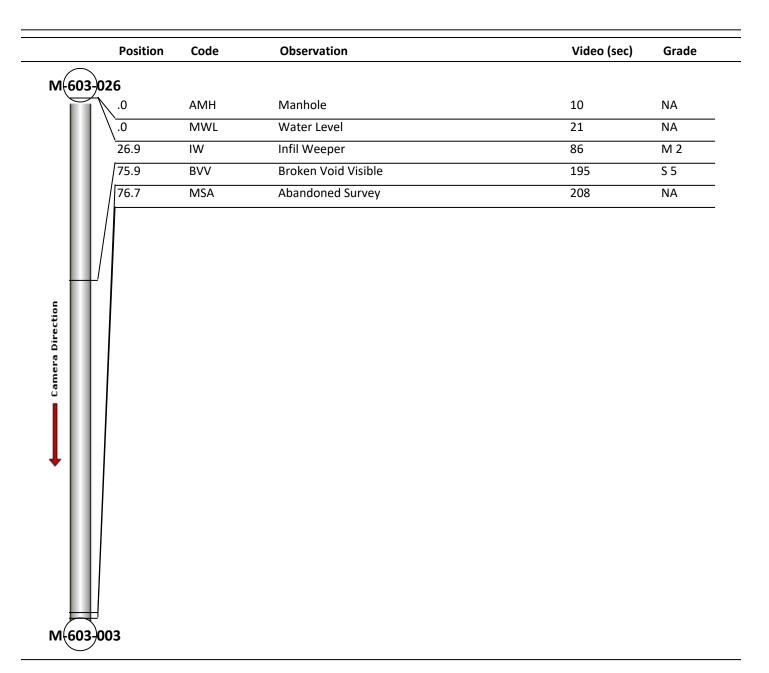
Code: Description:	AMH Manhole
Distance (ft):	.0
Structural Grade:	0
O&M Grade:	0
Clock Start/From:	
Clock To:	
1st Value:	
2nd Value:	
Value Percent:	
Continuous Index:	
Within 8" of Joint:	NO
Remarks:	M-603-003
