Profile/Ph	oto Observation	Report			RedZon
Date:	04/11/2018	Weather:		Coding:	PACP 6.0
Pipe Length (ft	z): <b>331.4</b>	Owner:	NA	Pre Clean:	No Pre-Cleaning
P.O.#:		Surveyor:	Jen Costello	PSR:	P-607-054-071
Customer:		Clean Date:	01/01/1900	Shape:	С
Street:	OFF W 10TH ST		Flow Control:	Not Controlled	
City:	Hobart, IN		Year Renewed:		
Location:	Yard		Tape/Media #:		
Purpose:	Routine Assessmen	t	Dia/Height:	10"	
Use:	Sanitary		Material:	PVC	
Drain Area:	NA		Lining:		
Category:	NA				
Comment:					
Location Detai	ls:		Direction of Sur	vey: Upstream	
US MH:	M-607-054	DS MH:	M-607-071	Total Length Surveyed (ft)	): <b>323.9</b>
0&M Index:	0.00	O&M Quick:	000	00 O&M Rating:	0.00
tructural Index	0.00	 Structural Qu	uick: 000	00 Structural Rating:	0.00
Overall Index:	0.00	Overall Quick			0.00

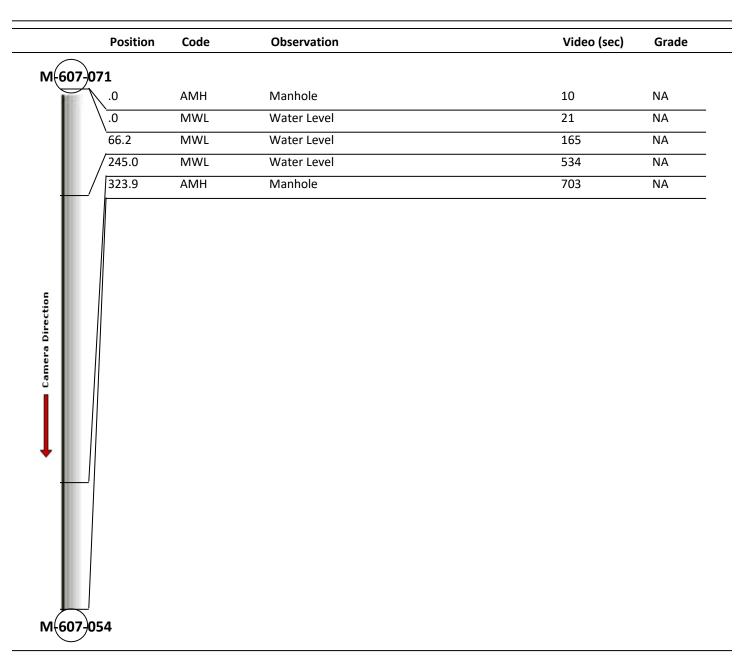
Code: Description:	AMH Manhole
Distance (ft):	.0
Structural Grade:	0
O&M Grade:	0
Clock Start/From:	
Clock To:	
1st Value:	
2nd Value:	
Value Percent:	
Continuous Index:	
Within 8" of Joint:	NO
Remarks:	M-607-071
