Profile/Ph	oto Observatior	n Report				RedZone
Date: Pipe Length (ft P.O.#: Customer:	04/05/2018 :): 133.3	Weather: Owner: Surveyor: Clean Date:	NA Jen Costello 01/01/1900		Coding: Pre Clean: PSR: Shape:	PACP 6.0 No Pre-Cleaning P-608-032-033 C
Street:	FOXCROFT STREET	ſ	Flow Control:		Not Controlled	
City:	Hobart, IN		Year Renewed:			
Location:	Yard		Tape/Media #:			
Purpose:	Routine Assessme	nt	Dia/Height:		12"	
Use:	Sanitary		Material:		PVC	
Drain Area:	NA		Lining:			
Category:	NA					
Comment:	Flow direction is n	narked wrong.				
Location Detai	ls:		Direction of Sur	rvey:	Downstream	
US MH:	M-608-033	DS MH:	M-608-032	Total	Length Surveyed (ft):	130.5
D&M Index:	2.00	O&M Quick:	28	00	O&M Rating:	16.00
Structural Index:	0.00	Structural Q	uick: 00	00	Structural Rating:	0.00
Overall Index:	2.00	Overall Quic	k: 28	00	Overall Rating:	16.00

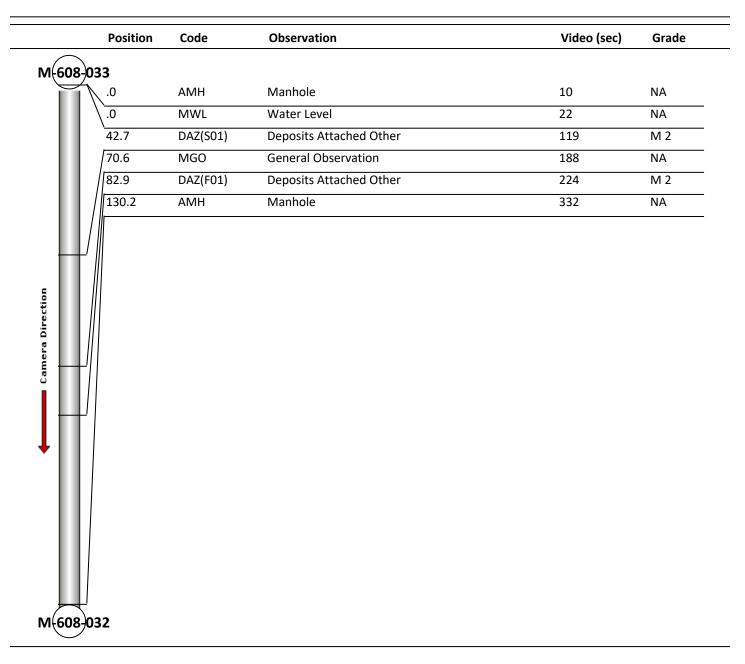
Code:	АМН
Description:	Manhole
Distance (ft):	.0
Structural Grade:	0
O&M Grade:	0
Clock Start/From:	
Clock To:	
1st Value:	
2nd Value:	
Value Percent:	
Continuous Index:	
Within 8" of Joint:	NO
Remarks:	M-608-033
