Profile/Ph	oto Observatio	n Report			RedZone
Date:	04/16/2018	Weather:		Coding:	PACP 6.0
Pipe Length (ft): 192.9	Owner:	NA	Pre Clean:	Not Known
P.O.#:		Surveyor:	Selasie Honu	PSR:	P-706-010.5-010.4
Customer:		Clean Date:	01/01/1900	Shape:	C
Street:	Capitol		Flow Control:	Not Controlled	
City:	Hobart, IN		Year Renewed:		
Location:	Ditch		Tape/Media #:		
Purpose:	Maintenance Rel	ated	Dia/Height:	12"	
Use:	Sanitary		Material:	PVC	
Drain Area:	NA		Lining:	Cured in Place	
Category:	NA				
Comment:	blk silt at 12'. flow	v incorrect.			
Location Detail	ls:		Direction of Survey	: Upstream	
US MH:	M-706-010.4	DS MH:	M-706-010.5	Total Length Surveyed (ft)	: 13.7
0&M Index:	0.00	O&M Quick:	0000	O&M Rating:	0.00
tructural Index:	0.00	Structural Qu	uick: 0000	Structural Rating:	0.00
Overall Index:	0.00	Overall Quick	c: 0000	Overall Rating:	0.00

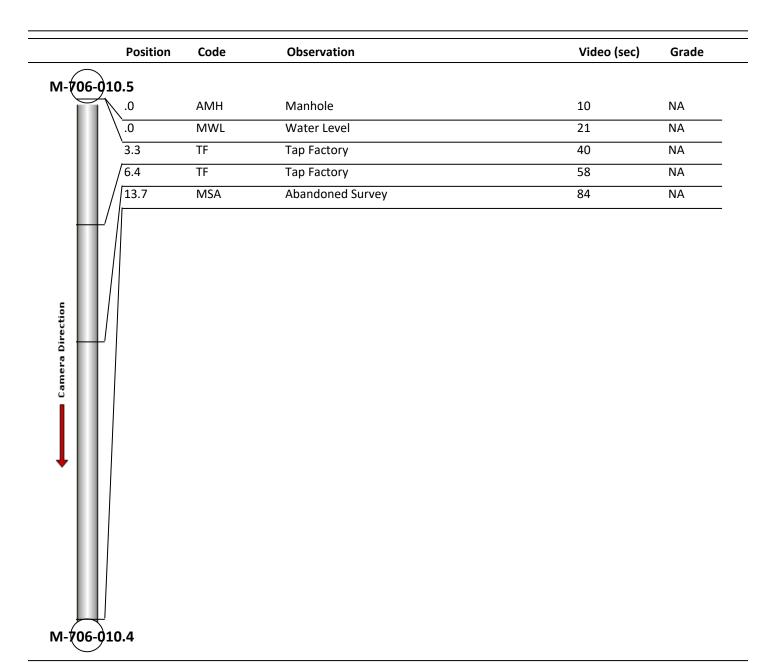
Code: Description:	AMH Manhole	
Distance (ft):	.0	
Structural Grade:	0	
O&M Grade:	0	
Clock Start/From:		
Clock To:		
1st Value:		
2nd Value:		
Value Percent:		
Continuous Index:		
Within 8" of Joint:	NO	
Remarks:	M-706-010.5
