Profile/Ph	oto Observatio	n Report				RedZor
Date:	04/03/2018	Weather:			Coding:	PACP 6.0
Pipe Length (ft): 126.4	Owner:	NA		Pre Clean:	Not Known
P.O.#:		Surveyor:	Jen Costello)	PSR:	P-708-111-110
Customer:		Clean Date	: 01/01/1900)	Shape:	с
Street: BRACKEN PKWY & LINCOLN ST		Flow Control:		Not Controlled		
City:	Hobart, IN		Year Renewe	d:		
Location:	Sidewalk		Tape/Media	#:		
Purpose:	Maintenance Rela	ated	Dia/Height:		8"	
Use:	Sanitary		Material:		PVC	
Drain Area:	NA		Lining:		Cured in Place	
Category:	NA					
Comment:						
Location Detai	ls:		Direction of S	Survey:	Upstream	
US MH:	M-708-111	DS MH:	M-708-110	Тс	otal Length Surveyed (ft)	25.2
O&M Index:	2.00	O&M Quick	:	2200	O&M Rating:	4.00
Structural Index:	0.00	Structural C	uick:	0000	Structural Rating:	0.00
Overall Index:	2.00	Overall Qui	ck:	2200	Overall Rating:	4.00

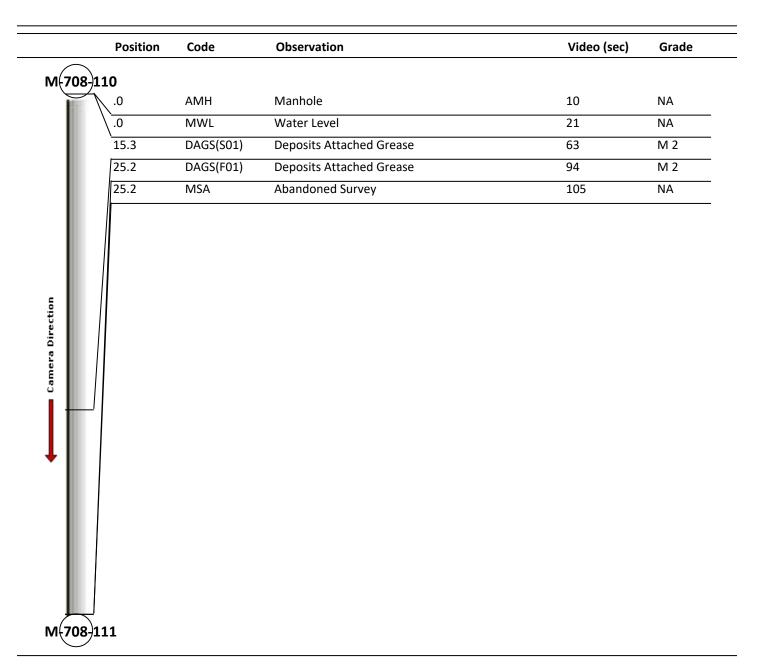
Code: Description:	AMH Manhole
Distance (ft):	.0
Structural Grade:	0
O&M Grade:	0
Clock Start/From:	
Clock To:	
1st Value:	
2nd Value:	
Value Percent:	
Continuous Index:	
Within 8" of Joint:	NO
Remarks:	M-708-110
