Profile/Ph	noto Observatio	n Report				RedZon
Date:	03/20/2018	Weather:			Coding:	PACP 6.0
Pipe Length (ft	t): 201.0	Owner:	NA		Pre Clean:	Not Known
P.O.#:		Surveyor:	John Kugl	maier	PSR:	P-709-005-006
Customer:		Clean Date	: 01/01/190	00	Shape:	с
Street:	Oak		Flow Contro	ol:	Not Controlled	
City:	Hobart, IN		Year Renew	ved:		
Location:	Yard		Tape/Media	a #:		
Purpose:	Maintenance Rela	ated	Dia/Height:		10"	
Use:	Sanitary		Material:		PVC	
Drain Area:	NA		Lining:			
Category:	NA					
Comment:						
Location Detai	ils:		Direction of	[:] Survey:	Upstream	
US MH:	M-709-005	DS MH:	M-709-006	Тс	otal Length Surveyed (ft):	192.7
)&M Index:	0.00	O&M Quick	:	0000	O&M Rating:	0.00
tructural Index	. 0.00	Structural Q	uick:	0000	Structural Rating:	0.00
Overall Index:	0.00	Overall Quid	·k·	0000	Overall Rating:	0.00

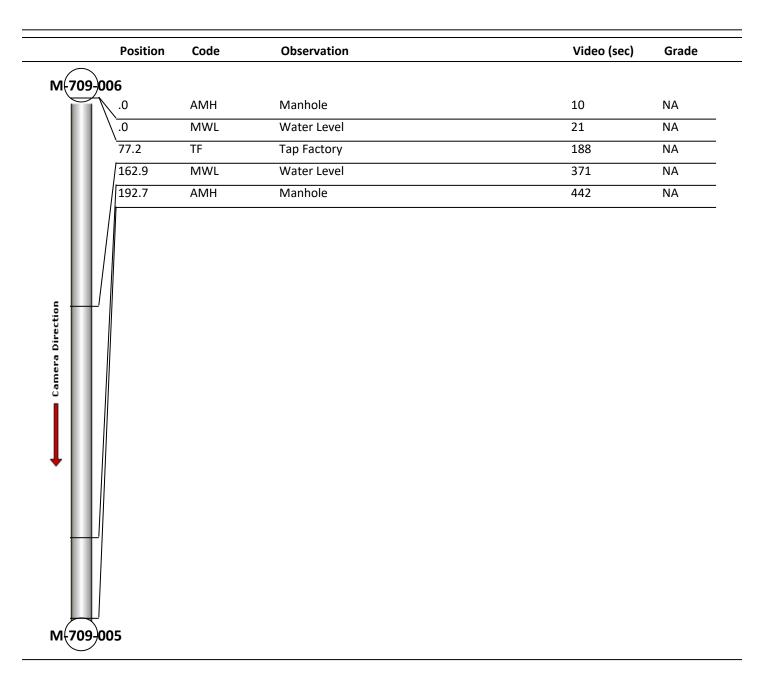
Code:	АМН
Description:	Manhole
Distance (ft):	.0
Structural Grade:	0
O&M Grade:	0
Clock Start/From:	
Clock To:	
1st Value:	
2nd Value:	
Value Percent:	
Continuous Index:	
Within 8" of Joint:	NO
Remarks:	M-709-006
