Profile/Ph	oto Observatio	n Report				RedZone
Date:	03/20/2018	Weather:			Coding:	PACP 6.0
Pipe Length (ft)	: 121.8	Owner:	NA		Pre Clean:	Not Known
P.O.#:		Surveyor:	John Ku	glmaier	PSR:	P-709-018-017
Customer:		Clean Date	e: 01/01/1	900	Shape:	С
Street:	Oak		Flow Cont	trol:	Not Controlled	
City:	Hobart, IN		Year Rene	ewed:		
Location:	Yard		Tape/Me	dia #:		
Purpose:	Maintenance Rela	ated	Dia/Heigh	nt:	8"	
Use:	Sanitary		Material:		PVC	
Drain Area:	NA		Lining:			
Category:	NA					
Comment:						
Location Details	s:		Direction	of Survey:	Upstream	
US MH:	M-709-017	DS MH:	M-709-018	Т	otal Length Surveyed (ft)	119.5
0&M Index:	0.00	O&M Quick	α.	0000	O&M Rating:	0.00
tructural Index:	0.00	Structural C		0000	Structural Rating:	0.00
Overall Index:	0.00	Overall Qui	ck:	0000	Overall Rating:	0.00

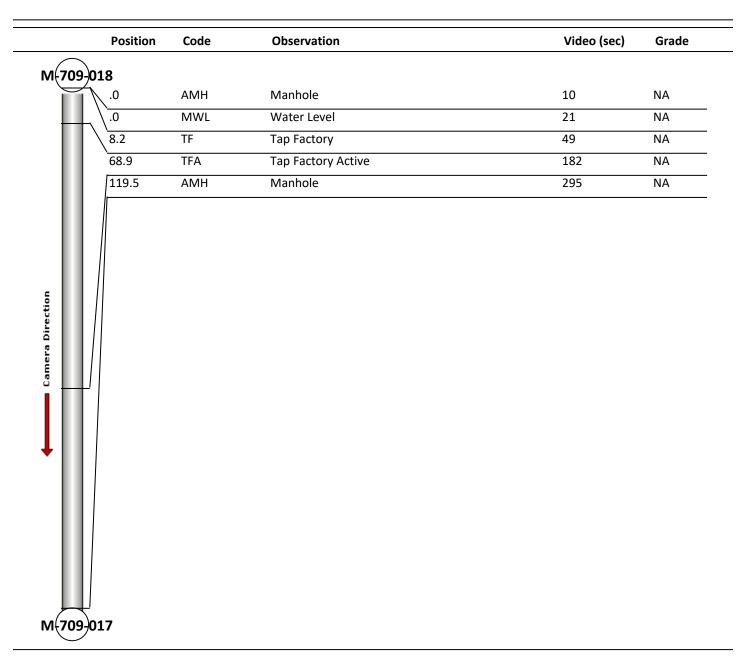
Code: Description:	AMH Manhole
Distance (ft):	.0
Structural Grade:	0
O&M Grade:	0
Clock Start/From:	
Clock To:	
1st Value:	
2nd Value:	
Value Percent:	
Continuous Index:	
Within 8" of Joint:	NO
Remarks:	M-709-018
