Date:	04/04/2018	Weather:		Coding:	PACP 6.0
Pipe Length (ft):	198.7	Owner:	NA	Pre Clean:	Not Known
P.O.#:		Surveyor:	Jen Costello	PSR:	P-803-049-050
Customer:		Clean Date:	01/01/1900	Shape:	С
Street:	N Kelly Ave.		Flow Control:	Not Controlled	
City:	Hobart, IN		Year Renewed:		
Location:	Other		Tape/Media #:		
Purpose:	Not Known		Dia/Height:	10"	
Use:	Sanitary		Material:	VCP	
Drain Area:	NA		Lining:		
Category:	NA				
Comment:					
Location Details	:		Direction of Surve	y: Upstream	
US MH:	M-803-050	DS MH:	M-803-049	Total Length Surveyed (ft)	: 3.3
D&M Index:	2.00	O&M Quick:	2100	O&M Rating:	2.00
Structural Index:	0.00	Structural Qu	uick: 0000		0.00
Overall Index:	2.00	Overall Quic		Overall Rating:	2.00

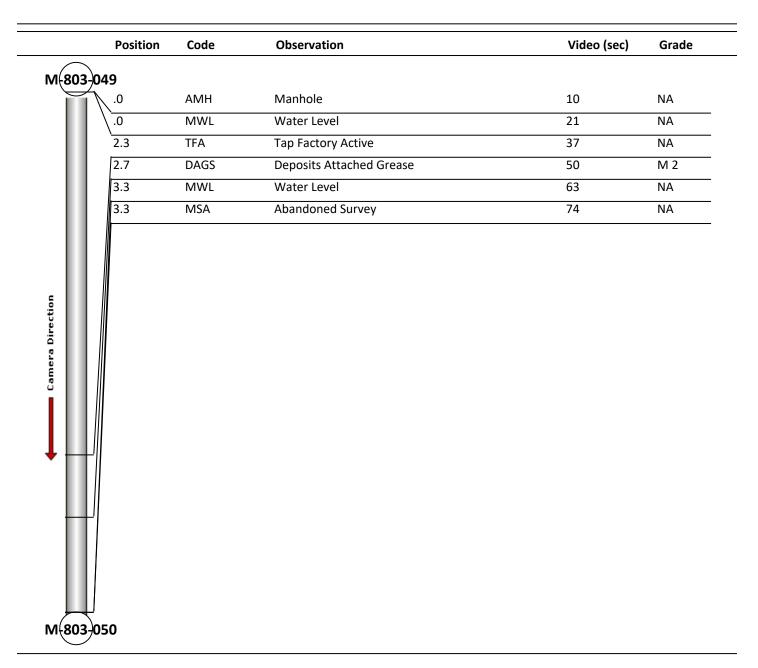
Code: Description:	AMH Manhole
Distance (ft):	.0
Structural Grade:	0
O&M Grade:	0
Clock Start/From:	
Clock To:	
1st Value:	
2nd Value:	
Value Percent:	
Continuous Index:	
Within 8" of Joint:	NO
Remarks:	M-803-049
