Profile/Ph	oto Observatior	n Report				RedZon
Date:	04/12/2018	Weather:			Coding:	PACP 6.0
Pipe Length (ft): 181.7	Owner:	NA		Pre Clean:	Not Known
P.O.#:		Surveyor:	Jen Costello		PSR:	P-806-030-029
Customer:		Clean Date	: 01/01/1900		Shape:	с
Street:	E 8TH ST & 9TH CT	Г	Flow Control:		Not Controlled	
City:	Hobart, IN		Year Renewee	d:		
Location:	Sidewalk		Tape/Media #	!:		
Purpose:	Maintenance Rela	ited	Dia/Height:		8"	
Use:	Sanitary		Material:		PVC	
Drain Area:	NA		Lining:		Cured in Place	
Category:	NA					
Comment:	flow incorrect.					
Location Detail	ls:		Direction of S	urvey:	Downstream	
US MH:	M-806-029	DS MH:	M-806-030	Tot	al Length Surveyed (ft):	178.9
0&M Index:	0.00	O&M Quick	. C	000	O&M Rating:	0.00
tructural Index:	0.00	Structural Q	uick: C	000	Structural Rating:	0.00
Overall Index:	0.00	Overall Quid	:k: C	000	Overall Rating:	0.00

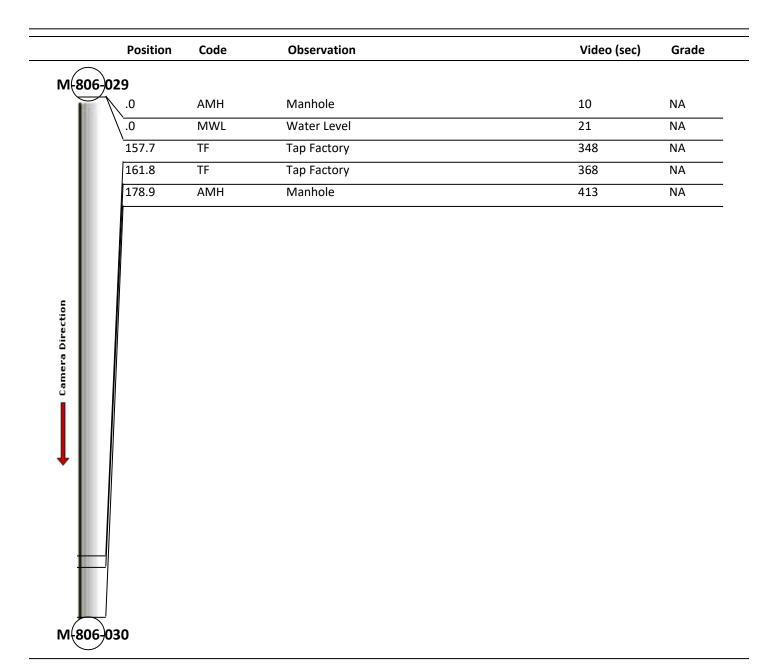
Code: Description:	AMH Manhole
Distance (ft):	.0
Structural Grade:	0
O&M Grade:	0
Clock Start/From:	
Clock To:	
1st Value:	
2nd Value:	
Value Percent:	
Continuous Index:	
Within 8" of Joint:	NO
Remarks:	M-806-029
