Profile/Ph	oto Observation	Report				RedZon
Date:	10/12/2018	Weather:			Coding:	PACP 6.0
Pipe Length (ft): 391.8	Owner:	NA		Pre Clean:	Not Known
P.O.#:		Surveyor:	Selasie Honu		PSR:	P-808-029-030
Customer:		Clean Date:	01/01/1900		Shape:	С
Street:	Hobart Rd.		Flow Control:		Not Controlled	
City:	Hobart, IN		Year Renewed	:		
Location:	Light Highway		Tape/Media #			
Purpose:	Routine Assessmen	t	Dia/Height:		12"	
Use:	Sanitary		Material:		PVC	
Drain Area:	NA		Lining:			
Category:	NA					
Comment:						
Location Detail	ls:		Direction of Su	rvey:	Downstream	
US MH:	M-808-030	DS MH:	M-808-029	Total	Length Surveyed (ft)	: 334.4
0&M Index:	1.00	O&M Quick:	1:	L00	O&M Rating:	1.00
tructural Index:	0.00	 Structural Qu	iick: 0	000	Structural Rating:	0.00
Overall Index:	1.00	Overall Quick	1:	100	Overall Rating:	1.00

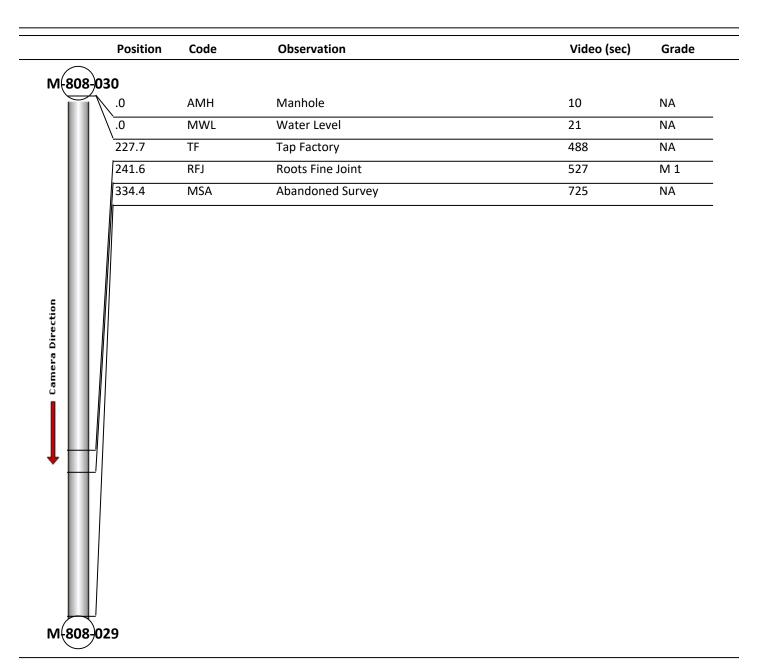
Code: Description:	AMH Manhole
Distance (ft):	.0
Structural Grade:	0
O&M Grade:	0
Clock Start/From:	
Clock To:	
1st Value:	
2nd Value:	
Value Percent:	
Continuous Index:	
Within 8" of Joint:	NO
Remarks:	M-808-030
