Data	02/20/2018	\\/aathaw		Cadinari	
Date:	03/20/2018	Weather:		Coding:	PACP 6.0
Pipe Length (ft):	181.4	Owner:	NA	Pre Clean:	Not Known
P.O.#:		Surveyor:	JUSTIN GONZA		P-903-051-052
Customer:		Clean Date:	01/01/1900	Shape:	C
Street:	OFF E 38TH PL		Flow Control:	Not Controlle	d
City:	Hobart, IN		Year Renewed:		
Location:	Other		Tape/Media #:		
Purpose:	Not Known		Dia/Height:	10"	
Use:	Sanitary		Material:	PVC	
Drain Area:	NA		Lining:		
Category:	NA				
Comment:					
Location Details:			Direction of Surv	vey: Upstream	
US MH: N	1-903-052	DS MH:	M-903-051	Total Length Surveyed (f	t): <b>197.8</b>
0&M Index:	2.00	O&M Quick:	210	0 O&M Rating:	2.00
Structural Index:	0.00	Structural Qu	uick: 000		g: <b>0.00</b>
Overall Index:	2.00	Overall Quic			2.00

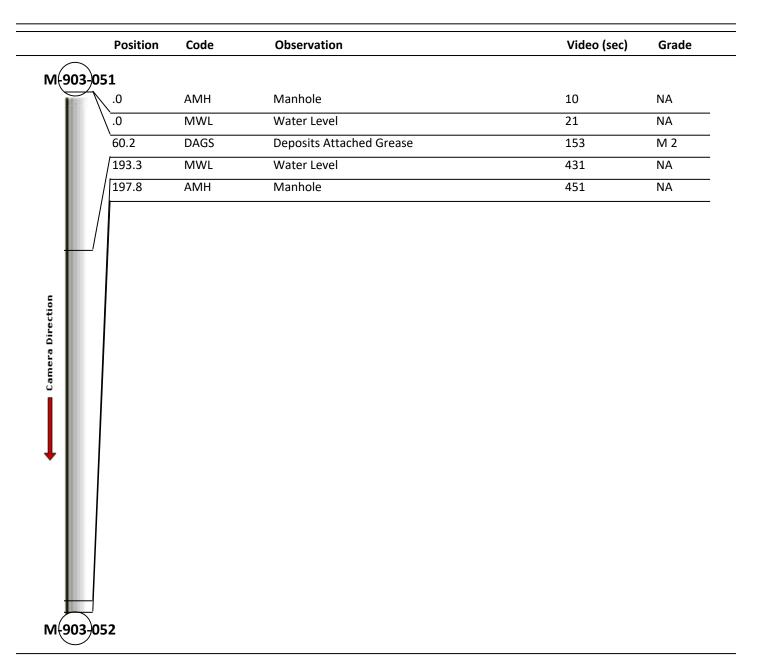
Code: Description:	AMH Manhole
Distance (ft):	.0
Structural Grade:	0
O&M Grade:	0
Clock Start/From:	
Clock To:	
1st Value:	
2nd Value:	
Value Percent:	
Continuous Index:	
Within 8" of Joint:	NO
Remarks:	M-903-051
