Date:	04/05/2018	Weather:		Coding:	PACP 6.0
Pipe Length (ft):	285.4	Owner:	NA	Pre Clean:	Not Known
P.O.#:		Surveyor:	Jen Costello	PSR:	P-904-072-063
Customer:		Clean Date:	01/01/1900	Shape:	С
Street:	Shelby St.		Flow Control:	Not Controlled	
City:	Hobart, IN		Year Renewed:		
Location:	Other		Tape/Media #:		
Purpose:	Not Known		Dia/Height:	8"	
Use:	Sanitary		Material:	VCP	
Drain Area:	NA		Lining:		
Category:	NA				
Comment:					
Location Details:	:		Direction of Survey	/: Downstream	
US MH:	VI-904-063	DS MH:	M-904-072	Total Length Surveyed (ft)	: 7.8
D&M Index:	1.00	O&M Quick:	1200	O&M Rating:	2.00
Structural Index:	0.00	Structural Qu	uick: 0000	Structural Rating:	0.00
Overall Index:	1.00	Overall Quic	1200	Overall Rating:	2.00

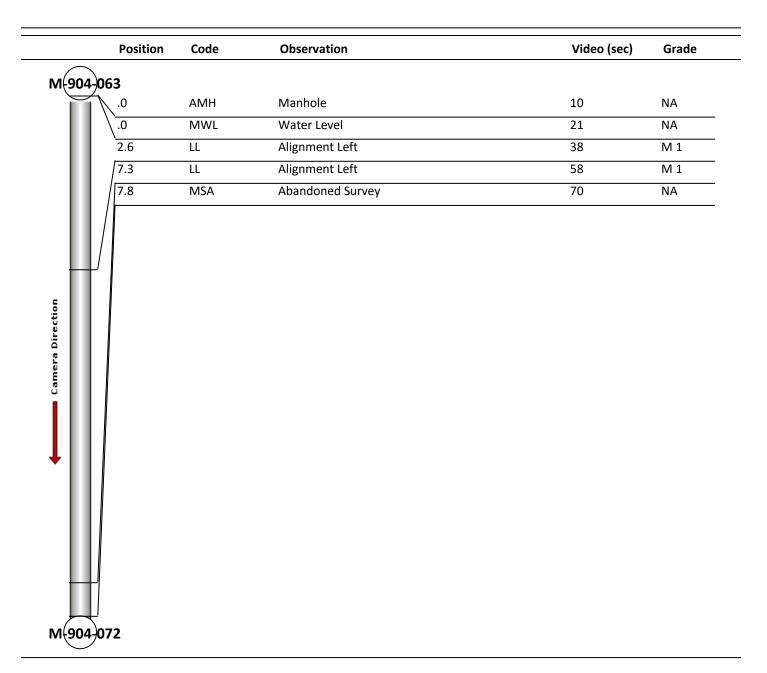
Code: Description:	AMH Manhole
Distance (ft):	.0
Structural Grade:	0
O&M Grade:	0
Clock Start/From:	
Clock To:	
1st Value:	
2nd Value:	
Value Percent:	
Continuous Index:	
Within 8" of Joint:	NO
Remarks:	M-904-063
