Profile/Ph	oto Observatio	n Report				RedZone
Date:	03/28/2018	Weather:			Coding:	PACP 6.0
Pipe Length (ft)): 91.1	Owner:	NA		Pre Clean:	Not Known
P.O.#:		Surveyor:	Selasie H	onu	PSR:	P-910-014-013
Customer:		Clean Date	e: 01/01/19	00	Shape:	С
Street:	Norris		Flow Contr	ol:	Not Controlled	
City:	Hobart, IN		Year Renev	ved:		
Location:	Sidewalk		Tape/Med	a #:		
Purpose:	Maintenance Rela	ated	Dia/Height	:	8"	
Use:	Sanitary		Material:		PVC	
Drain Area:	NA		Lining:			
Category:	NA					
Comment:	Flow direction wr	ong.				
Location Detail	S:		Direction c	of Survey:	Downstream	
US MH:	M-910-013	DS MH:	M-910-014	Тс	otal Length Surveyed (ft)	: 89.0
0&M Index:	0.00	O&M Quick	<:	0000	O&M Rating:	0.00
itructural Index:	0.00	Structural C	Quick:	0000	Structural Rating:	0.00
Overall Index:	0.00	Overall Qui	ck:	0000	Overall Rating:	0.00

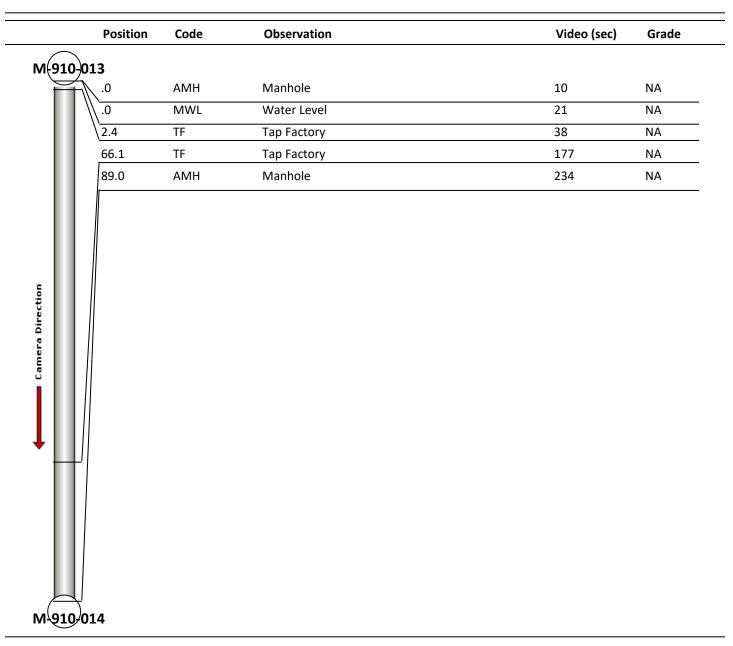
Code: Description:	AMH Manhole
Distance (ft):	.0
Structural Grade:	0
O&M Grade:	0
Clock Start/From:	
Clock To:	
1st Value:	
2nd Value:	
Value Percent:	
Continuous Index:	
Within 8" of Joint:	NO
Remarks:	M-910-013
