Manhole Inspection Report

Date:	04/18/2018	Weather:		Coding:	RZMACP
MH#:	M-103-109	Owner:	NA	Len. Surveyed:	6.8
P.O.#:		Surveyor:	John Kuglmaier	Rim to Invert:	8.0
Customer:		Cert. #:	U-1215-07002349	Wall Material:	Concrete (reinforced)

Street:	Alabama St. 307' South of 39th Ave.	Project:	Hobart, IN
City:	Hobart, IN	GPS Northing:	2889439.531
Location:		GPS Easting:	2889439.531
Drain Area:	Northwest	GPS Accuracy:	Sub-Meter
Cover Shape:	Circular	Evidence of Surcharge:	No
Cover Size:	23.0	Potential for Runoff:	None
Comments:

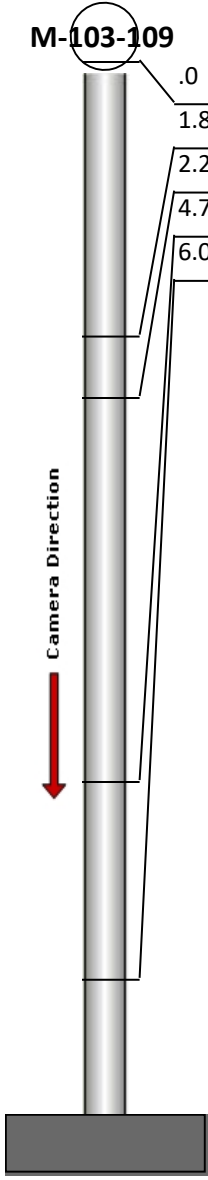
.0	MGP	General Photo	10	NA
	1.8	DAE	Deposits Attached Encrustation	25	M 2
	2.2	MGP	General Photo	40	NA
	4.7	DAZ	Deposits Attached Other	58	M 2
	6.0	MGO	General Observation	72	NA

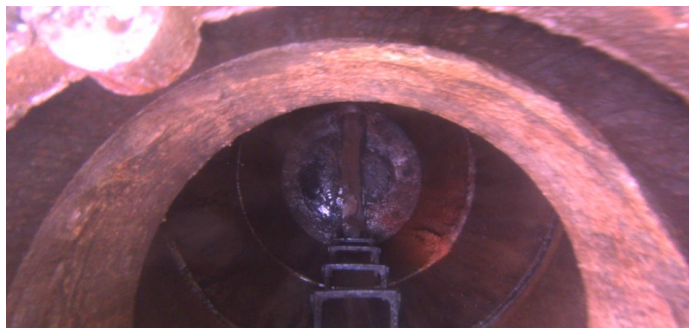
Code: **MGP**
Description: **General Photo**

Distance (ft): **.0**
Structural Grade: **0**
O&M Grade: **0**
Clock Start/From:
Clock To:
1st Value:
2nd Value:
Value Percent:
Step: **NO**
Remarks:

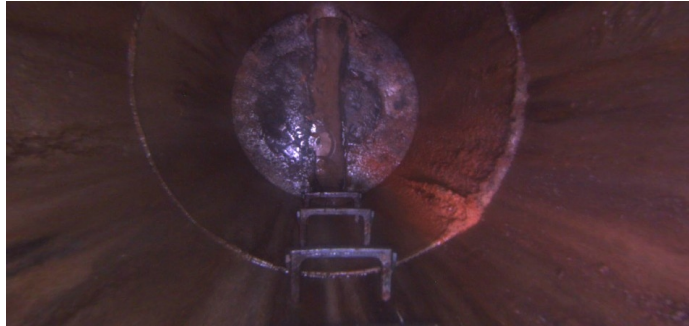
Code: **DAE**
Description: **Deposits Attached Encrustation**

Distance (ft): **1.8**
Structural Grade: **0**
O&M Grade: **2**
Clock Start/From: **5**
Clock To:
1st Value:
2nd Value:
Value Percent: **5.000**
Step: **NO**
Remarks:

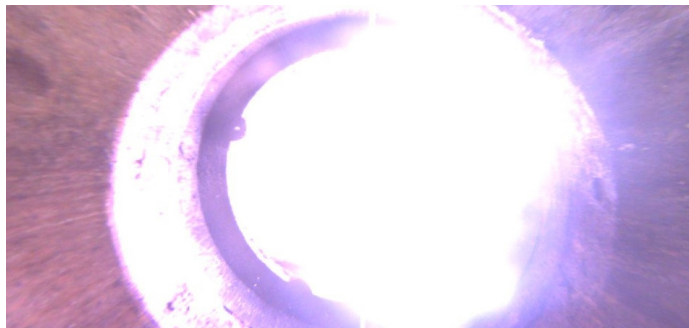
Code: **MGP**
Description: **General Photo**

Distance (ft): **2.2**
Structural Grade: **0**
O&M Grade: **0**
Clock Start/From:
Clock To:
1st Value:
2nd Value:
Value Percent:
Step: **NO**
Remarks:

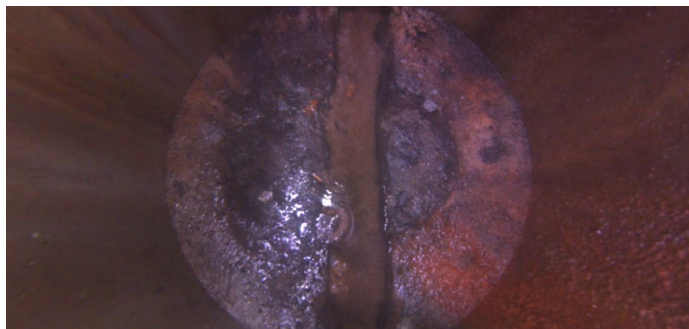
Code: **DAZ**
Description: **Deposits Attached Other**

Distance (ft): **4.7**
Structural Grade: **0**
O&M Grade: **2**
Clock Start/From: **12**
Clock To: **12**
1st Value:
2nd Value:
Value Percent: **10.000**
Step: **NO**
Remarks: **Mixed materials**

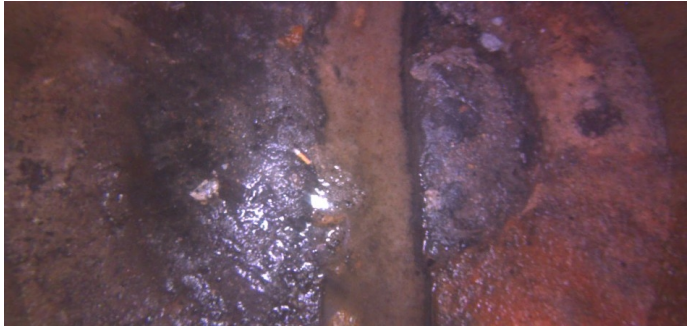
Code:	MGO
Description:	General Observation
Distance (ft):	6.0
Structural Grade:	0
O&M Grade:	0
Clock Start/From:	
Clock To:	
1st Value:	
2nd Value:	
Value Percent:	
Step:	NO
Remarks:	Ins. Comp.
